Ground Failures in Coal Mines with Weak Roof

Greg Molinda, MS

Chris Mark, PhD

ABSTRACT

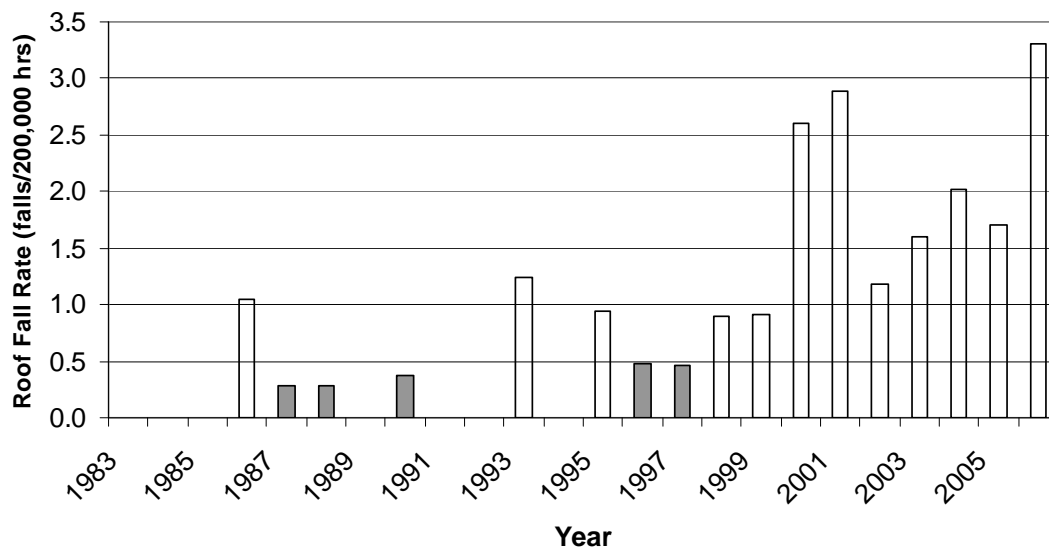
At the study mine roof deterioration and falls are time-dependant and much more frequent in the older workings (Fig. 28). More than 90% of the falls occur 2 or more years after mining. Roof falls are directly related to deterioration of rock between bolts. Roof and rib damage due to weathering steadily decreases when travelling away from the shaft from older workings into newer workings. Roof falls typically begin to occur 4-7 yrs after mining after rib guttering has severed the roof beam. In places where there is humidity roof conditions are extremely poor.

Figure 28: Reportable roof falls increase with time and roof deterioration at an Illinois mine.

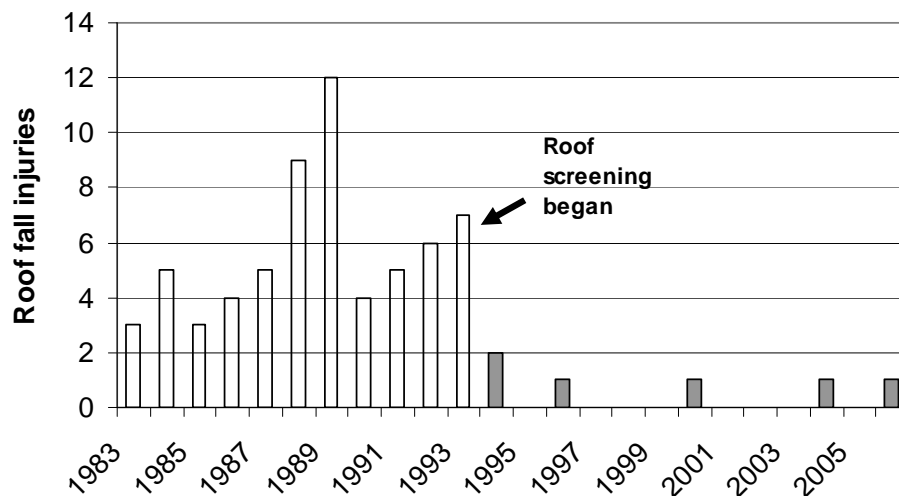
Figure 31: Roof fall injuries dropped dramatically with the use of roof screen at an Illinois coal mine.

The roof fall rate was calculated for those areas where roof screen was installed, and compared against those areas with no roof screen. The roof fall rate was 10.1 falls/10,000 ft of drivage for unscreened areas and was reduced to 2.5 roof falls/10,000 ft of drivage for areas with full screen. Roof fall injuries also decreased dramatically in the screened areas (Fig. 31).
