IC 9149

Bureau of Mines Information Circular/1987

Coal Mine Bumps: Five Case Studies in the Eastern United States

By Alan A. Campoli, Carla A. Kertis, and Claude A. Goode

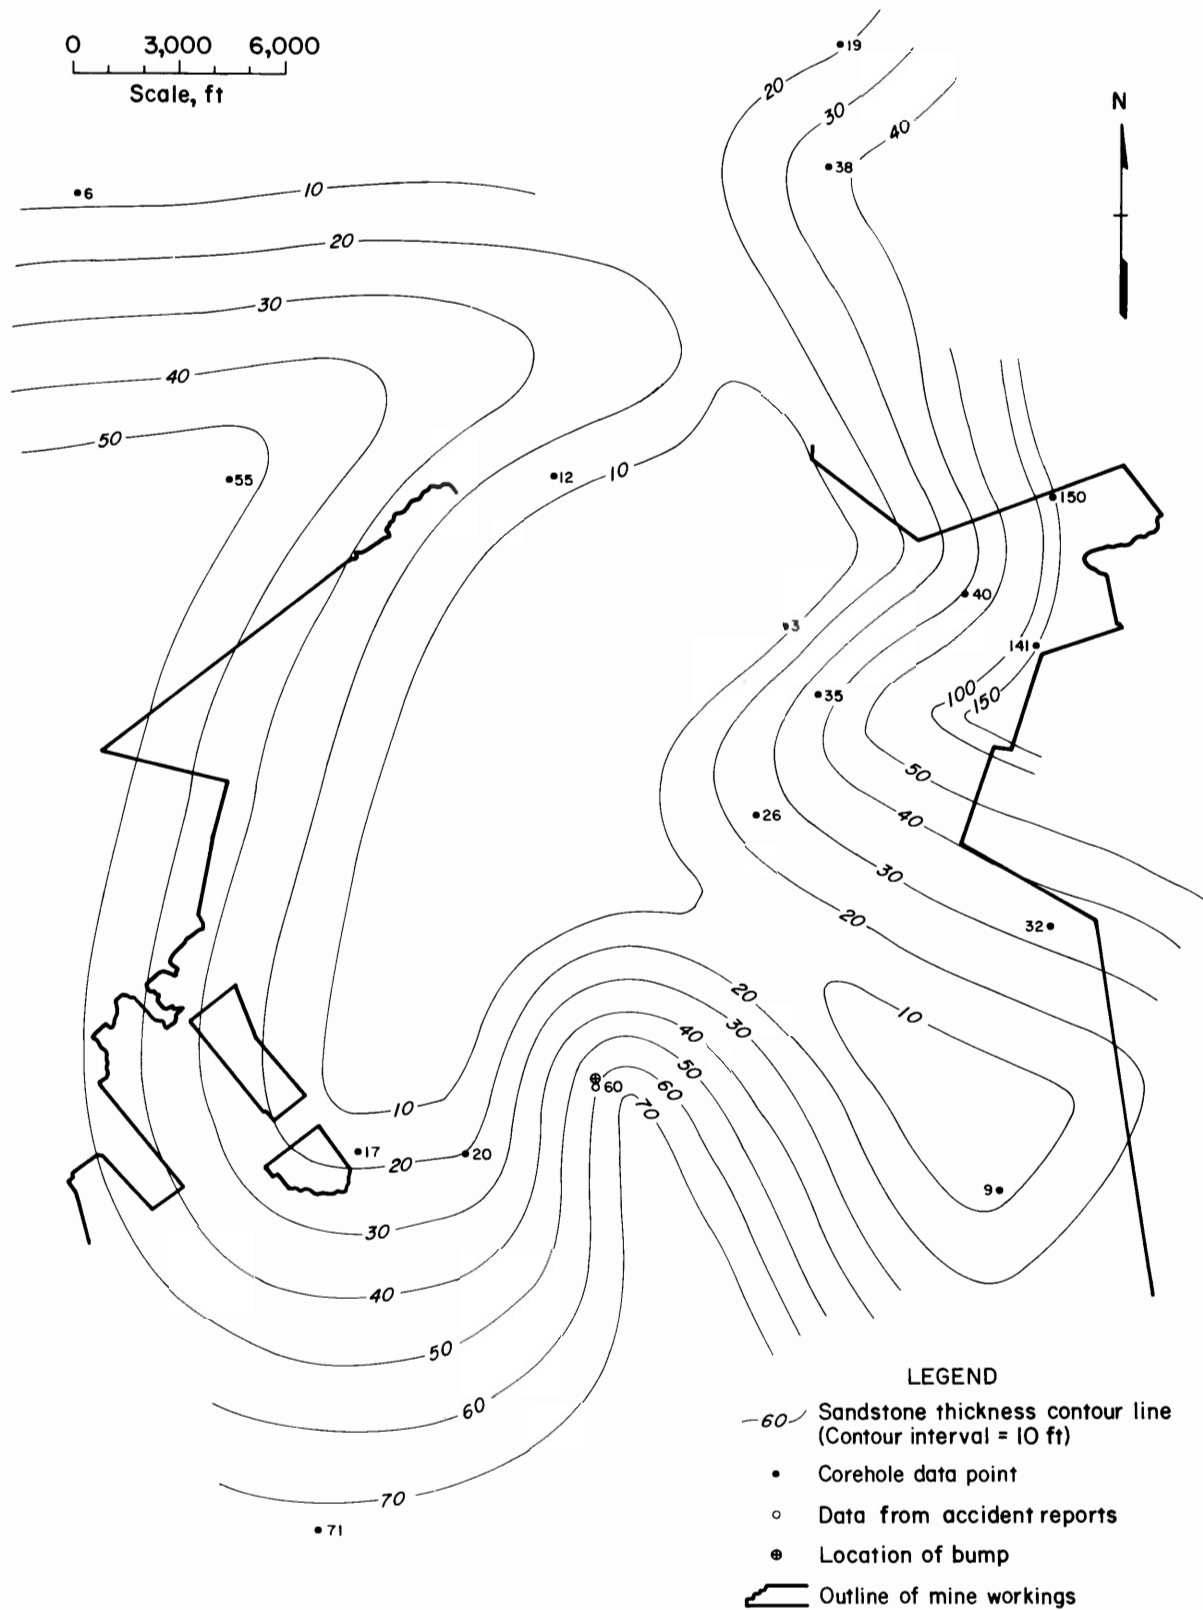
Figure 7.—Sandstone thickness map of Eckman Sandstone, which immediately overlies Pocahontas No. 4 Coalbed, mine 1.

On October 18, 1983, two miners were killed by a bump accident on a continuous miner section, located as marked on figures 7 through 9. No deviations from the general structural trend were evident in the area (fig. 7). Therefore, unusual structural conditions did not lead to the occurrence of the bump. Overburden thickness was in excess of 900 ft (fig. 9). Additionally, data from a Mine Safety and Health Administration (MSHA) accident report (5) and in-mine observations indicated that a hard sandstone approximately 60 ft thick was present immediately above the coalbed (fig. 7). The bump occurred during the mining of the 140- by 350-ft No. 3 barrier pillar. Figure 10 illustrates the conditions directly after the accident. Eight entries on 39-ft centers were planned to divide the pillar. Forces from the bump moved the continuous miner against the right rib and the shuttle car into the crosscut between entries 5 and 6 (fig. 10). The left rib in the No. 5 entry was displaced approximately 8 ft and coal filled the rest of the entry to a depth of 42 in for a distance of approximately 86 ft. The displaced coal is indicated by a dashed line on figure 10. The roof bolting machine was not moved by the forces; however, coal was expelled, filling the No. 2 entry with coal from 3.5 to 5 ft deep, for a distance of 60 ft (5).

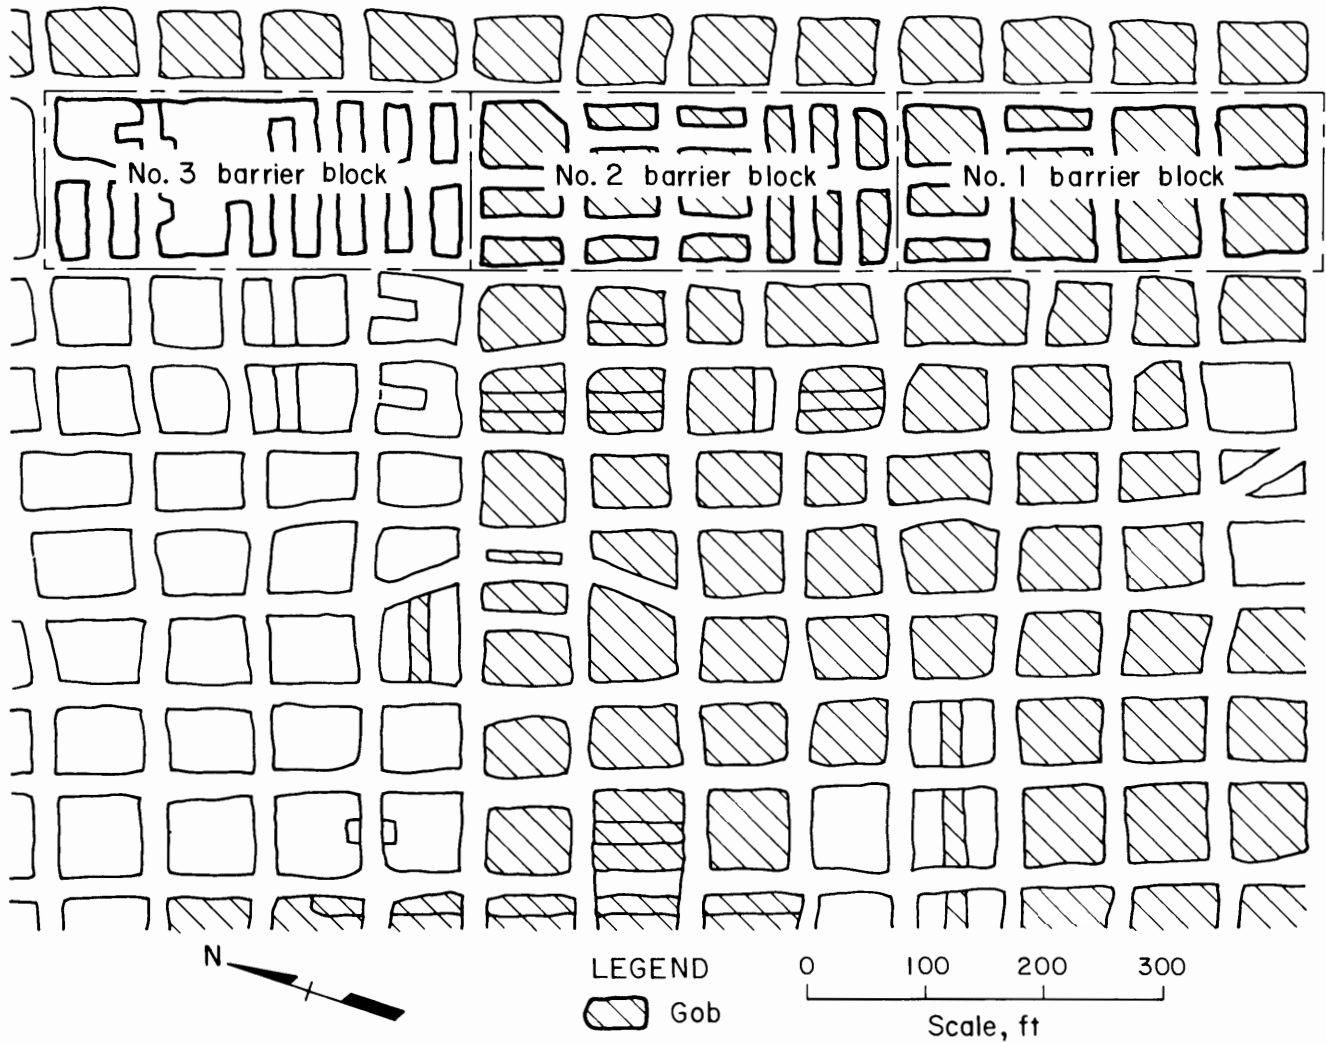
Figure 11.—Plan view of mining sequence prior to bump accident, mine 1.

specific approach to mining was determined on block-by-block evaluation, based on the knowledge of the miners and mine management (5). Two pillars of similar size and shape (directly inby) were mined prior to the fatal bump pillar (fig. 11). The No. 2 barrier pillar was also developed using the narrow-room method. It bumped during an idle shift, expelling several tons of coal and moving the continuous miner. The No. 1 barrier pillar was split into blocks similar in size to the adjacent chain pillars and was retreated without incident.

The No. 3 barrier pillar was located at the intersection of two gob areas; loads were transferred from both the old gob to the east and the new gob directly inby (fig. 11). Also, the 100- by 100-ft block was surrounded by small yielding pillars on two sides. Figure 12 presents a theoretical schematic of the load transfer along section A-A' (fig. 10). The smaller pillars, through their convergence, permitted the rigid roof [approximately 60 ft of massive sandstone (5)] to transfer the load onto the pillar between entries 2 and 5 (fig. 10). The pressure bump manifested itself when the lateral forces exerted by the pressurized pillar core overcame the confining pressure of the crushed periphery. At that point the pillar expanded laterally in an explosive failure.

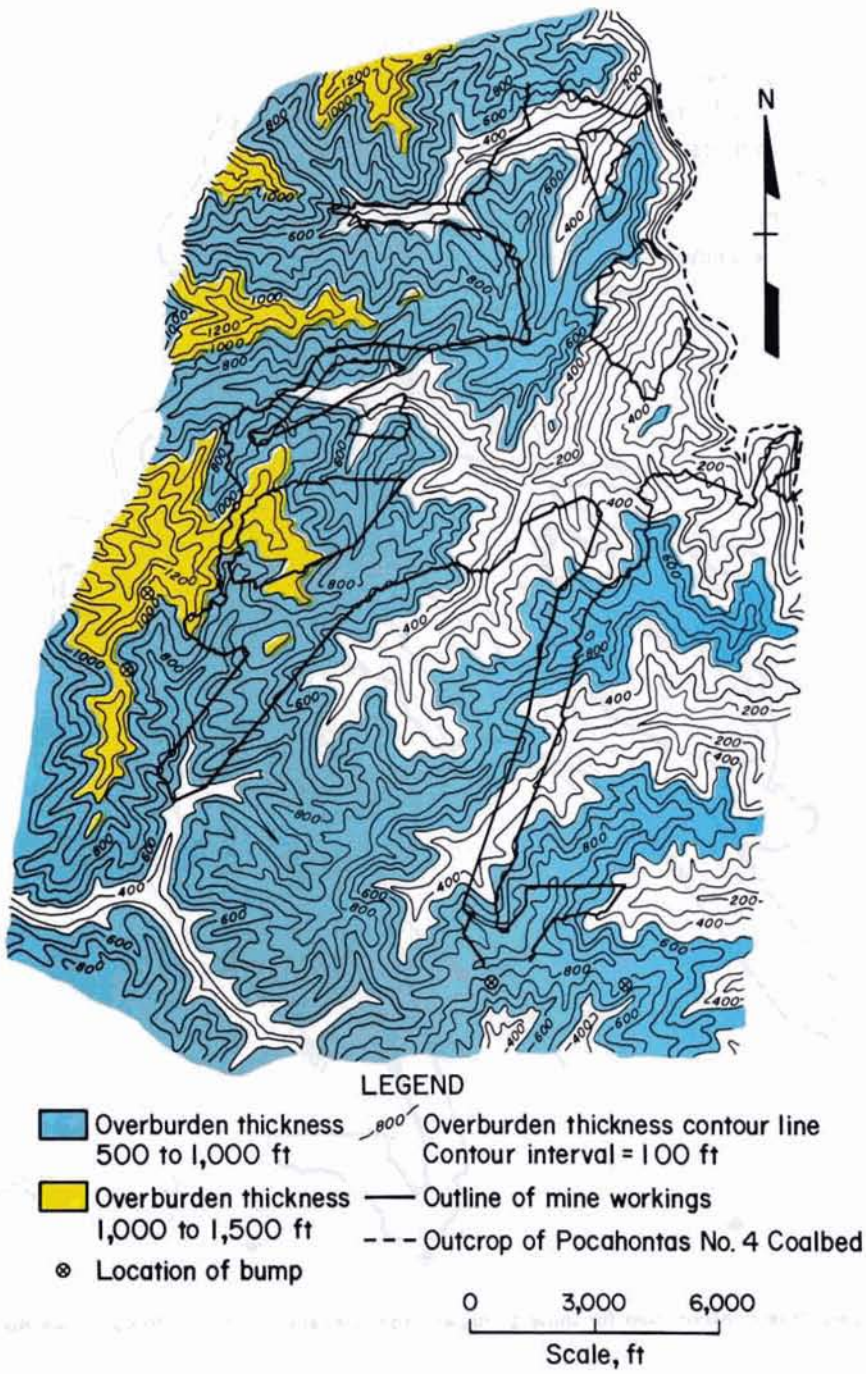
Figure 19.—Overburden map for mine 2.

Overburden thicknesses at mine 2 are less extreme than those at mine 1. The Pocahontas No. 4 Coalbed crops out along Tug Fork where several portals lead into mine 2 toward the west. Highest overburden thicknesses are attained in the west-central portion of the mine (fig. 19). Two major bumps have been documented from this area;

both occurred in areas with greater than 1,000 ft of cover. Two other bumps were experienced under 700 to 800 ft of strata (fig. 19). Mine personnel indicate that no bumps have been recorded under creekbeds, plausibly as a result of lower overburden thicknesses in such areas. Additionally, mine personnel note that where surface fractures have been recognized just off the crests of mountains on the mine property, there have been no bumps in the mine below. Mine personnel believe that these fractures may extend to a depth of 200 ft and theorize that they may relieve some of the stresses imposed by greater overburden thicknesses.

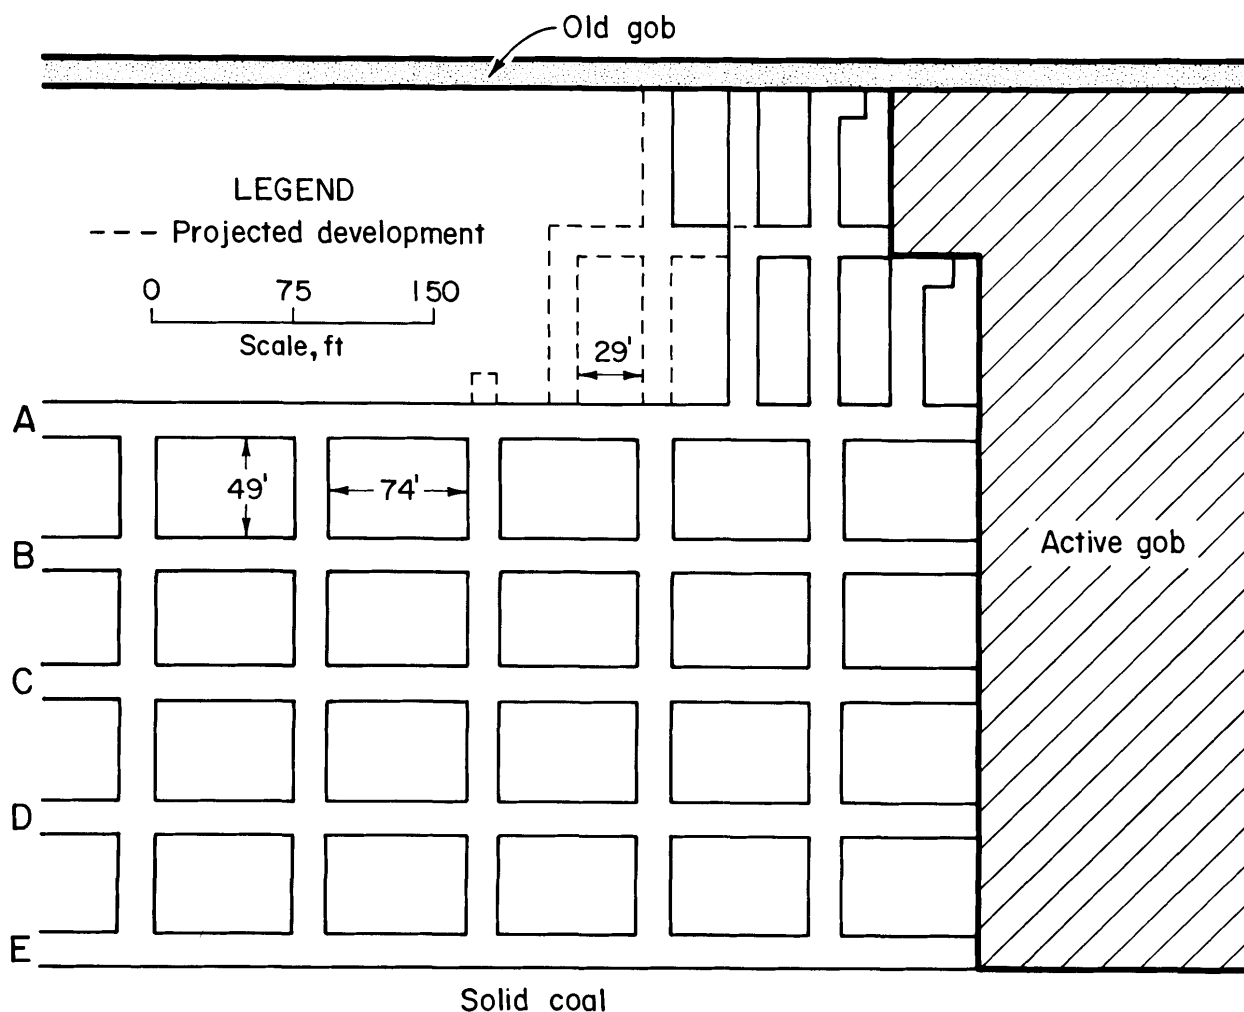
Figure 20.—Thin-pillar mining method diagram, mine 2.

The thin-pillar mining system, designed in the 1950's to combat bumps during the mining of barrier blocks, is still in use today. Figure 20 is a schematic of the thin-pillar mining system; the five entries labeled A, B, C, D, and E are developed in advance. The entries are driven on centers of 65 to 75 ft with breakthroughs every 90 ft. Further refinement of the system revealed that 65-ft centers produced optimum balance between pillar softening and squeeze prevention.

The important feature of the thin-pillar method is that it incorporates a bare minimum of barrier splitting outby the pillar line. Barrier splitting is limited to the active gob edge of the barrier pillar. The rigid portion of the barrier pillar is carrying the main roof load, and its gob sides become crushed and softened. All barrier splitting is confined to the yielded portion of the barrier pillar, and mining in the highly stressed core is avoided. When the outby end of the barrier is approached, the critical size of the pillar, generally considered to be 160 by 160 ft, is formed. This bump block is left to avoid a potential bump.

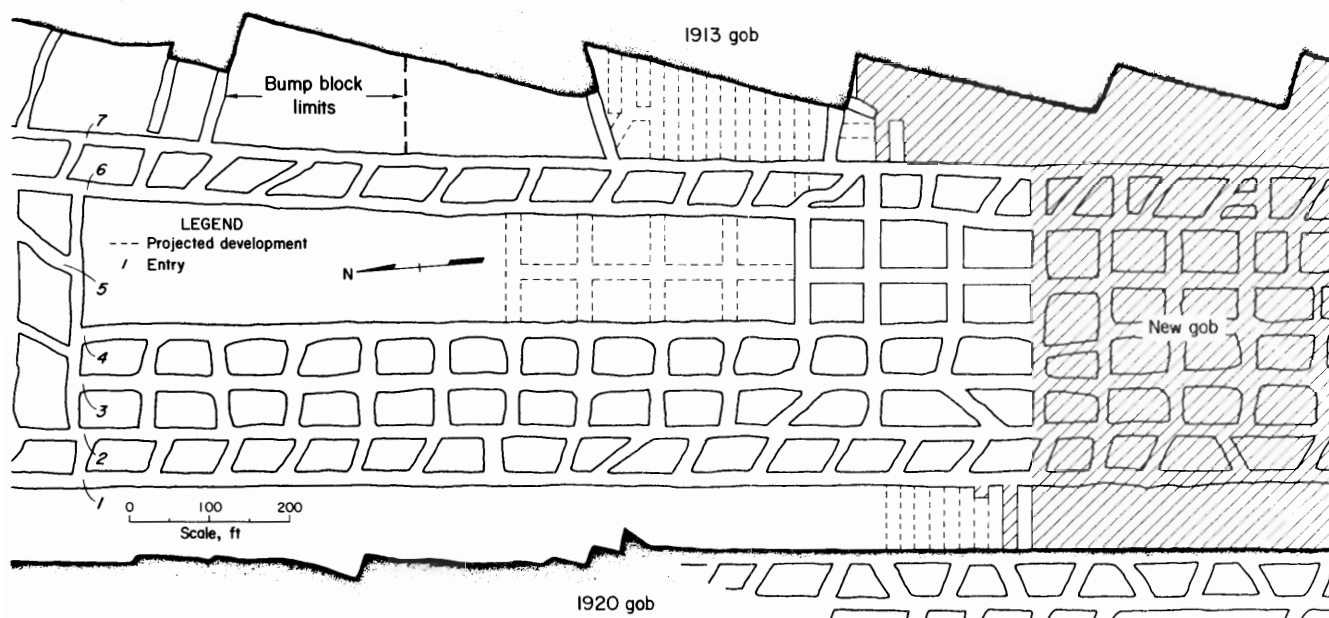
Figure 22.—Thin-pillar mining method as used to retreat old mains located between two gobs, mine 2.

A variation of the thin-pillar method is used to retreat old mains that are located between two gobs (fig. 22). A section 600 ft wide was rehabilitated for a distance of 6,000 ft. Entries labeled 1 and 2 were driven on the rehabilitation-advance phase, while entries 3 and 4 were widened, cleaned, and resupported with roof bolts. The section forms a finger between two expansive gob areas, both of which have been inactive since the 1920's.

Several features of this work merit discussion. First, rehabilitation would have been more productive and profitable if entries 3 and 4 were not rehabilitated and new entries had been developed in the barrier pillar. However, mine management felt that the possibility for a squeeze would be too great if the center barrier pillar were developed completely on advance. Second, the barrier pillar is split no less than 300 ft outby the pillar line; and no mining is permitted toward the new gob, as pressure could be trapped in the pillar and not transferred outby. Third, when the thin-pillar mining outlines a bump block, it is evaluated by the mining engineering staff on site. If the bump block, such as the one displayed in figure 22, is deemed to be under hazardous loading, it is left as a holding block.

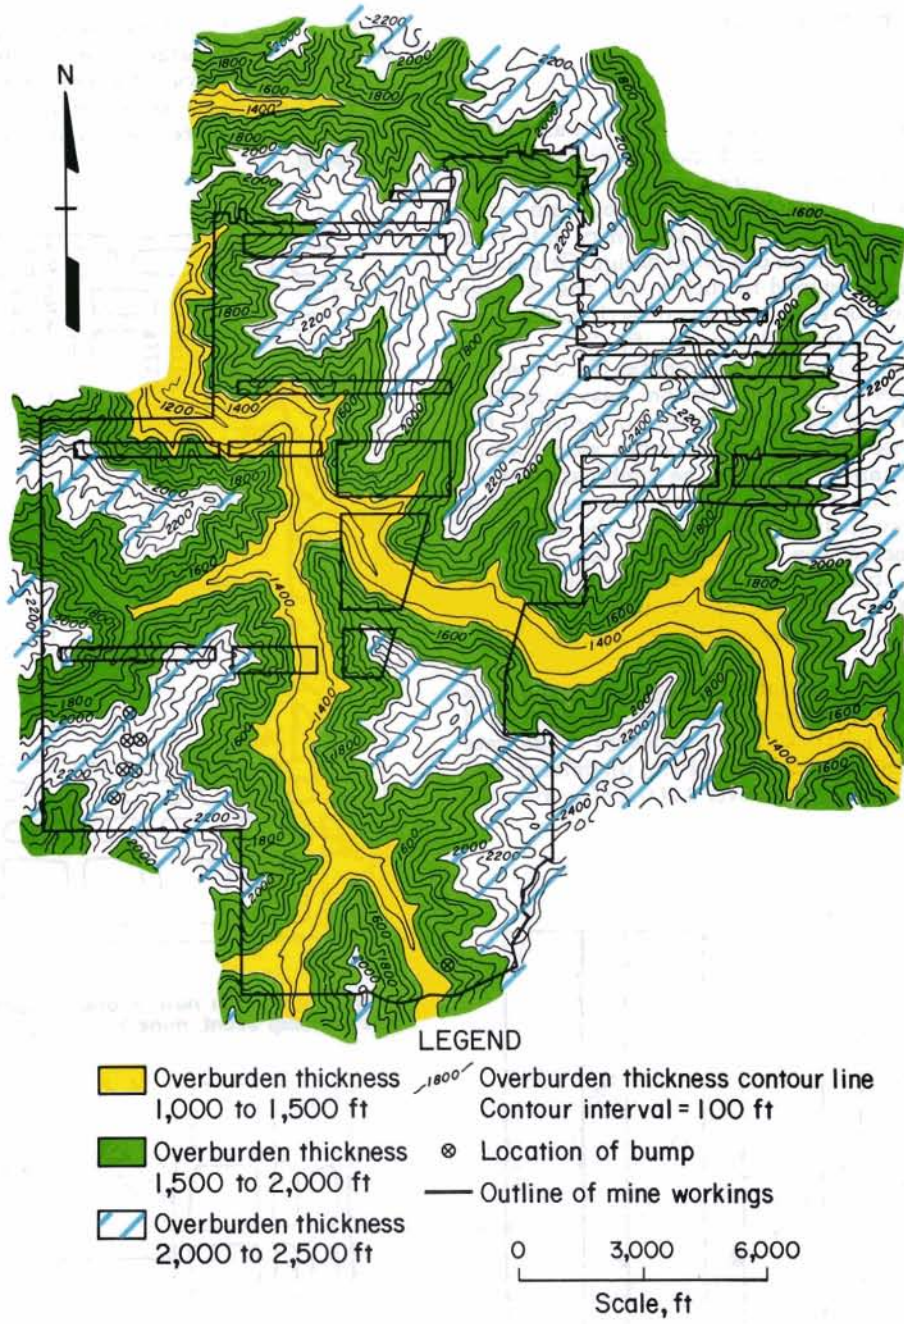
Figure 25.—Overburden map for mine 3.

Overburden thicknesses at mine 3 are extreme; this mine is the deepest of the five examined in this study. Depth of cover ranges from just under 1,200 ft to in excess of 2,400 ft (fig. 25). Bumps have been noted to occur at various depths throughout the mine, but, according to mine personnel, the majority of bumps are experienced under greater than 2,200 ft of overburden. The locations of several previous bump occurrences are indicated on figure 25. All but one of these bumps took place under more than 2,200 ft of cover.

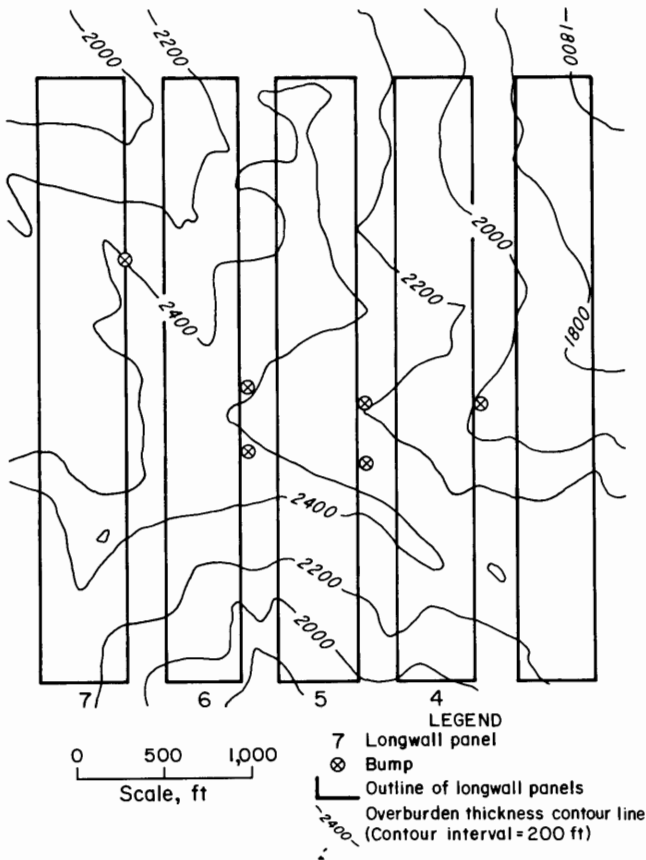
Figure 26.—Locations of retreating longwall bump events and overburden thicknesses, mine 3.

Mine 3 has experienced bumps on longwall as well as room-and-pillar retreat workings. Figure 26 (8) displays the location of six retreating longwall bump events that occurred from March 1972 to May 1974. Mountain bump occurrences were minimized in the tail entry gate road pillars by the implementation of a novel design. Originally, the gate roads were designed in such a way that a large block cut on 100- by 100-ft centers was directly adjacent to the longwall panel on the tailgate side (fig. 27).

Two steps were taken by mine management to prevent further bump hazards: (1) the softening, via shot firing of the large tail entry pillar, and (2) a redesign of the gate roads for subsequent panels. Where firm, unyielding roof and floor strata are present with over 2,200 ft of overburden

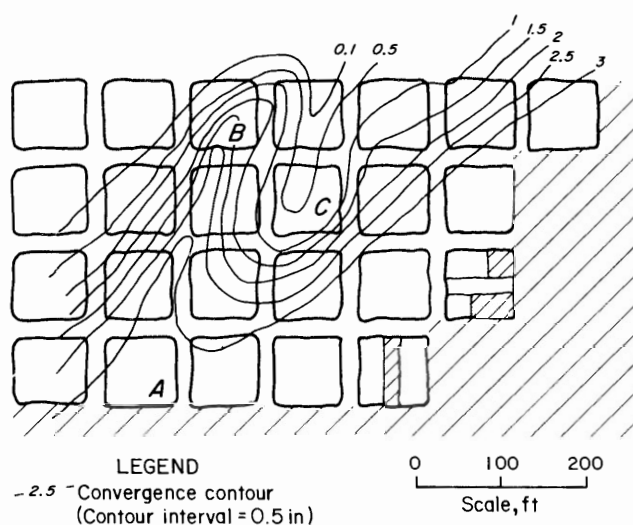
Figure 30.—Convergence contour map for room-and-pillar retreat mining, mine 3.

As stated earlier, the gradual yielding of pillars near the pillar line is necessary to avoid the energy storage in the pillar core, which leads to pressure bumps. Without a better measurement method, it is assumed that roof-to-floor convergence may indicate the extent of pillar yield. Figure 30 displays the convergence contours outby the pillar line. Note the 2- to 3-in total convergence along the line from pillar A to B and the 0.5- to 1.5-in total at pillar C. Pillar C was later water infused to enhance pillar yielding.

The water infusion of pillar C was accomplished by pumping water at 800- to 1,200-psi pressure, into the pillar at a rate of 10 gal/min. Figure 31 shows the effect on the convergence rate around the infused pillar. The dramatic increase in the convergence rate caused by the water infusion led mine officials to assume that the pillar was destressed. It was then mined without incident. The same test was performed on other pillars. The increases in convergence rate were not as pronounced, but the pillars were mined without incident. Water infusion is not presently conducted for bump control at mine 3.

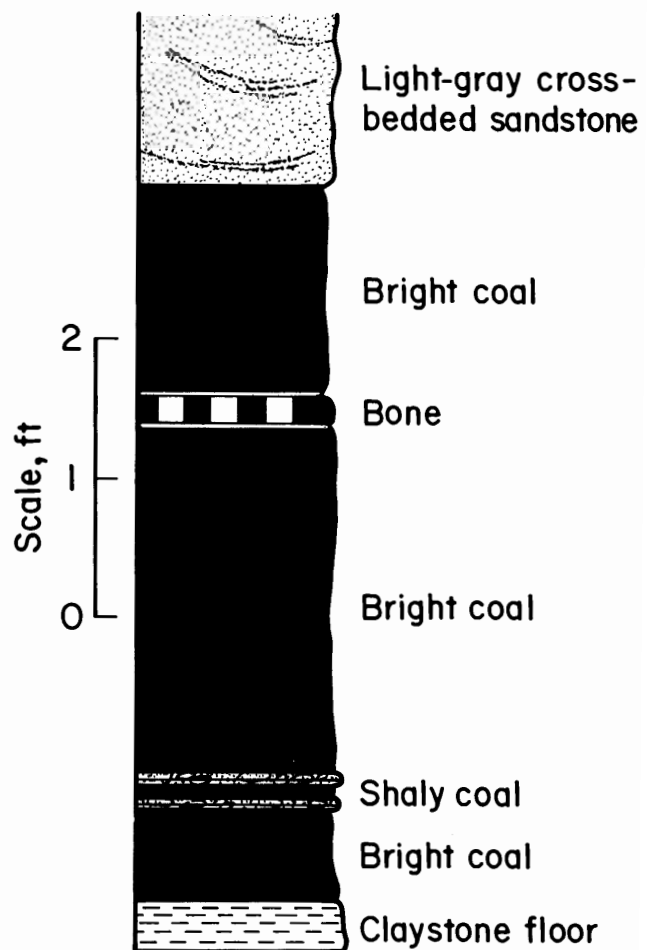
Figure 32.—Generalized stratigraphic column for mine 4.

Mine 4 is actively working in the Chilton Coalbed of the Kanawha Formation (Pottsville Group, Pennsylvanian System) near Stirrat, Logan County, WV. The brightly banded coalbed displays irregular thickness, but averages about 4 ft thick at mine 4. The Chilton is generally multiple-bedded, with intervening partings of shaly coal and bone (fig. 32).

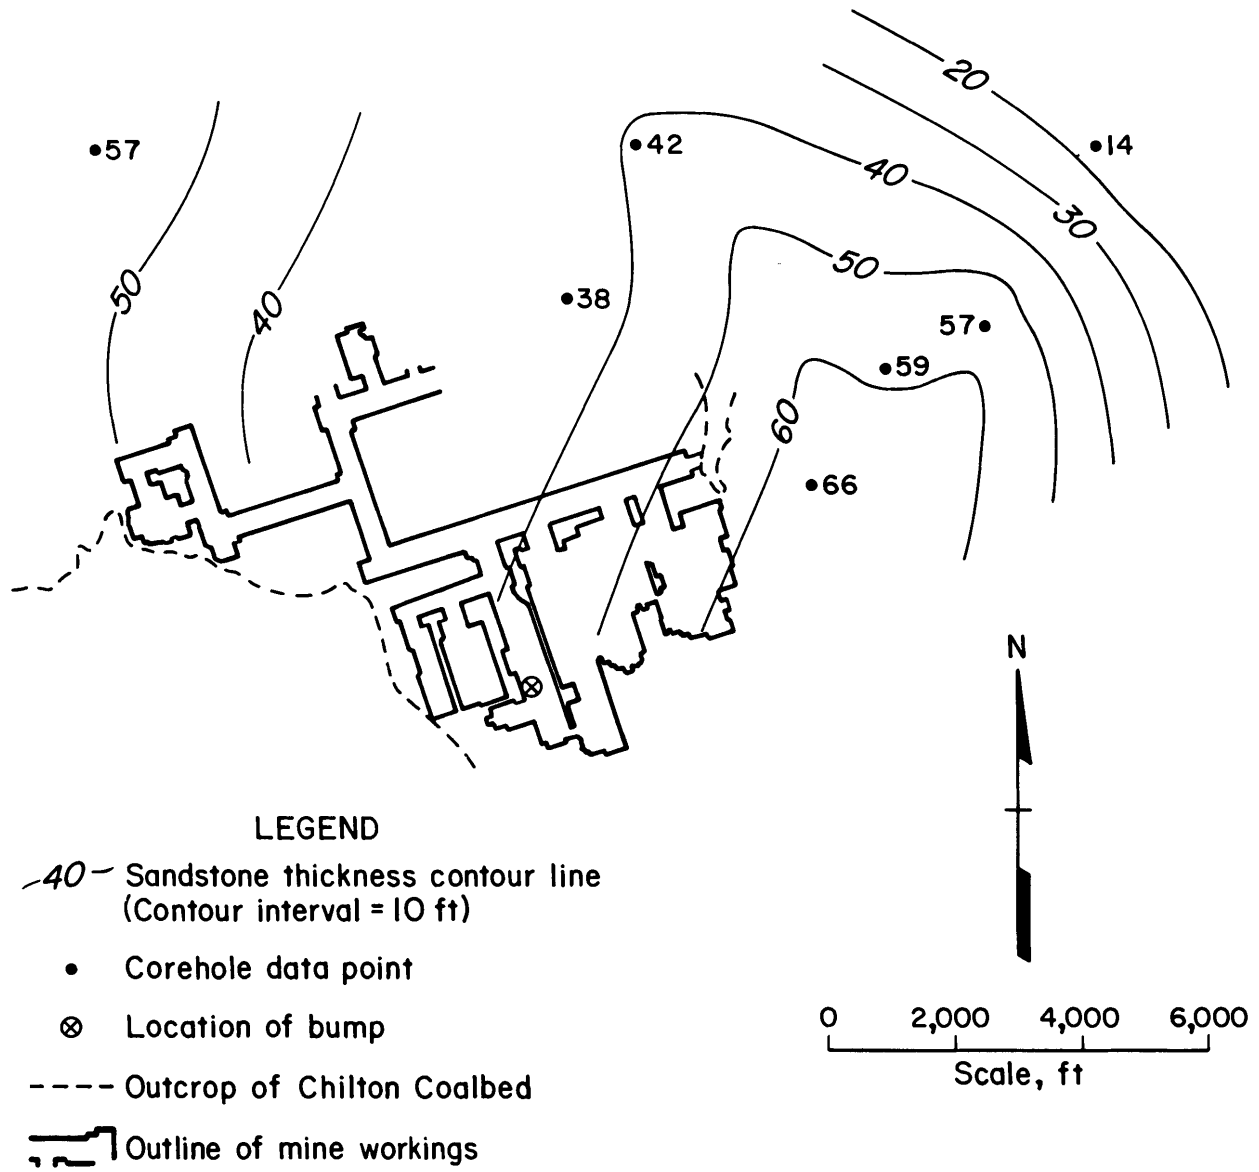
Figure 33.—Sandstone thickness map of Lower Winifrede Sandstone, which immediately overlies Chilton Coalbed, mine 4.

The coalbed is underlain by a fairly soft, medium- to dark-gray claystone. Above the coalbed is a light-gray, cross-bedded sandstone (4). In the areas of mine development, the sandstone lies directly upon the coalbed. However, corehole logs indicate the presence of an intervening gray shale layer approximately 2 ft thick in an area north of mine 4. The sandstone is poorly cemented and brittle and usually breaks at the pillar line. The thickness of the overlying sandstone is fairly uniform. Except for one corehole data point in the northeasternmost portion of the studied area, the sandstone is generally 40 to 60 ft thick (fig. 33).

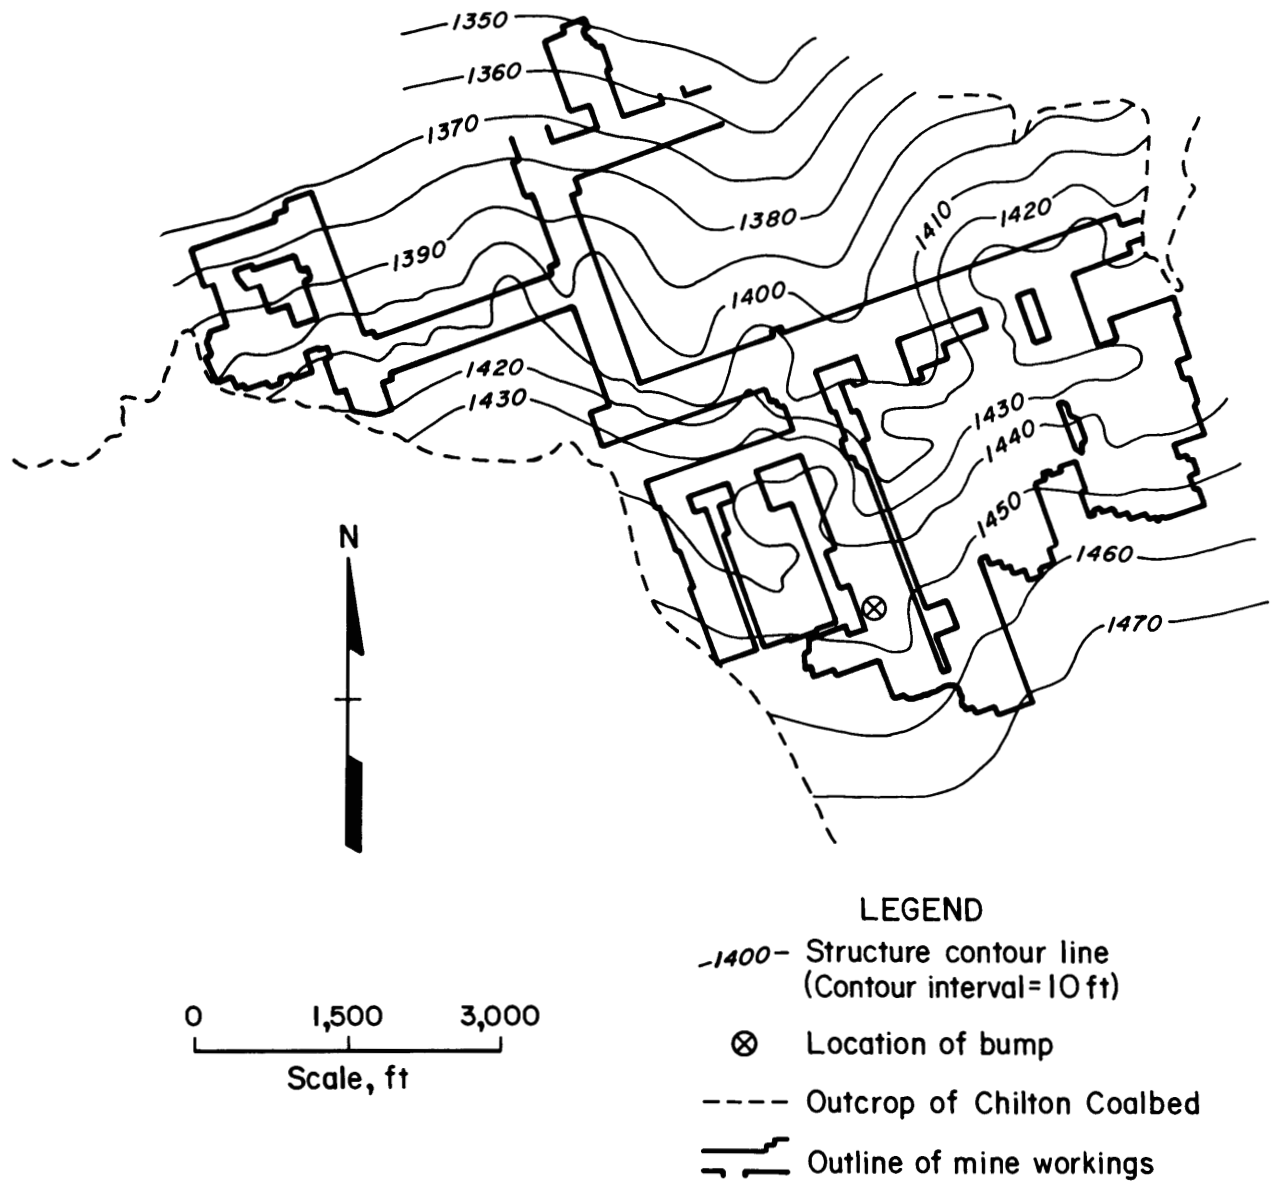
Figure 34.—Structure contour map for mine 4, drawn from elevation of top of Chilton Coalbed.

Mine 4, located in the Appalachian Plateaus physiographic province, is situated in a relatively uncomplicated structural setting. Structural contour lines, drawn on the top of the Chilton Coalbed, trend northeast-southwest (fig. 34). The mine lies on the east flank of the Handley syncline; therefore, the coalbed drops in elevation toward the northwest. No faults or clastic dikes have been observed in the area of mine 4.

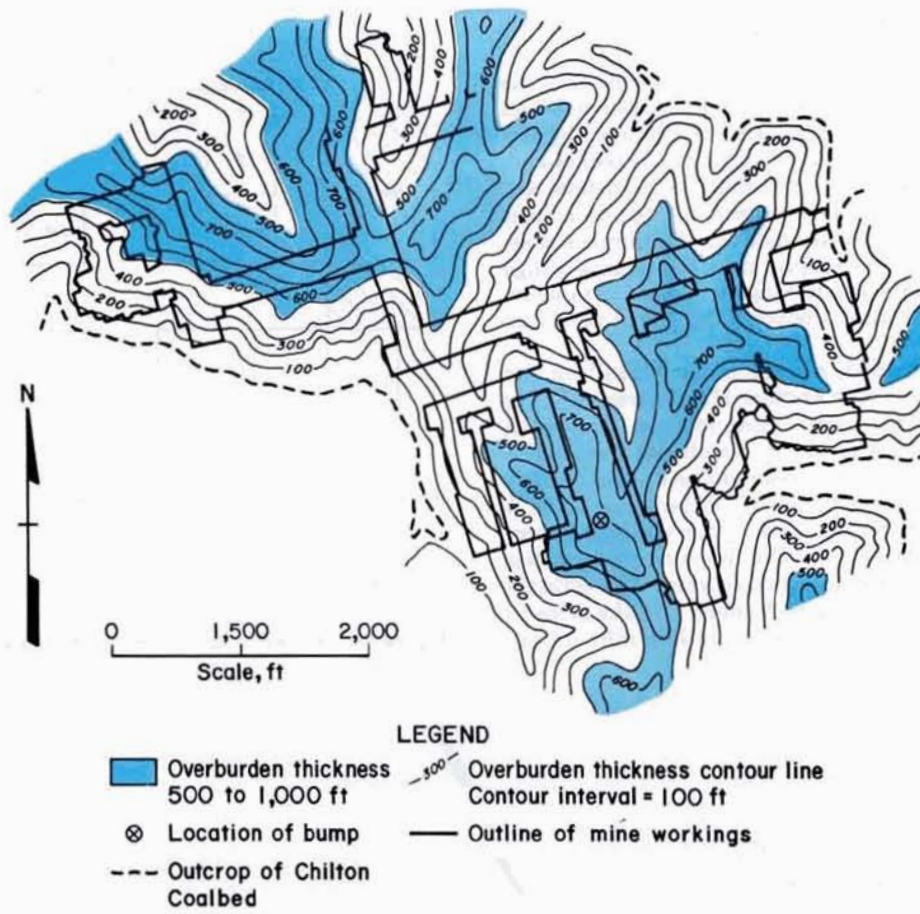
Figure 35.—Overburden map for mine 4.

In comparison with other mines examined in this study, overburden depths at mine 4 are relatively shallow (fig. 35). The mine is outlined, for the most part, by the outcrop of the Chilton Coalbed. Only under the hilltops does the overburden thickness increase to over 700 ft. A fatal bump occurred in one of these areas of maximum overburden thickness (fig. 35).

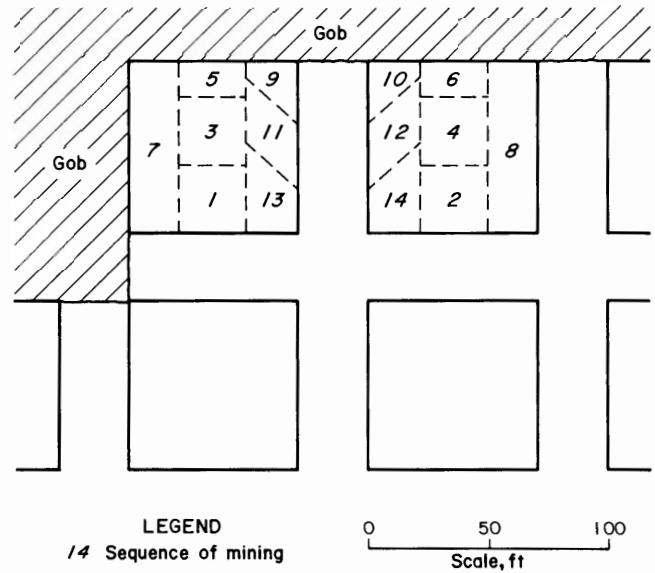
Figure 36.—Pocket-and-wing method mining sequence, mine 4.

Continuous miners are exclusively employed in mine 4. Mining is conducted on the room-and-pillar system. When retreat mining is performed, pillars are removed by the pocket-and-wing method. Figure 36 displays the pocket-and-wing method in the twin-mining format. The sandstone roof directly above the coalbed permits twin mining, because it is uniform and stable. Cuts are made in the numbered sequence shown. Each pillar is split, then the outside wings are removed. Finally, the inside wings are mined in tandem. The twin-mining procedure produces a high coal yield and total extraction.

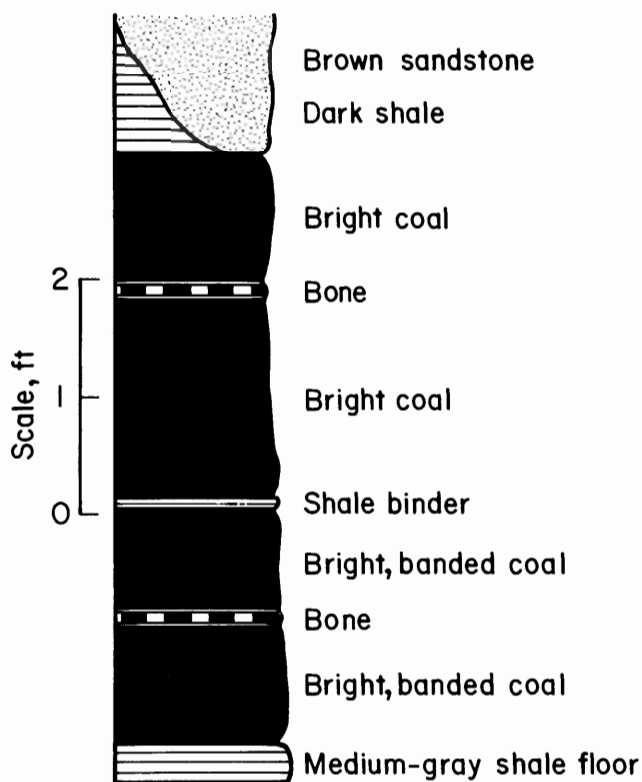
Figure 39.—Generalized stratigraphic column for mine 5.

southeastward of Campbell Creek, Kanawha County (12). Throughout the mine, the No. 2 Gas Coalbed is 43 to 63 in thick. The coalbed is friable and displays multiple benches, each separated by binders of bone or shale (fig. 39). A persistent bone binder, noted at several locations in the mine, occurs approximately 1 ft from the top of the coalbed. A thicker, more prominent and continuous bone layer is also found approximately 1 ft above the bottom of the coalbed. Mine personnel believe that this binder stores energy from overburden pressure. Therefore, they recommend the removal of the lower parting first when mining commences.

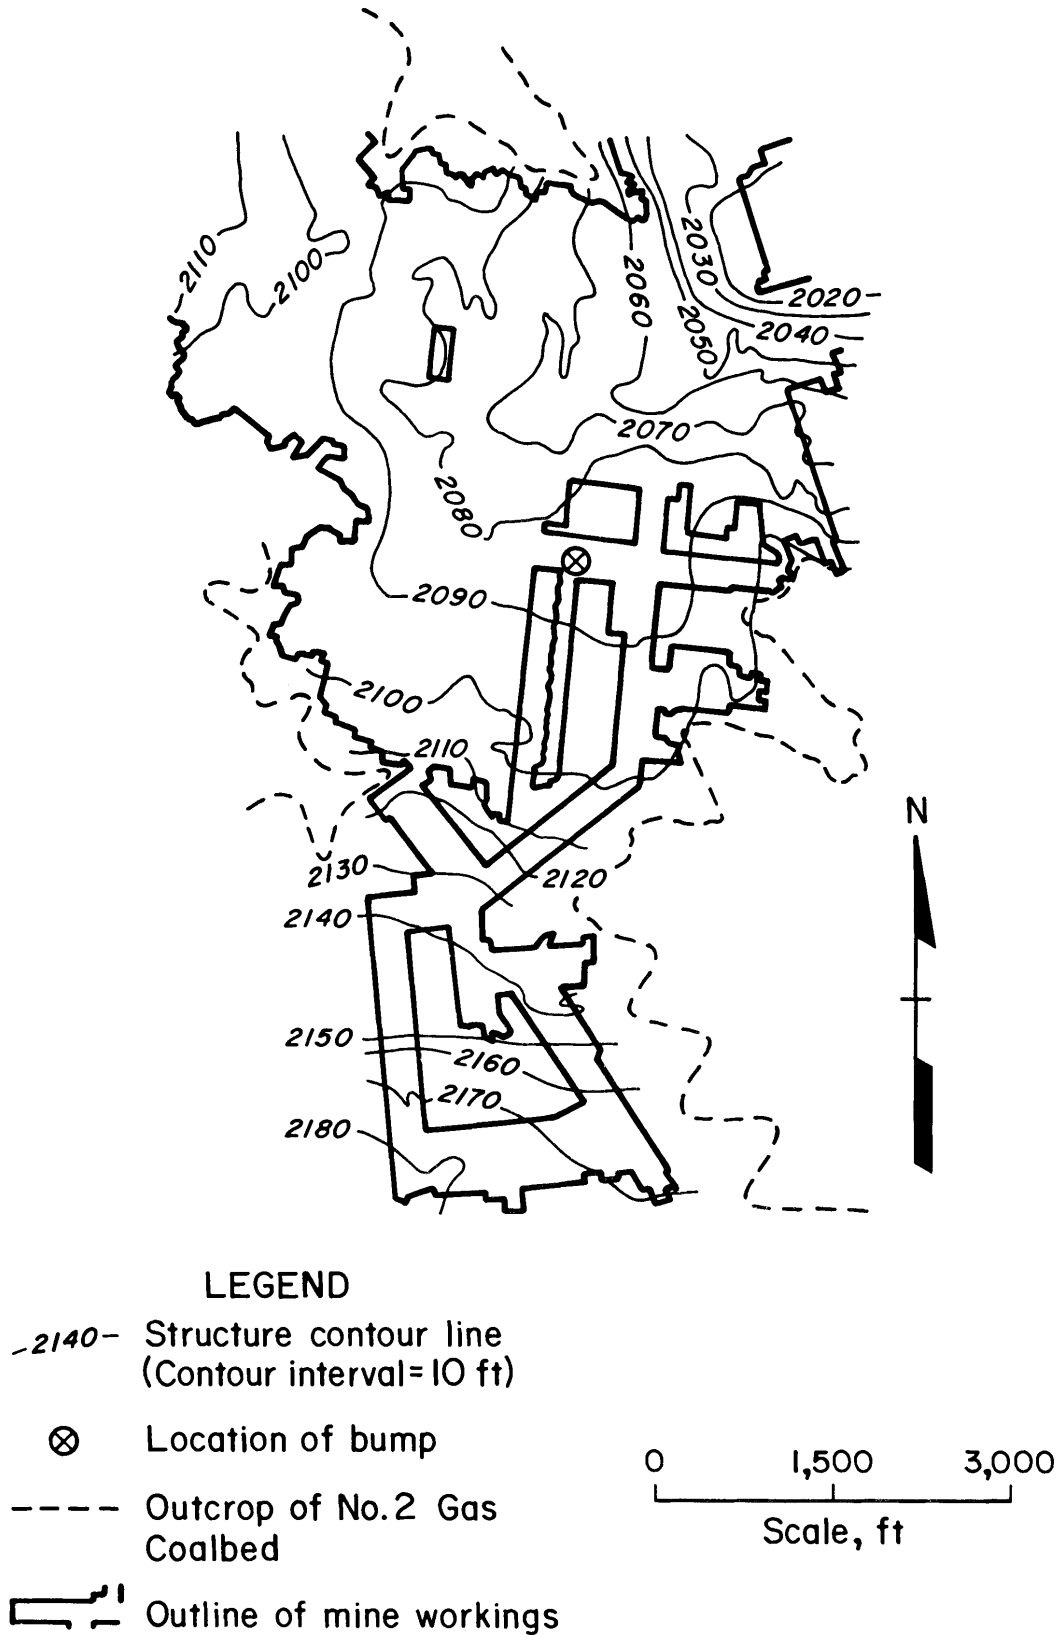
Figure 40.—Structure contour map for mine 5, drawn from elevation of top of No. 2 Gas Coalbed.

of the axis of the Handley syncline. The No. 2 Gas Coalbed dips at 1° to 1.5° to the northwest toward the axis of this syncline (fig. 40). No faults or clastic dikes have been observed in the mine. A few kettlebottoms are present where the shale intervenes between the coalbed and the overlying sandstone.

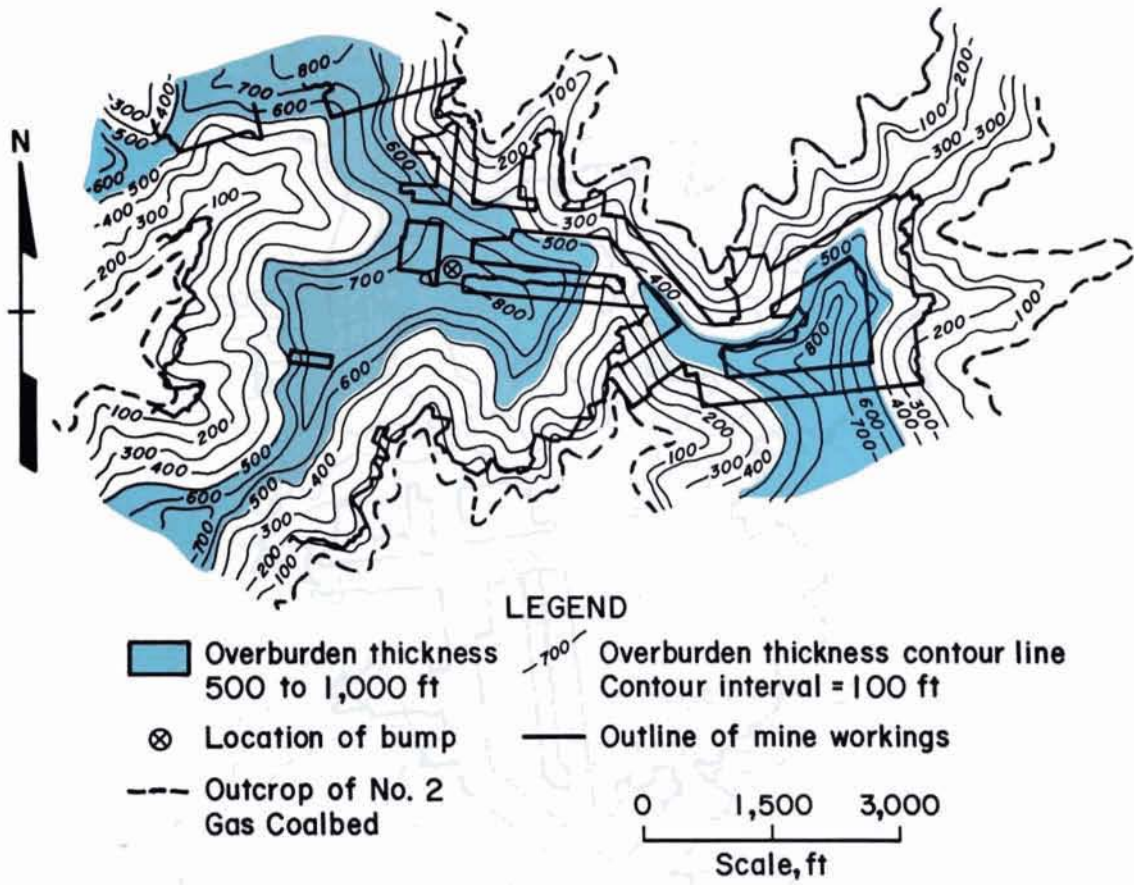
Figure 41.—Overburden map for mine 5.

Overburden intervals at mine 5 are relatively thin when compared with overburdens of the other mines examined in this study. A large portion of the mine is outlined by the outcrop of the No. 2 Gas Coalbed. As at mine 4, the thickest overburden is present under hilltops on the mine property. In those areas, the coalbed may be much as 850 ft deep (fig. 41). Large surface cracks have been observed above the coalbed on these mountains. The bump that occurred in this mine on February 10, 1984, was located in the deepest portion of the mine, under more than 800 ft of cover (fig. 41).
