Volunteer Lieutenant Killed and Two Fire Fighters Injured Following Bowstring Roof Collapse at Theatre Fire – Wisconsin

Executive Summary

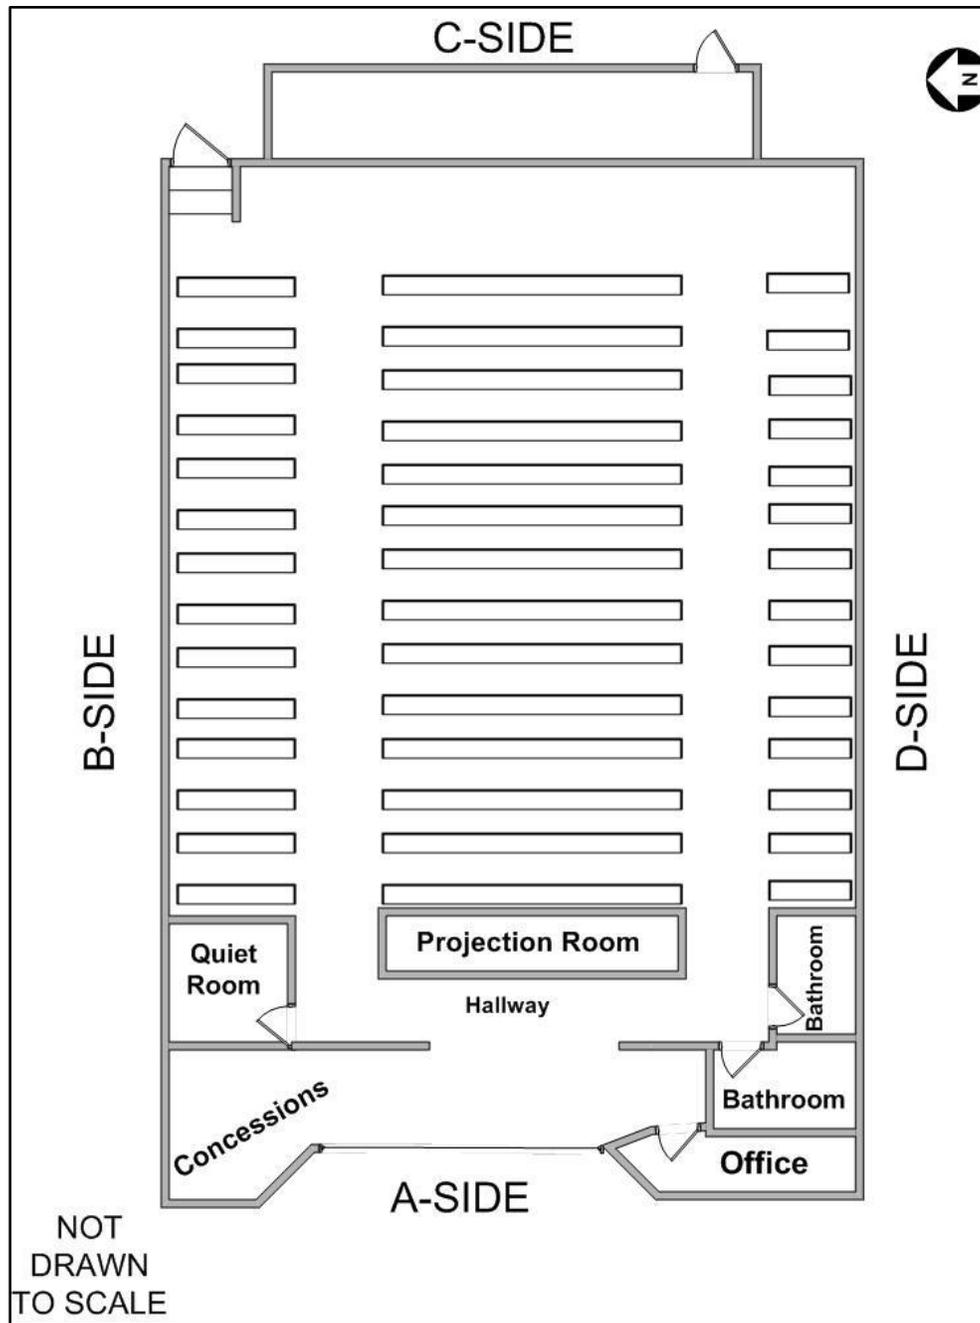
contained a total of six ceiling fans with lights (three lights suspended above each theatre aisle). Further details regarding the materials used to construct the new ceiling were not available to NIOSH investigators. The side wall curtains were placed over existing peg board and sound foam insulation (unprotected) that covered all exposed masonry walls within the viewing area (see Photo 4).

Diagram 1. Rendered floor plan of interior of theatre.

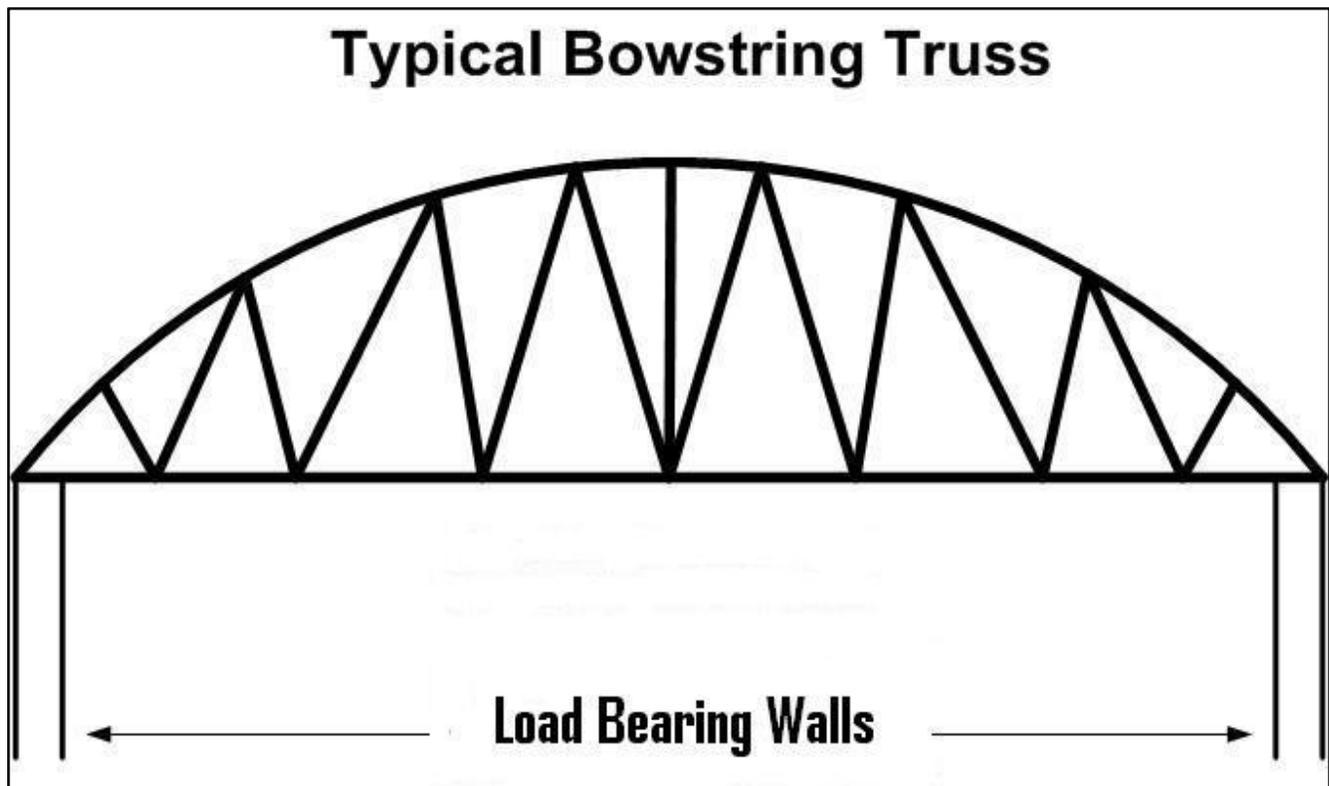
Diagram 2. Typical bowstring truss roof spanning between load bearing walls.

The principles of bowstring truss construction are similar to other types of truss construction in that web members are used to form multiple series of triangles that transfer tension from the bottom chord and compression from the top chord of the truss onto the load bearing walls. One big difference with the bowstring truss is that the compressional forces within the top chord act to force the load bearing walls outward as well as downward.

Bowstring truss roof systems may suffer from a little-known phenomenon related to inaccuracies in early industry-accepted truss design assumptions. One significant design deficiency involves the tensile strength of the bottom chord. Early truss designs assumed wood tensile strength could be defined by bending tests of small, straight-grained wood samples free of common wood defects. Prior to the 1960s, large-scale test facilities were uncommon, so full-size lumber tests were rarely

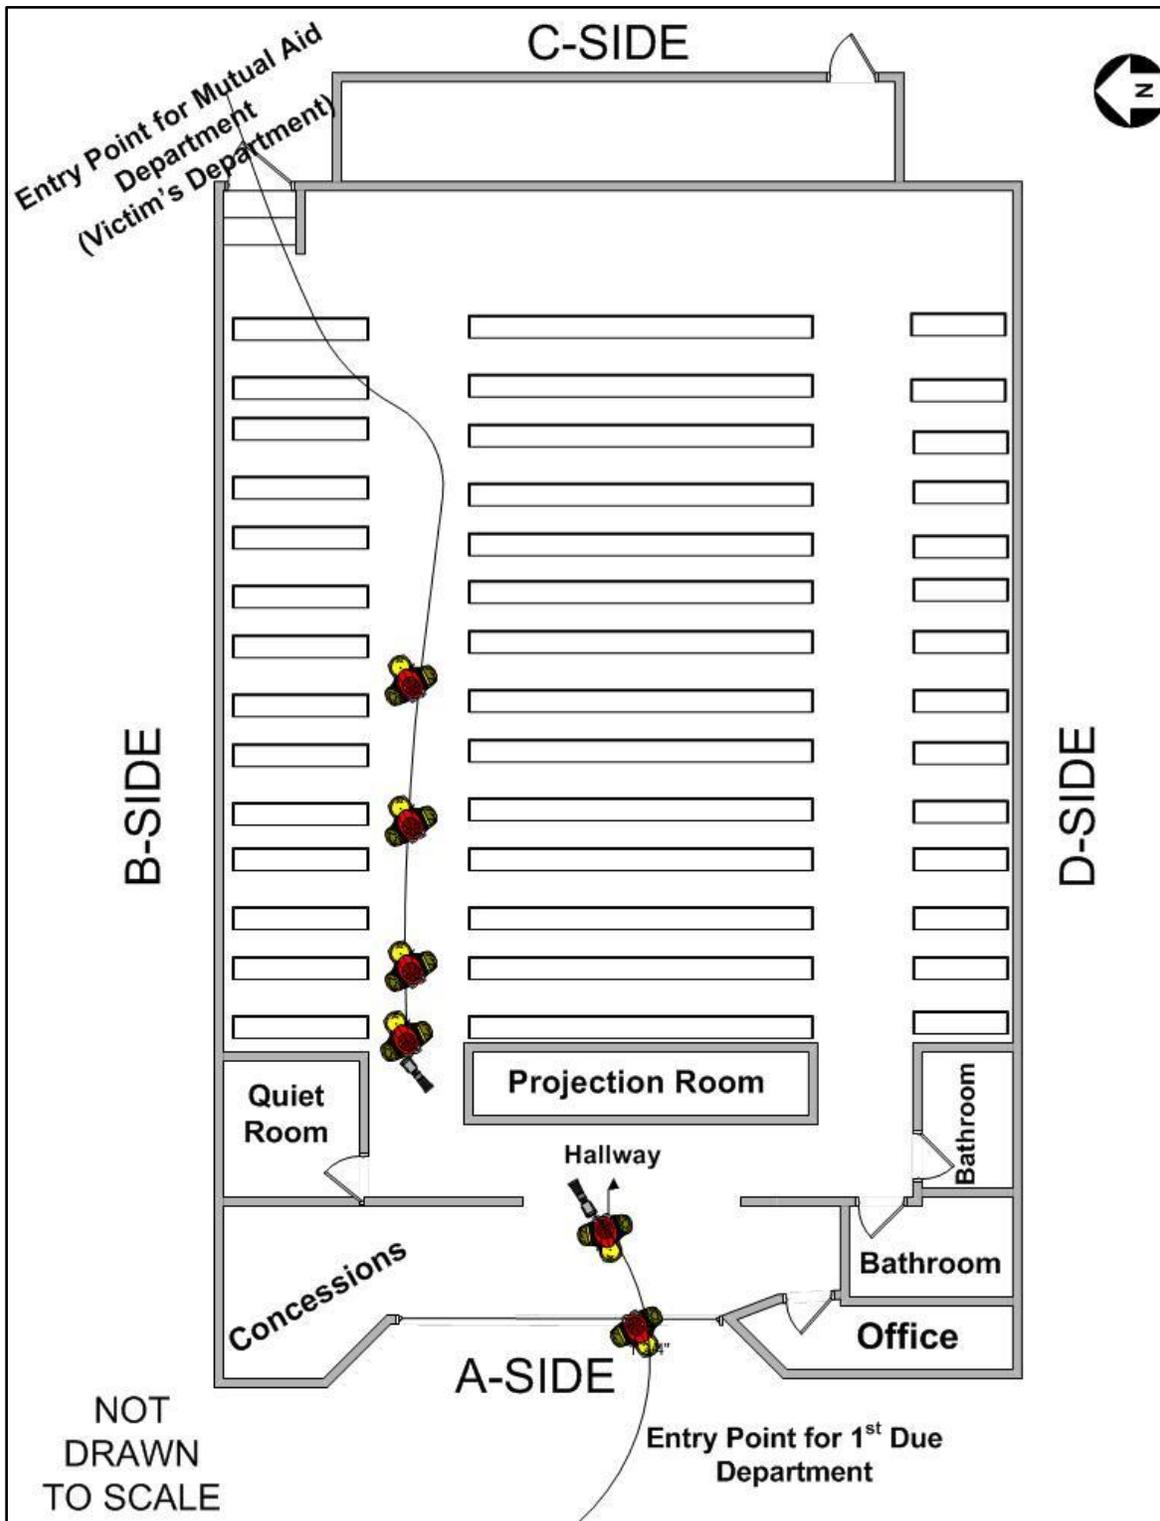
Diagram 3. Interior operations prior to collapse.
