# MIFACE Investigation Report #10MI021

## Subject: Farmer Grading Field Pinned Under Overturned Tractor

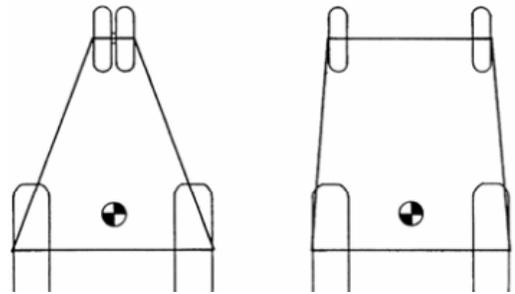
Tricycle-configured tractors, with the narrow-front wheel design are inherently less stable than tractors with a wide-wheel configuration. Tricycle tractors also have stability baselines which leave little room for error (Figure 7). The stability baseline of a tractor is made up of imaginary lines drawn between the points where the tractor tires contact the ground. Front, rear, and side stability baselines are established.

Figure 7. Stability baselines for tricycle and wide-front tractors

- Limit use of narrow-front (tricycle) tractors to tasks with low risk for overturn. Tricycle tractors may not be suitable for use with push blades or front-end loaders.

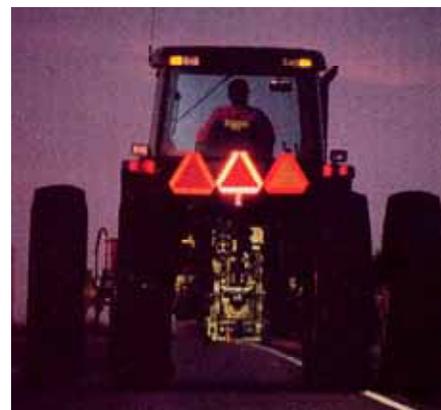
The new SMV emblems have fluorescent material aiding daytime visibility and reflective material aiding nighttime visibility (Figure 8). Replacing worn SMV emblems is important because the orange fluorescent center portion of the SMV emblem fades and turns color over time, changing from orange to yellow, pink or white. This portion is the most vulnerable to light and moisture degradation because fluorescent dyes decompose.

Retro-reflective material as found in the outer border of the SMV emblem reflects the headlights of vehicles approaching from the rear at night. Retro-reflective material lasts longer than fluorescent material. The retro-reflective readings on SMV emblems meeting the new ASAE standard are over ten times greater than most of the readings on SMV emblems currently in use. Figure 8 shows a comparison of older and newer SMV emblems. The SMV on the left is a new sign under the old standard, the SMV sign in the middle is the sign under the new standard, and the SMV on the right is an old sign under the old standard.

Figure 8. Center SMV emblem equipped with ASAE 276.6 recommendations

- Ensure any implement of husbandry, such as a tractor, when used on a public roadway has a slow moving vehicle sign.
