Volunteer Fire Fighter Dies When Struck By a Bus While Working Along an Interstate Highway – Illinois

Fatality Assessment and Control Evaluation Investigation Report # F2007-26

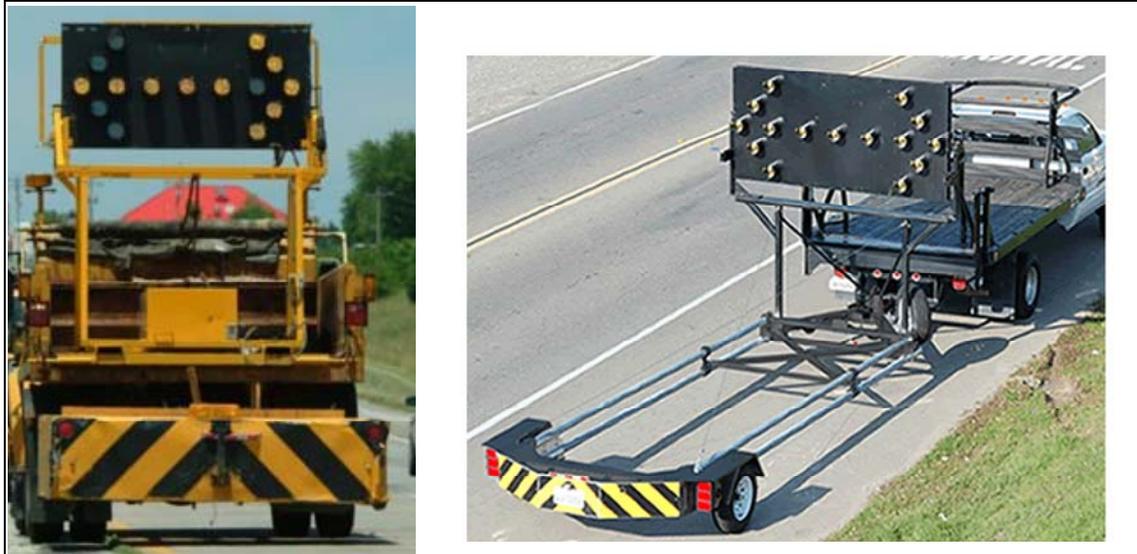
It is possible that an upstream police vehicle could have alerted the bus driver or warned the victim, or a properly positioned highway department truck that was equipped with a large flashing directional arrow and truck mounted attenuator^a (Photo 4) could have absorbed the impact of the bus prior to striking the victim. Additional traffic control resources should be summoned at all times when a fire department goes in service on a highway incident that is expected to involve a substantial period of time.

Photo 4. Examples of truck mounted attenuators.
