NIOSH
Fire Fighter Fatality Investigation
and Prevention Program

A summary of a NIOSH fire fighter fatality investigation

Volunteer Deputy Fire Chief Dies When Struck by Motorized Water Monitor that “Launched” Off Aerial Ladder Truck – Pennsylvania

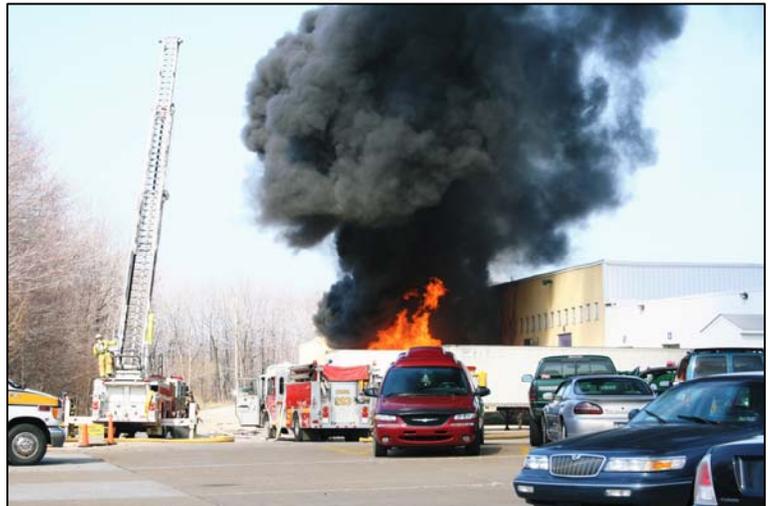
Photo 1. Aerial ladder being raised into position for master stream operation.

On April 8, 2008, a 24-year old volunteer Deputy Fire Chief (the victim, acting as the Incident Commander), was killed when struck by a motorized water monitor and 30 feet of aluminum pipe that was launched from an elevated aerial ladder at an industrial fire in Pennsylvania (see Photo 1). On April 9, 2008, the U.S. Fire Administration (USFA) notified the National Institute for Occupational Safety and Health (NIOSH), Division of Safety Research (DSR) of the fatality. The fire apparatus was impounded following the April 8, 2008 incident and secured in a private restricted-access storage facility. The NIOSH Fire Fighter Fatality Investigation and Prevention Program contracted with a fire service consultant knowledgeable in all aspects of fire apparatus operations, performance and equipment requirements to assist with the investigation. On April 21, 2008 a NIOSH safety engineer and the consultant, along with a criminal investigator with the Pennsylvania State Police, the district attorney, and representatives from two volunteer fire departments involved in the incident inspected the fire apparatus and checked the function of the aerial ladder and water delivery system. Two representatives of the local municipal fire department were also present (one was the chief of the department and one was present to operate the fire apparatus). Following the inspection of the fire apparatus, the NIOSH investigator and the consultant visited and photographed the incident scene and met with and interviewed the manufacturing plant representatives who were involved in the fire suppression activities. The NIOSH investigator and consultant also inspected an apparatus from the same manufacturer, similar in design, but 4 years newer than the incident apparatus. On April 23, 2008 the NIOSH safety engineer and consultant conducted interviews with members of the victim’s fire department who were involved in the incident. On April 24, 2008, the NIOSH investigators met with representatives of the manufacturer of the fire apparatus and again inspected the apparatus at the secure storage facility. The fire apparatus was photographed and measured. Specifications for the apparatus were obtained from the fire department and also from the manufacturer. Additional photographs were obtained from a number of sources including the state police, the fire department involved in the incident, and from fire fighters from mutual aid departments that responded to the incident. NIOSH investigators also reviewed training records, standard operating procedures, dispatch tapes, and the coroner’s report.

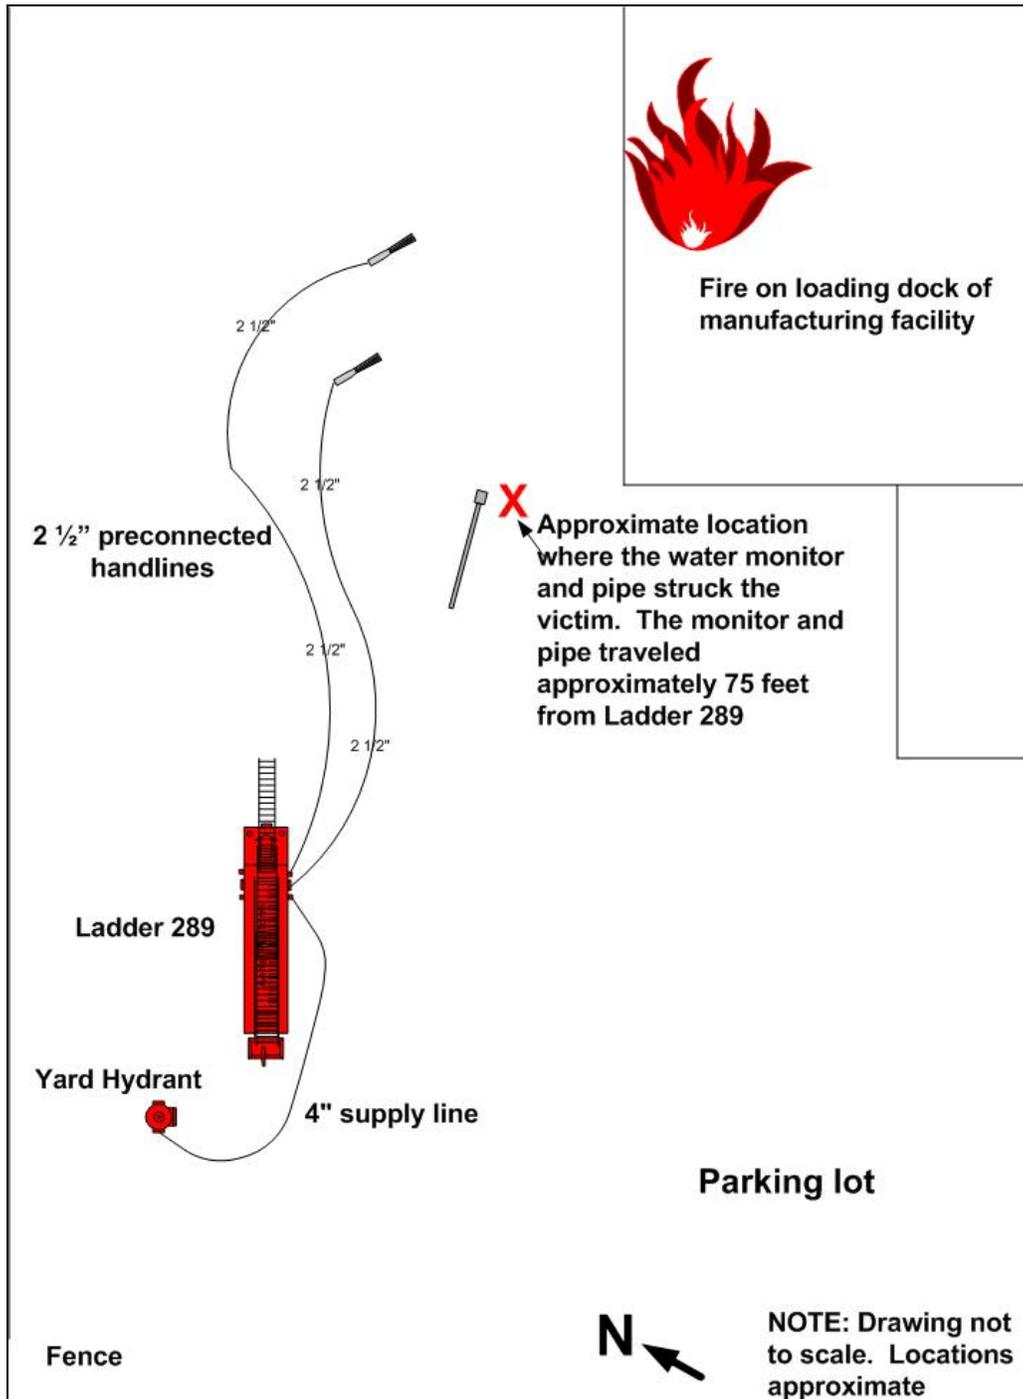
Diagram 1. Simplified layout of incident scene
