A summary of a NIOSH fire fighter fatality investigation

February 26, 2010

## A Career Lieutenant Dies and Three Fire Fighters are Injured in Ladder Truck Crash – Massachusetts

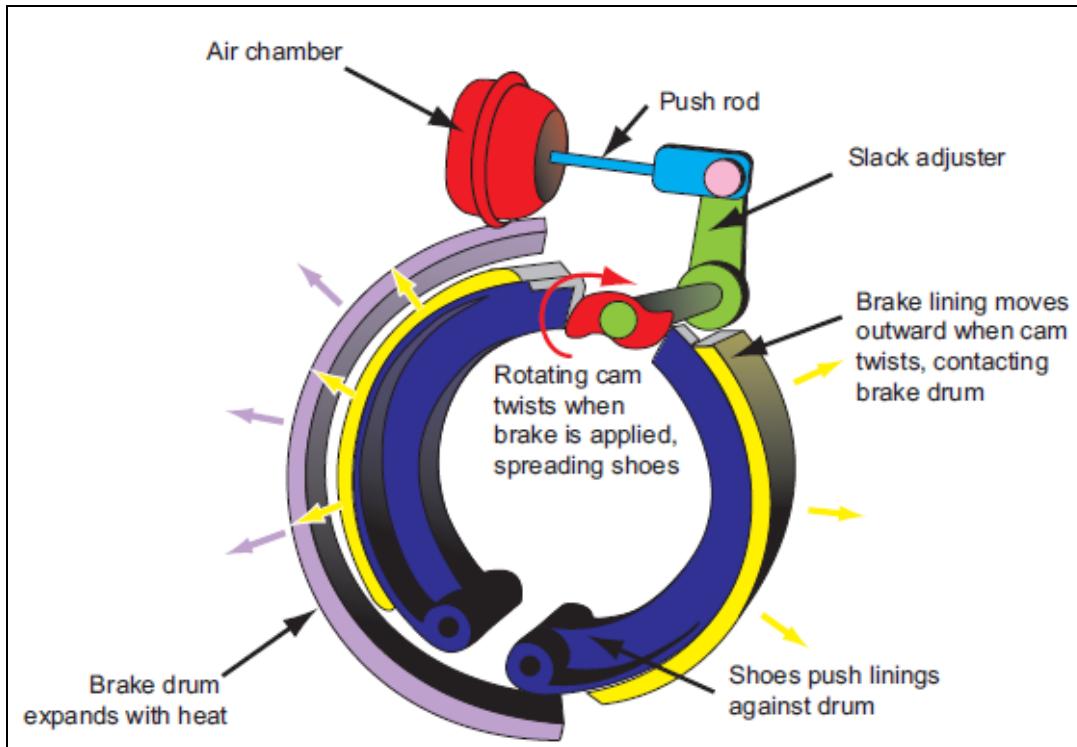
Discussion: Air brake systems are used on most heavy-duty vehicles for reasons of efficiency and reliability. Air brake systems use air as a medium for transmitting pressure or force from the driver control to the service brakes. When an operator of a vehicle presses down on the brake pedal, air is passed through supply lines to the brake chambers forcing the pushrod out. The pushrod, which is attached to a slack adjuster, actuates the slack adjuster and turns the camshaft, which in turn twists the S-cam, forcing the brake shoes to contact the brake drum, which slows the vehicle down due to friction (see Figure 1).

**Figure 1. Actuation of air supplied brake drums.**  
(Schematic reprinted from NTSB report.<sup>10</sup>)

***Recommendation #4: Fire departments should work with local, state, and federal authorities having jurisdiction (AHJ) in adopting an air brake endorsement for noncommercial driver's licenses that would require individuals operating air brake equipped fire apparatus to verify their knowledge and skill proficiency (e.g. air brake system, air pressure gauges and alarms, and pre-trip inspection) prior to operating the fire apparatus.***
