NIOSH HEALTH HAZARD EVALUATION REPORT

**HETA 90-226-2281
ALASKA AIRLINES
SEATTLE, WASHINGTON**

**HETA 90-226-2281
JANUARY 1993
ALASKA AIRLINES
SEATTLE, WASHINGTON**

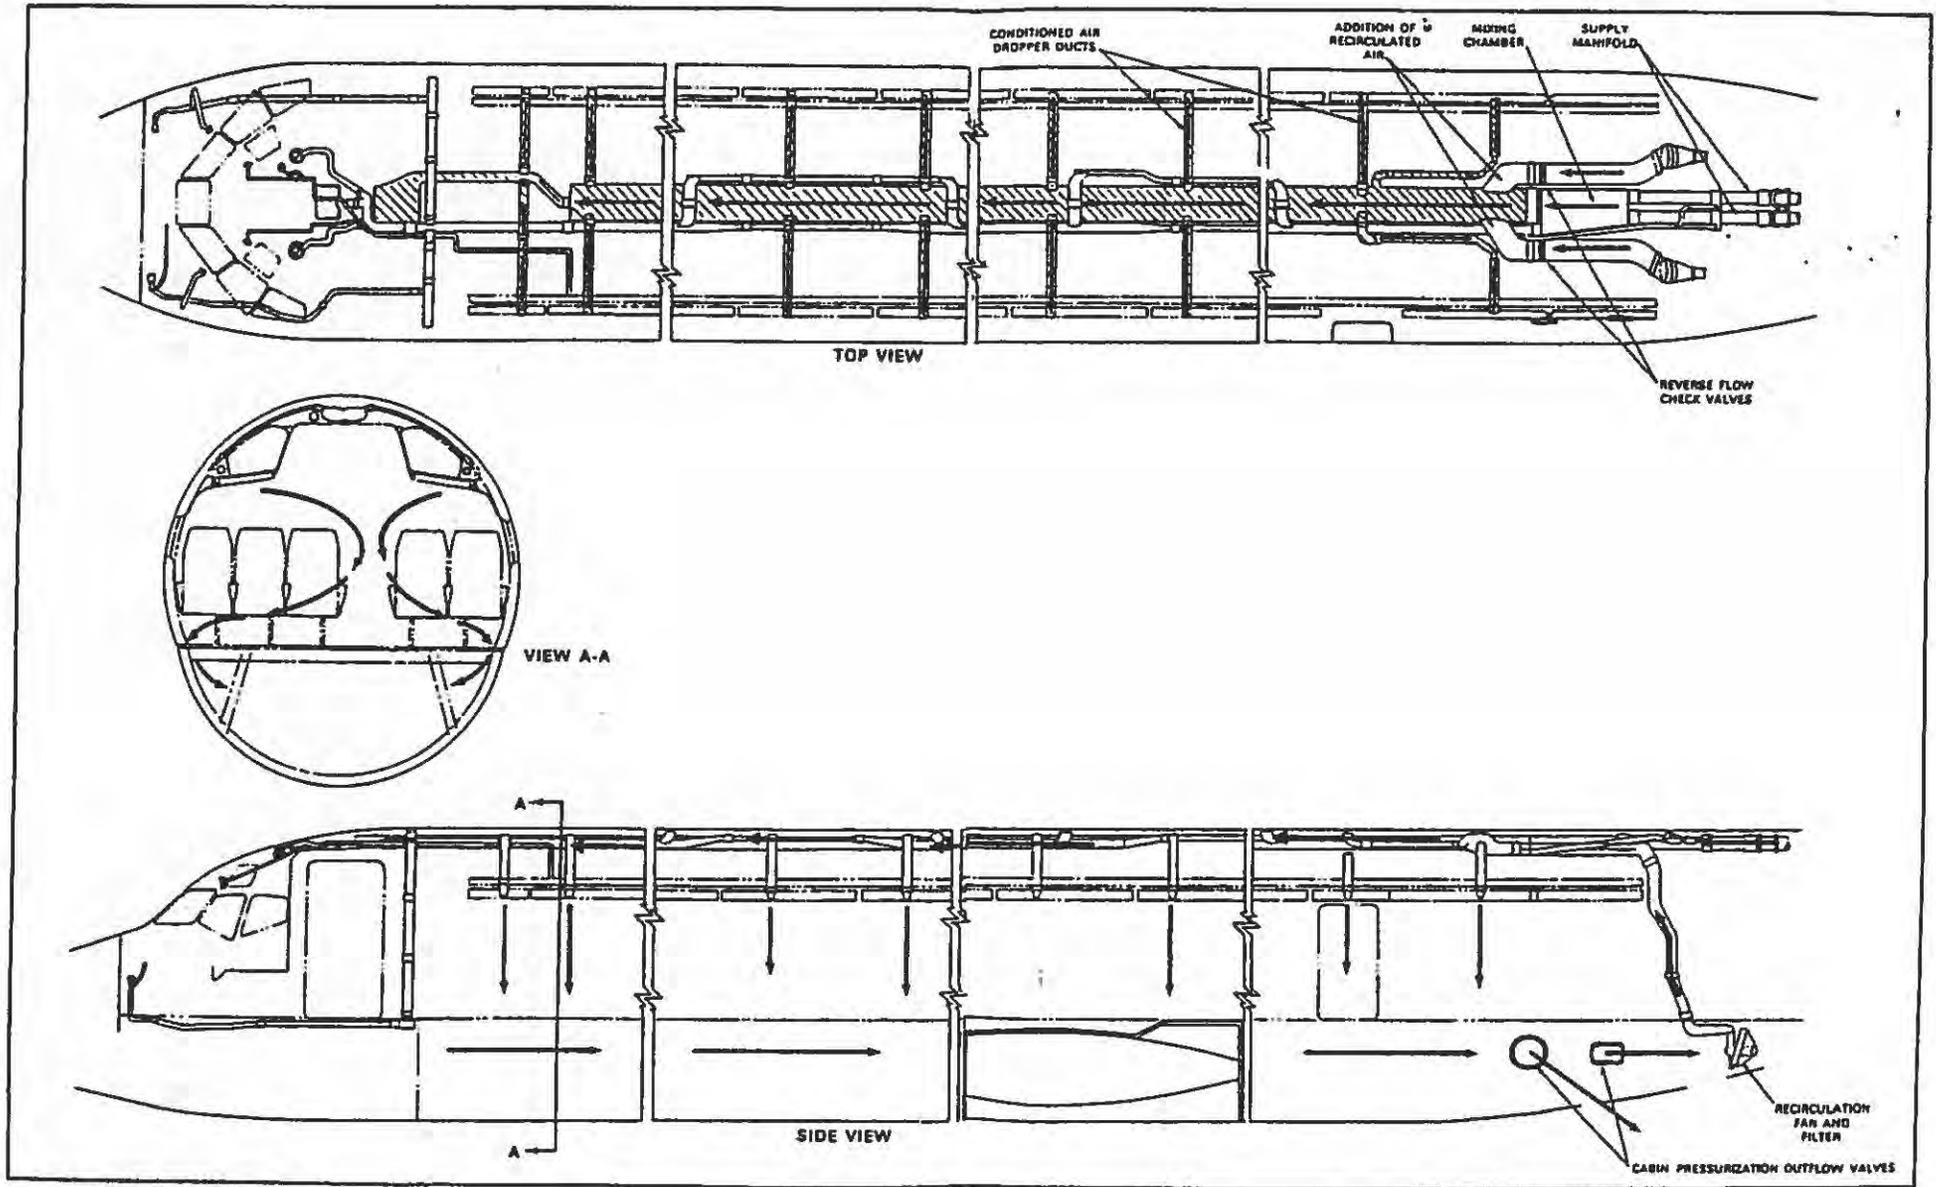
Figure 1
MD-80 Cabin Air Distribution
Alaska Airlines HETA 90-226

When the aircraft is on the ground, outside air may be provided by an auxiliary power unit (APU) or by a pneumatic connection to a pressurized ground system. Outside air from the engines or auxiliary sources is ducted to two air conditioning units (ACUs). On the ground and at lower altitudes, excess humidity is removed from the outside air in two water separators located downstream of the ACUs. The conditioned outside air is mixed in a plenum, and provided to the cockpit and cabin through fixed outlets located in the ceiling and adjustable ("eyeball") vents above passenger seating. Recirculation air for the first class and main cabin areas is added to the conditioned air downstream of the mixing plenum and supplied through the fixed ceiling outlets. The distribution of cabin air is shown in Figure 1.

Air flows from the cockpit to avionics cooling below, and then is exhausted overboard. In the first class and main cabin areas, air flows into return grills located along the floor, through cargo bay areas, and to a recirculation plenum or overboard exhaust (Figure 1). Overboard exhaust through outflow valves is automatically controlled to maintain the desired cabin pressure. Galleys are located in the first class and main cabin areas, with one and two lavatories located in first class and main cabin areas, respectively (Figure 2). Air is exhausted directly from the lavatories and galleys through outflow (venturi) valves. The exhaust in the galleys and lavatories is designed to keep them under negative pressure with respect to the rest of the cabin.

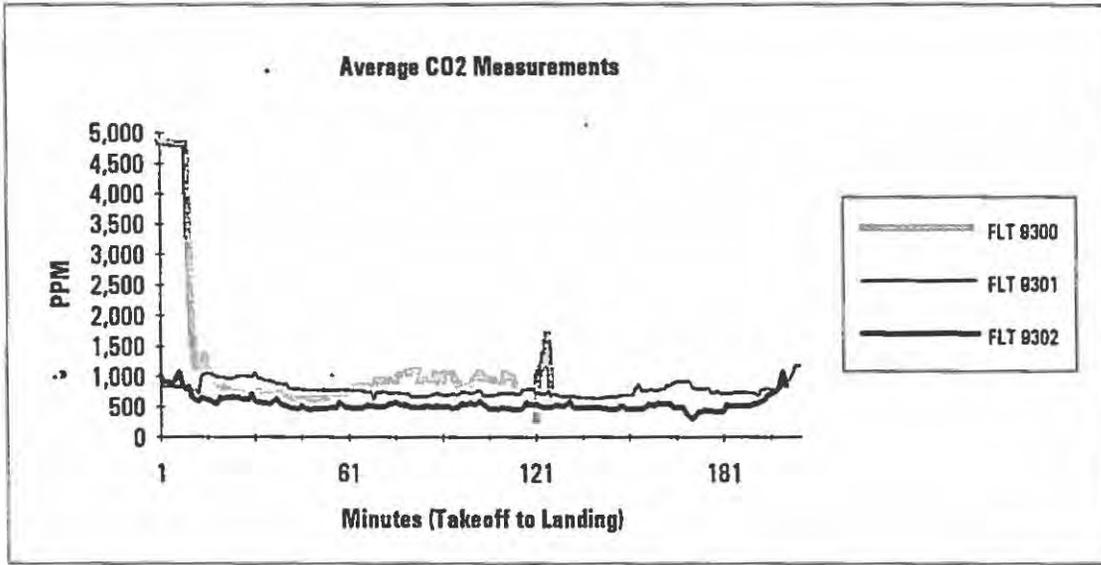
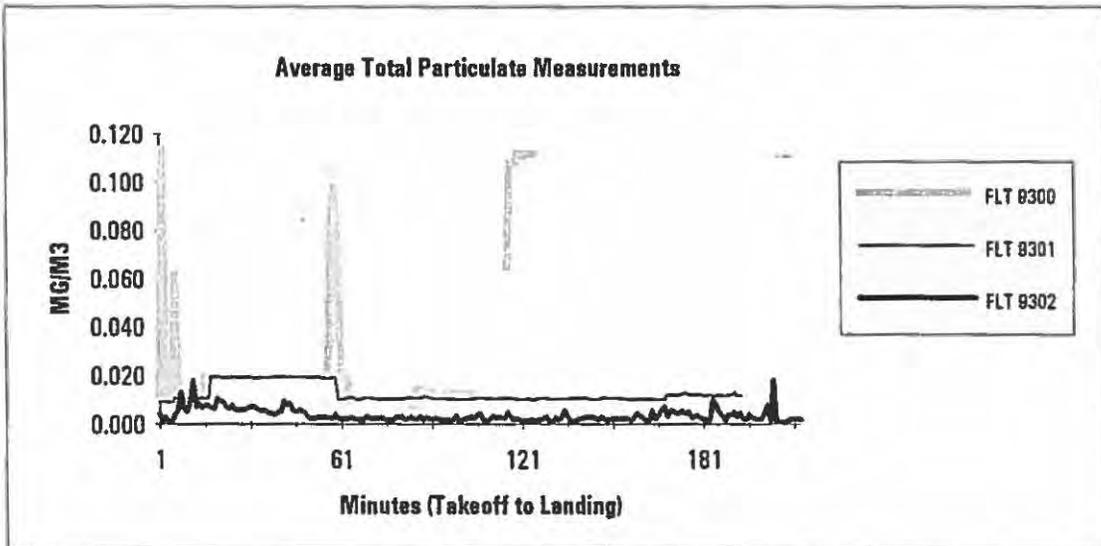
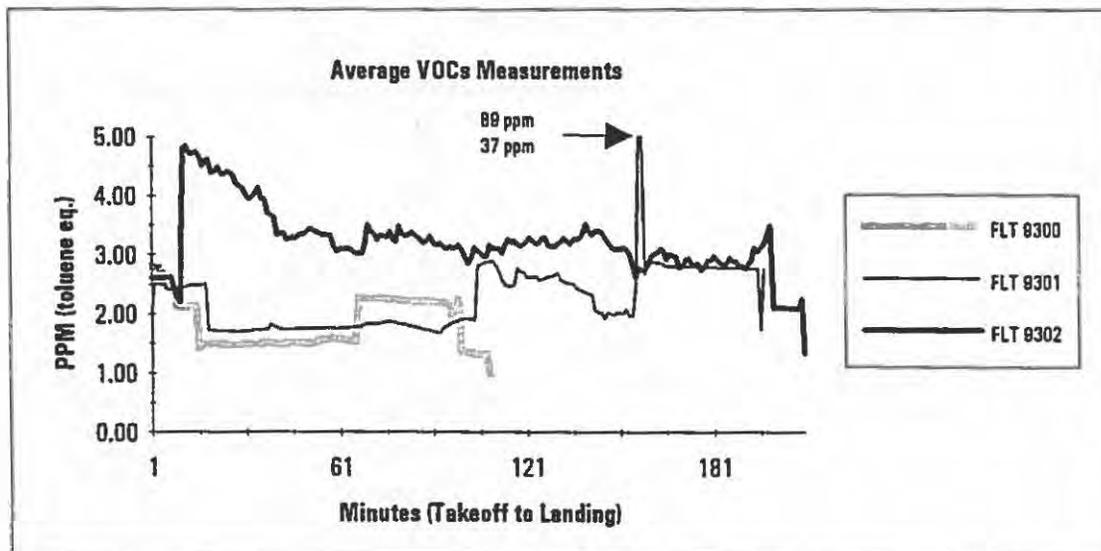
Figure 5
Average Measurements for Test Flights (Take off to Landing)
July 10-11, 1990
Alaska Airlines HETA 90-226

CO₂ results are presented in Figure 4 (continuous monitoring by seat location) and Figure 5 (continuous monitoring--in-flight averages). The maximum readings on flight 9300, shortly before and after takeoff (> 4820 ppm) may have been instrument maximums; they were within 3% of the manufacturer's reported instrument maximum (4975 ppm). Some readings that would have been used to compute averages are missing due to battery failure. Due to instrument battery limitations discovered on flight 9300, the continuous monitoring for the second and third test flights (9301 and 9302) was not initiated until near, or shortly after, take off. Instantaneous (grab sample) readings were made with the direct-reading instrument prior to take off at seat 17D on flight 9302; these are included in Figure 4.

The results of direct-reading continuous monitoring of total particulates (optical sensor) are presented in Table 4 (in-flight averages), and Figures 5 (charted averages) and 9 (charted by seat location). The average total particulate concentrations for the three test flights were low (range: 0.003-0.027 mg/m³), and within ASHRAE guidelines. There was no cigarette smoking (a common source of particulates) on the flights monitored. For acceptable indoor air quality, ASHRAE recommends that supplied air at minimum meet the Environmental Protection Agency National Ambient Air Quality Standards: 0.075 mg/m³ (annual geometric mean) and 0.260 mg/m³ (maximum 24-hr TWA).²⁰

The results of direct-reading continuous monitoring of VOCs with a photo-ionization detector (PID) are presented in Table 4 (in-flight averages) and Figure 5 (charted averages) Figure 10 (charted by seat location). Results are expressed as total VOCs in ppm, toluene equivalent (the instrument was laboratory calibrated with 7.5 ppm toluene). It should be noted that the PID does not distinguish between potentially toxic and non-toxic VOCs; it measures all gases and vapors with an ionization potential below 10.5 electron volts.

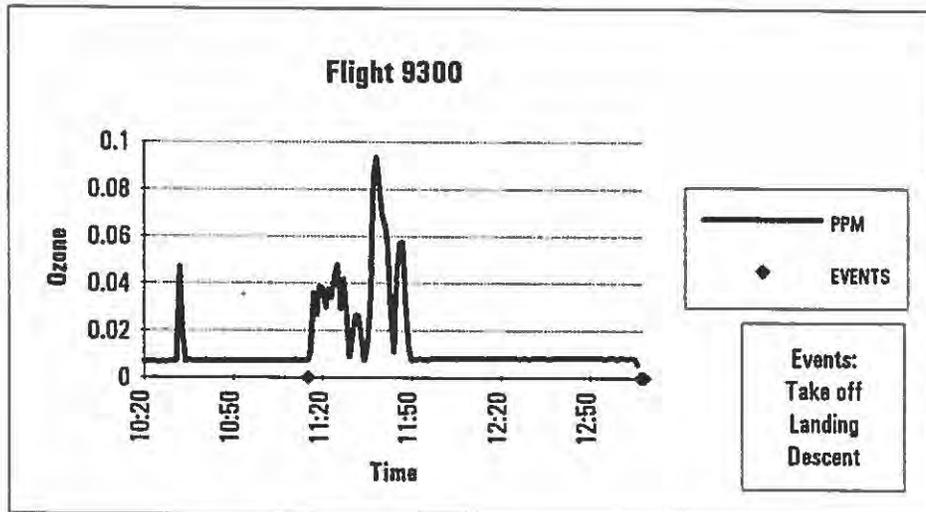
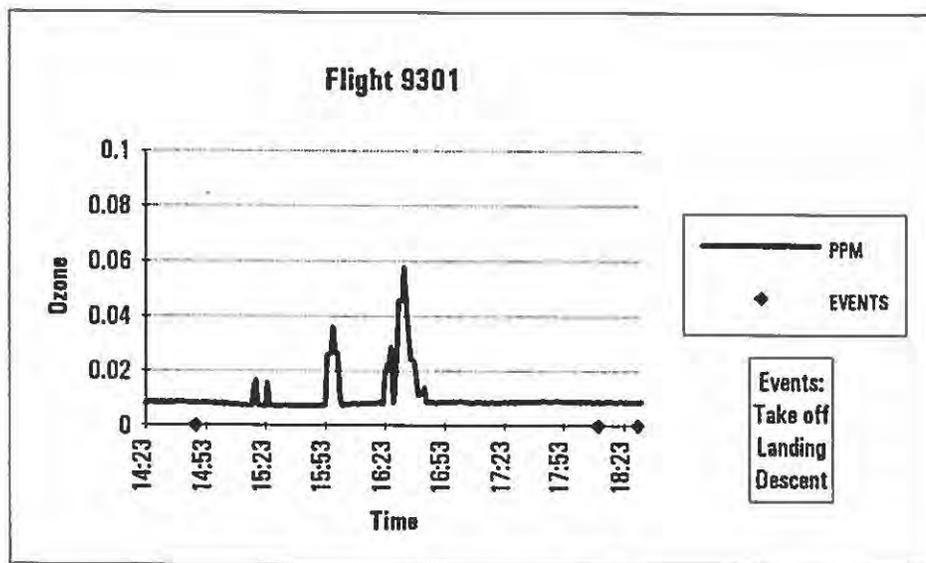
Figure 7
 Results of Direct-Reading Ozone Measurement
 Test Flights
 July 10-11, 1990

Flight and Location	Sampling Times			OZONE (PPM)		
	Start	Stop	Mean	Min	Max	Max-time
Flt 9300--Seat 16D	10:20	13:06	0.014	0.006	0.093	11:38
Flt 9301--Seat 16D	14:23	18:32	0.01	0.007	0.058	16:33
Flt 9302--Seat 16D *	10:05	15:56	0.005	<0.001	0.060	15:56
