## **NIOSH HEALTH HAZARD EVALUATION REPORT**

**HETA #2000-0400-2956**

**Glen Canyon National Recreation Area  
Arizona and Utah**

**January 2005**

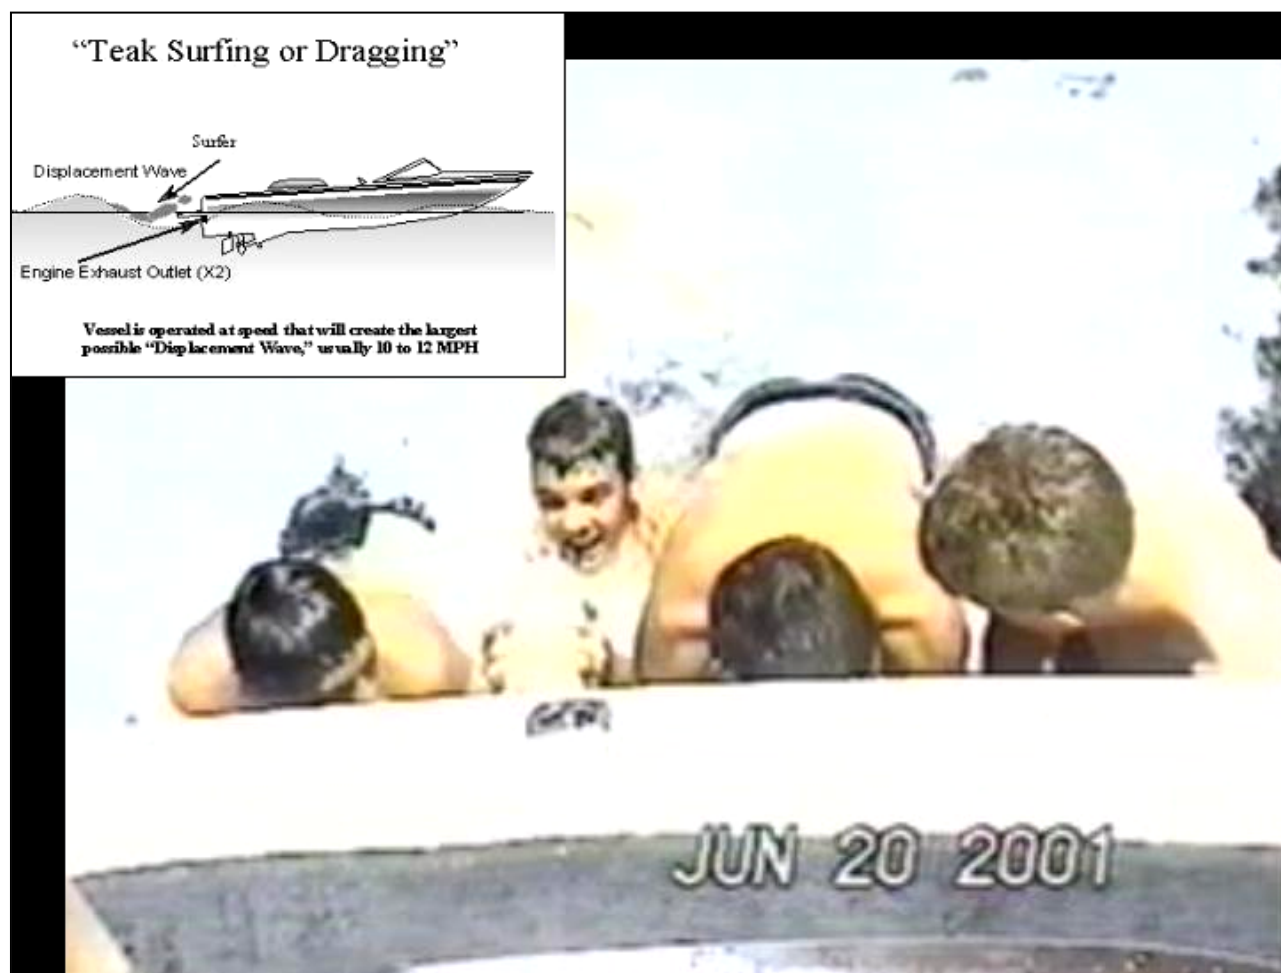
**Figure 4. Teak Surfing or Platform Dragging**

activity referred to as “teak surfing” or “platform dragging”, shown in Figure 4. Two others lost consciousness while sitting on the platform of a stationary ski boat, either pausing while accessing the boat or playing with a shower device that uses warm water from the operating boat engine. COHb concentrations, available for three of the six, were as follows: 18% after 50 minutes of oxygen therapy; 32% after 37 minutes of oxygen therapy; 56% on autopsy.

This letter reported NIOSH evaluation methods, findings, and conclusions related to the death of an 18-year-old boy. In summary, this person succumbed to exposure to extremely high concentrations of CO within 5 minutes of beginning an activity that the family referred to as “teak surfing.” This activity, shown in Figure 4, is made possible by specific design features of ski boats with an extended water-level teakwood swim platform and recessed propeller. The boy’s measured COHb was reported by the coroner as 56%. At the time of this report, NIOSH was aware of four other similar fatal poisonings nationwide, and at least two non-fatal CO poisonings resulting in loss of consciousness also associated with similar activities and boats.

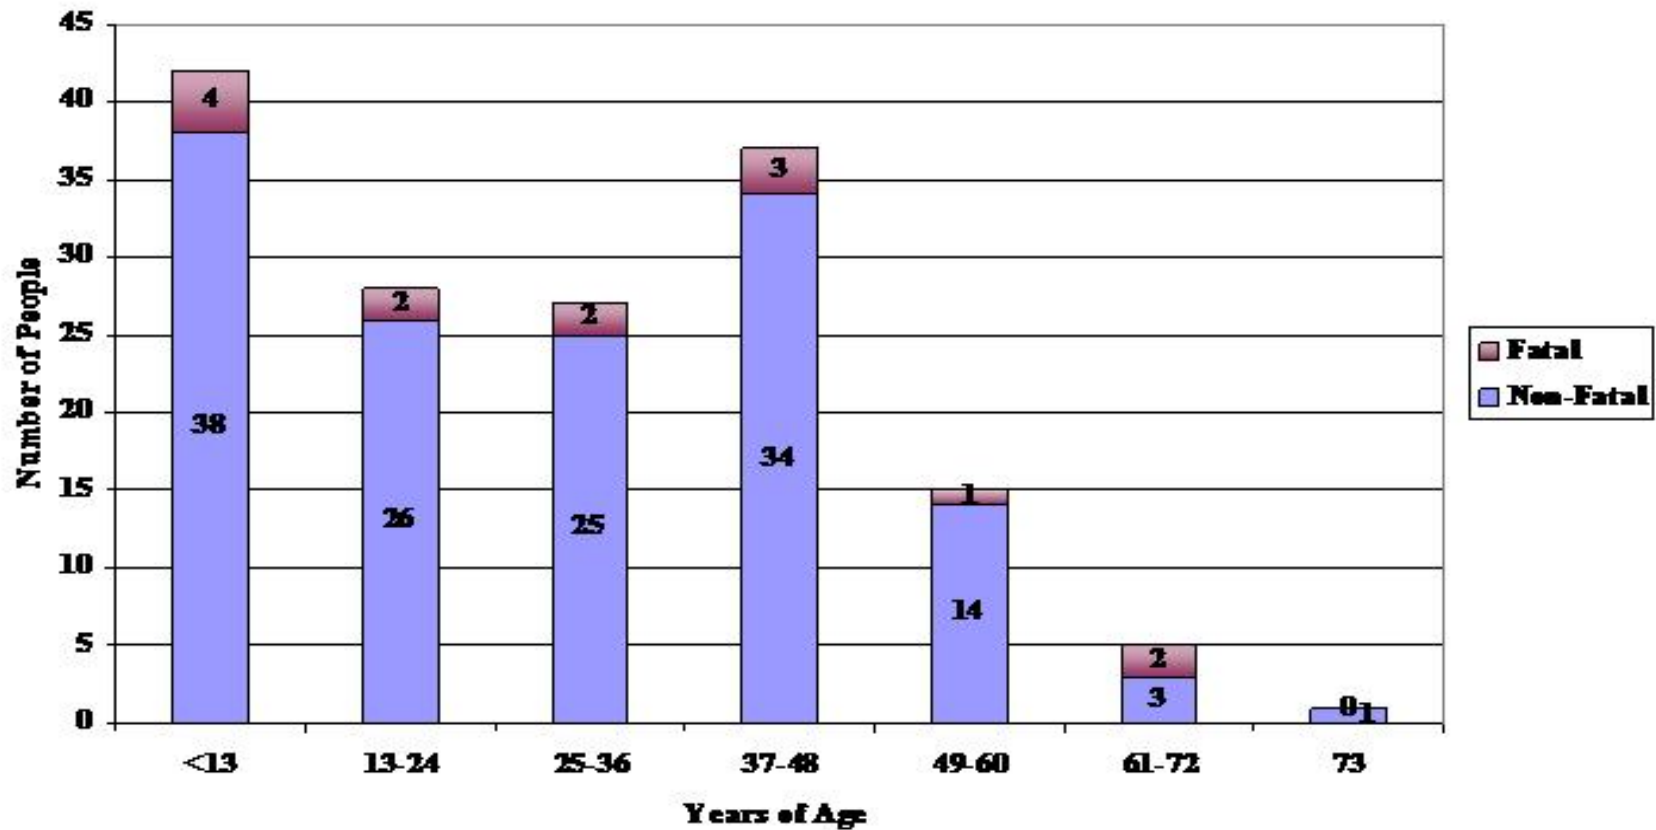
**Figure 5. Boat-Related CO Poisonings by Age**  
**GCNRA 1990 - 2004**  
**Ages were known for 155 / 176 cases**

Figures 5–8 show the following information: Boat-related CO poisonings by month of the year; by age of victim; by source of CO exposure; by location of the victim when exposed.
