FATAL ACCIDENTS DUE TO FLYROCK AND LACK OF BLAST AREA SECURITY AND WORKING PRACTICES IN MINING

National Institute for Occupational Safety and Health
Pittsburgh, Pennsylvania, USA

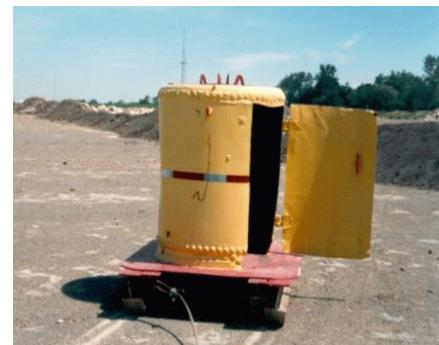
2. Blasting shelter

At a surface mine a blasting shelter (Figure 2) was readily available for use. No one was allowed in the blast area after blastholes were loaded and lead-in line connected. The blasting shelter was available for the blaster to stay inside the blast area during any scheduled blasting. In general, access to the blast area was controlled by signs, barricades, and ground supervision. The blaster removed all unused explosives, communicated with the guards, and visually inspected the bench top prior to firing the shot. Radio communication was used by personnel involved in these activities.
