# Laborer, Pipefitter, and Utility Foreman Crushed by Falling Block Wall - Tennessee (FACE 2014-02)

REPORT#: 2014-02

REPORT DATE: January 30, 2018

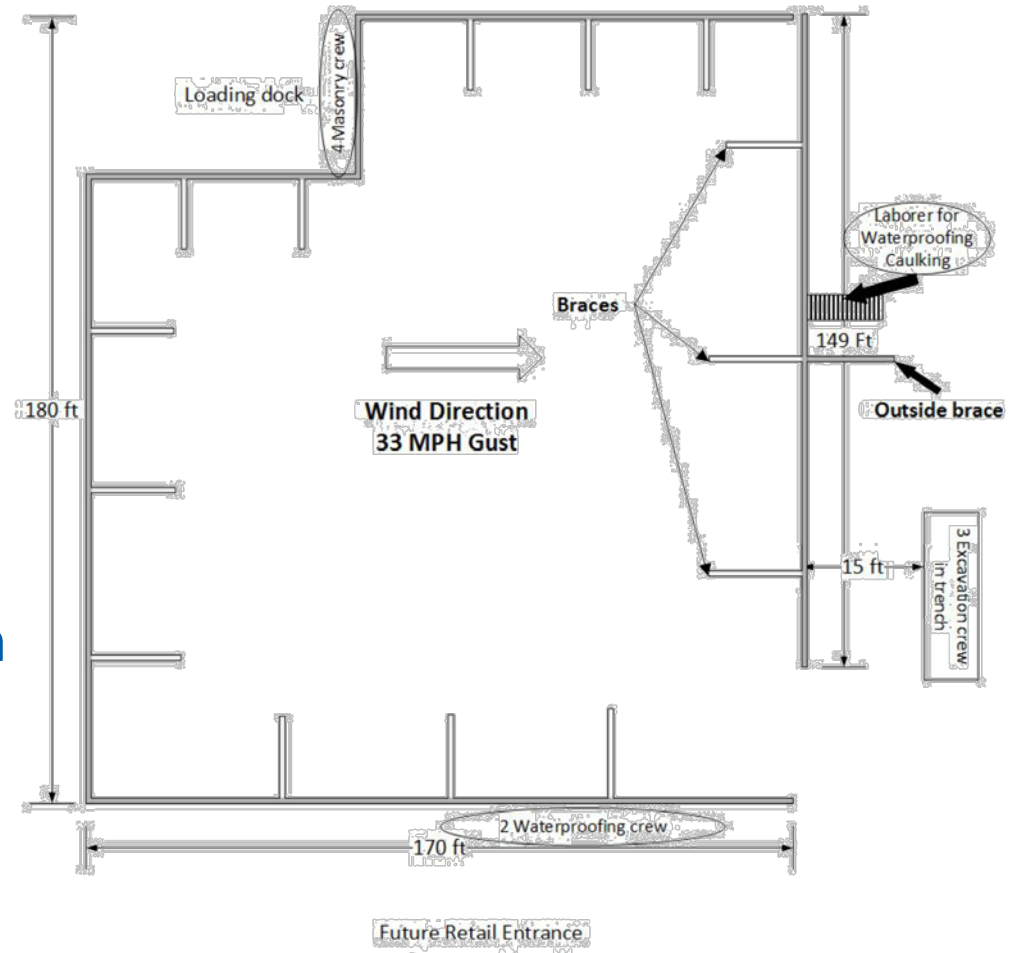
Site Diagram, Not to Scale

- At the time of the incident, the laborer was applying caulking to the expansion joints of a block wall, and the pipefitter and the utility foreman were installing piping for the building's sprinkler system in a trench next to the block wall.
- A wind gust caused the block wall to fall onto the laborer, pipefitter, and utility foreman.
