**LINE OF DUTY
DEATH REPORT**
VISUAL EXTENSION

F2019-16 ME

Captain Killed and Six
Firefighters Injured at a Propane
Explosion in an Office Building-
Maine

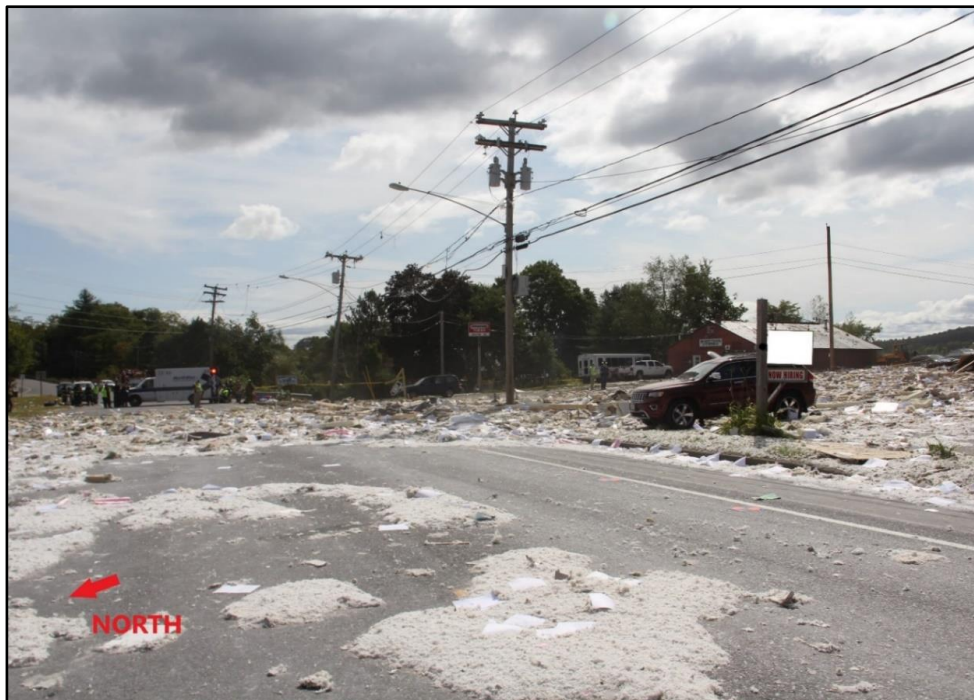
The ambulance is located at the triage, treatment, and transportation unit after the explosion. All patients were transported to the hospital from this location.
(Photo courtesy of the Maine Office of the State Fire Marshal)
