Bureau of Mines Report of Investigations/1987

**Effects of Stimulation Treatments
on Coalbeds and Surrounding Strata**
Evidence From Underground Observations

By William P. Diamond and David C. Oyster

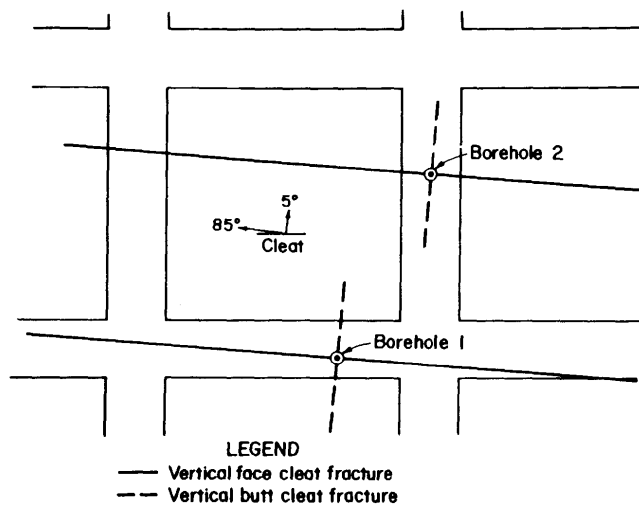
Figure 1.—Relationship of mine entry orientation and interception of vertical fracture wings parallel to coal cleat.

A hydraulic fracture trending in the face cleat direction perpendicular to the long axis of an entry would presumably be contained in the ribs adjacent to the borehole (borehole 2, figure 1) and would be available for observation as long as the pillar remained. Butt cleat fractures, if present, would have been intercepted head on. Since butt cleat fractures are often relatively short, they would often be completely mined by a single mining cut and never observed.

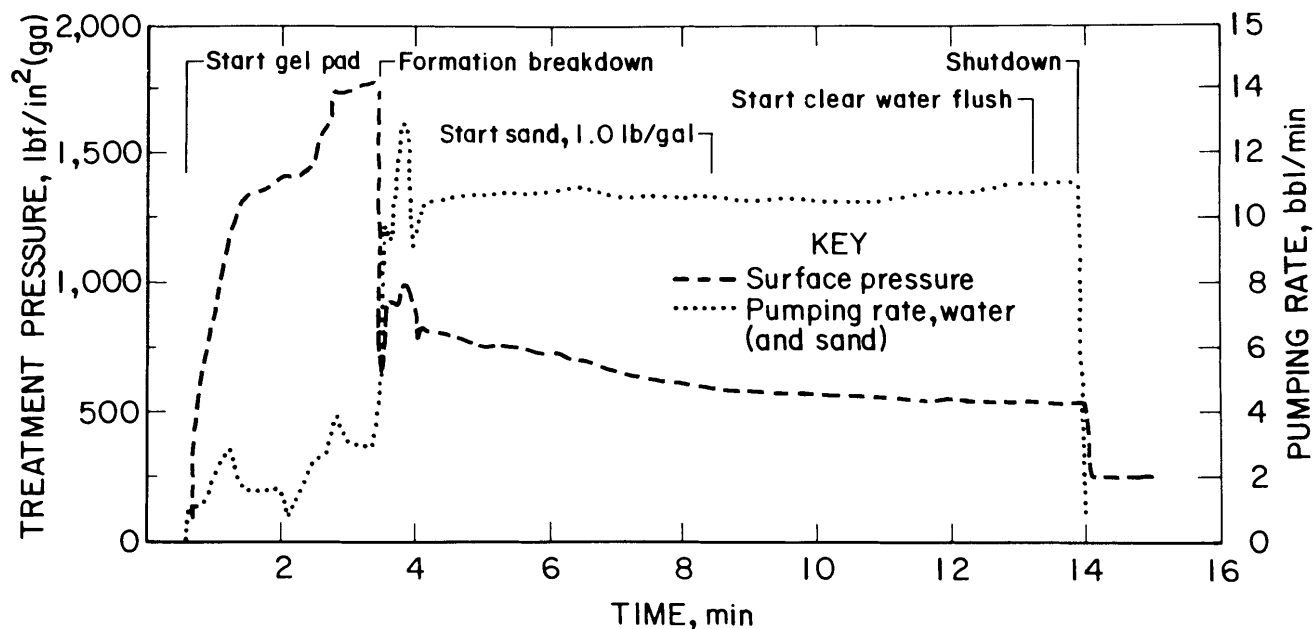
The borehole was stimulated through 2 $\frac{7}{8}$ -in-diameter tubing set at 1,084 ft with a packer installed at the top of the wellhead to prevent the stimulation fluid from flowing to the surface in the annulus between the casing and tubing. No prestimulation cleanup or slotting of the coal face with a jetting tool was reported. The treatment was initiated with a 2,500-gal gelled water pad injected at rates averaging about 2 bbl/min. Surface treatment pressures quickly increased to about 1,400 lbf/in²(ga), leveled off (indicating leakoff into the formation), then gradually increased to 1,775 lbf/in²(ga) where formation break occurred with an accompanying sharp pressure decline to 600 lbf/in²(ga).

After the formation break, the injection rate was increased to 10.5 bbl/min. The surface pressure increased to nearly 1,000 lbf/in²(ga) and then gradually decreased to about 600 lbf/in²(ga) throughout the remainder of the pad injection. An additional 2,500 gal of gelled water

Figure 2.—Treatment record, borehole TW-1 (18).

containing 2,500 lb of minus 20- to plus 40- (20/40) mesh sand (at 1 lb/gal) was injected at a pump rate of 10.5 bbl/min. This was followed by a 290-gal fluid flush without sand. A total of 5,290 gal of fluid were injected during the treatment. Treatment pressures (surface) immediately after formation breakdown averaged about 650 lbf/in²(ga). Surface treatment pressures averaged about 550 lbf/in²(ga) during the sand injection stage of the treatment. An instantaneous shut-in pressure (ISIP) of 250 lbf/in²(ga) (surface) was recorded at the end of the treatment. The ISIP is a measure of the minimum pressure required to keep a fracture open. Gas production from borehole TW-1 began at about 2,500 ft³/d and gradually increased to a maximum of only 8,500 ft³/d just prior to underground interception.

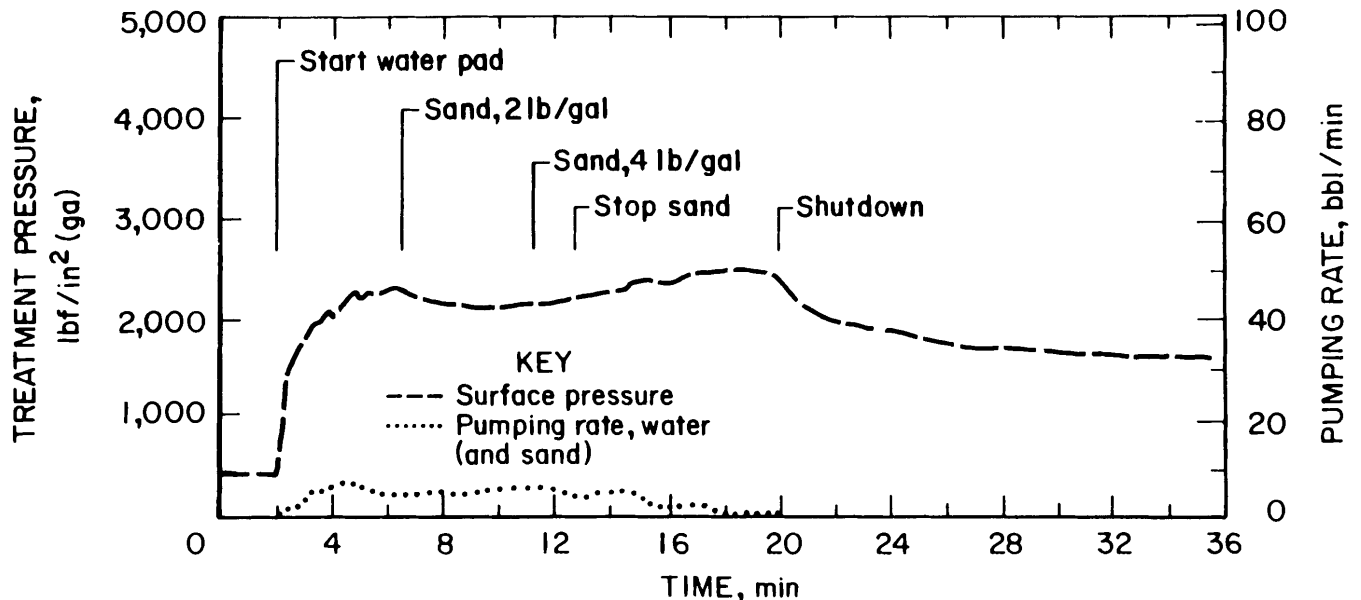
Figure 5.—Treatment record, borehole TW-2. (Modified from Lambert (20))

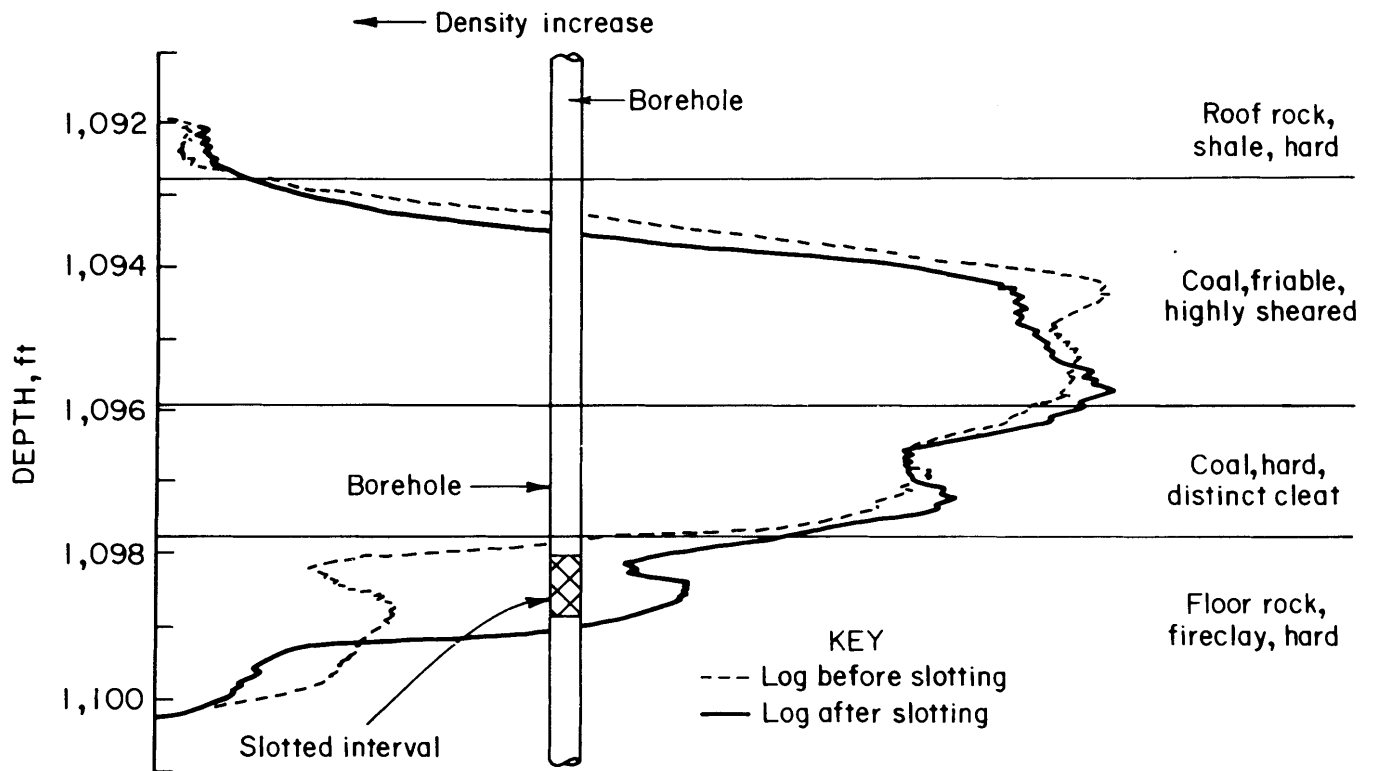
Lambert (20) reported that before the start of production the presence of the slots only in the floor rock below the target coalbed could have been revealed by a comparison of density logs from before and after slotting operations (fig. 8). The logs run after the slotting show a significant density decrease along the casing interval identified by underground observation to have been successfully slotted.

Figure 8.—Comparison of gamma density logs before and after jet slotting, borehole TW-2. (Modified from Lambert (20))

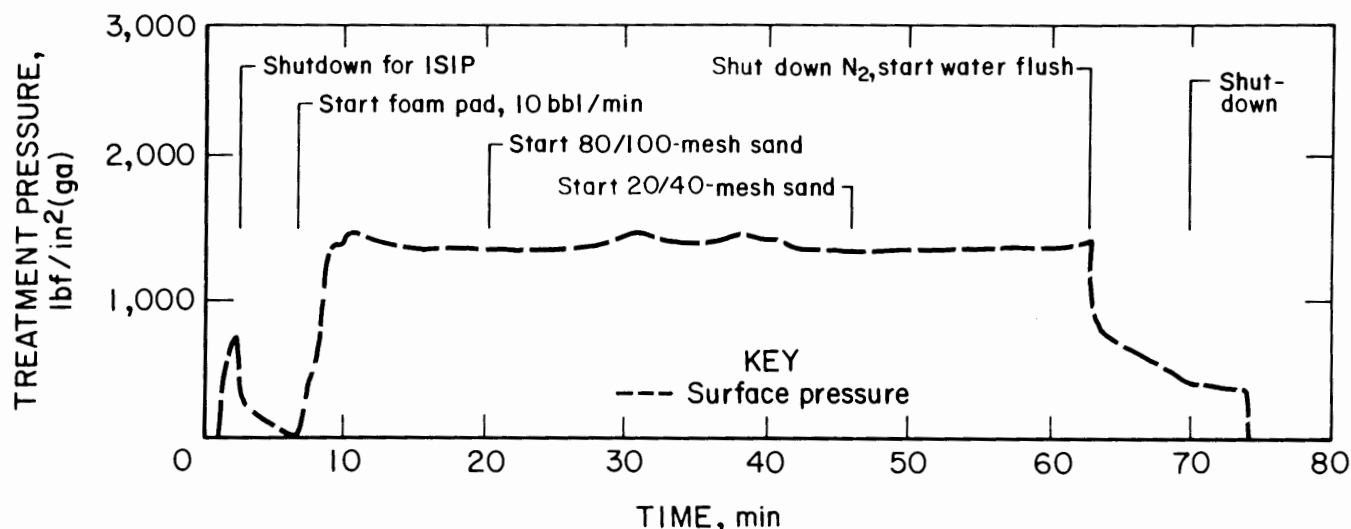
The Blue Creek Coalbed was stimulated with a 75-pct-quality nitrogen-generated foam and sand proppant. The stimulation treatment record for this borehole is shown in figure 9. An initial formation break was interpreted by Lambert (21) to have occurred at a surface pressure of 700 to 750 lbf/in²(ga). After the initial formation break, fluid injection was briefly stopped to determine the instantaneous shut-in pressure, which was interpreted to be approximately 400 lbf/in²(ga). Maximum and average surface treating pressures were approximately 1,500 and 1,400 lbf/in²(ga), respectively, at injection rates averaging 10 bbl/min. The borehole was stimulated through 2³/₈-in-diameter tubing with a packer set in the casing near the bottom of the hole. A total of 20,000 gal of foam and 25,000 lb of sand (10,000 lb of 80/100-mesh and 15,000 lb of 20/40-mesh) were injected. The finer 80/100-mesh sand was used as a fluid loss additive to allow more of the stimulation fluids to propagate fractures instead of leaking away nonproductively into the formation.

Figure 9.—Treatment record, borehole TW-3 (18).

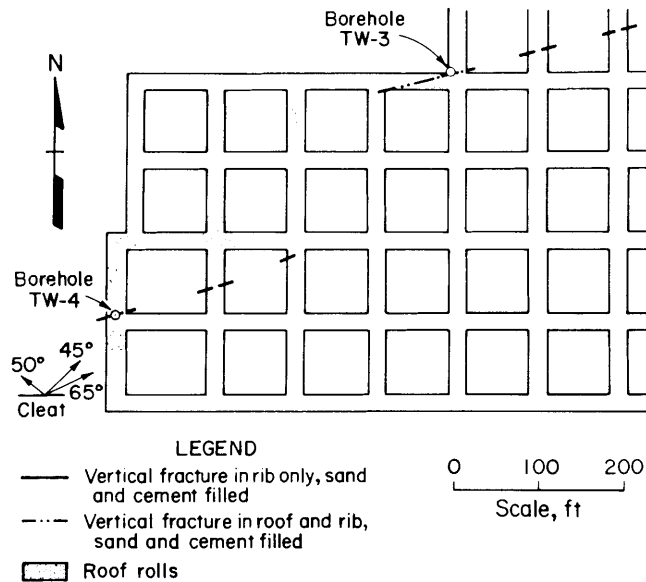
Figure 10.—Mine map, boreholes TW-3 and TW-4, with fracture orientations. (Modified from Lambert (21))

The entry nearest TW-3 is also shown (fig. 10) to be a location of natural roof disturbances. Geologists also noted the presence of many wet roof joints in this area. Except for the single sand-filled crack leading from TW-3 (fig. 10), no evidence could be found to indicate that these wet roof joints had been created by stimulation. Unusually large amounts of seepage from roof openings near TW-3 could, however, be due to the borehole's presence, since it is an accumulation point for water within a coal unit only 7 ft above the open entry.

Previous geologic inspection of the mine near TW-4 showed the well to be nearly surrounded by minor deformation and dislocations in the coal associated with lenticular shale ridges projecting from the roof. Areas of the mine where these features, called "rolls", were observed are shown in figure 10. Because inherent rock weaknesses develop near such features, these areas generally require some degree of additional roof support. The necessity for more roof support near TW-4 than used

in many other portions of the mine, as reported by mine management, may be attributed to this geologic phenomenon rather than stimulation of the test well. The fact that additional roof support was not required at the base of TW-4 nor was it required along the fracture wings indicates borehole stimulation was not the cause for providing additional roof support.

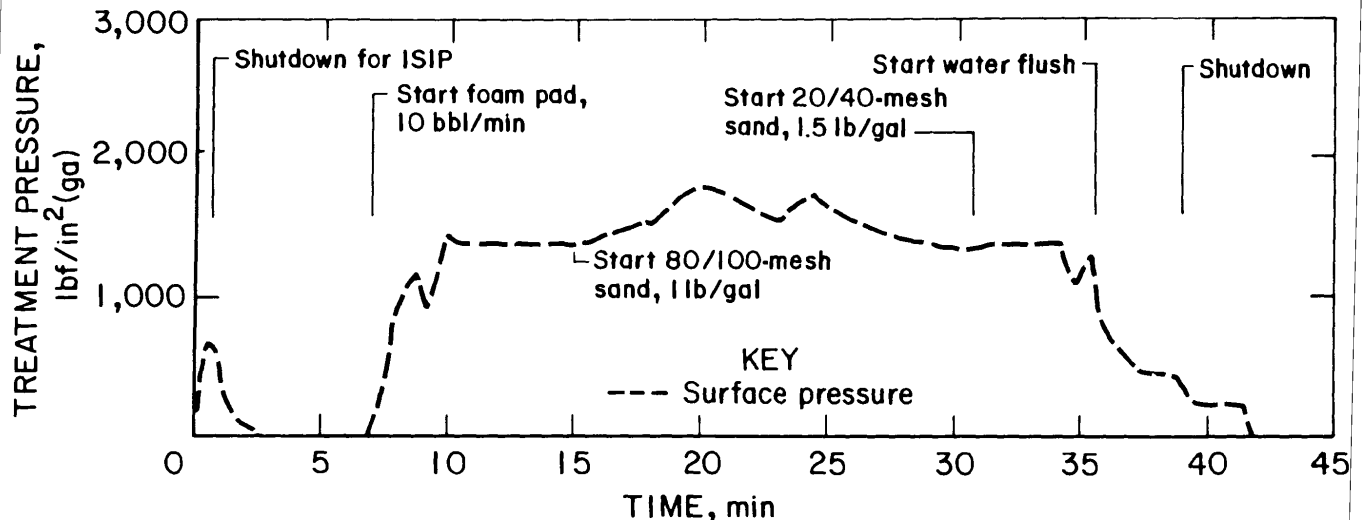
Figure 11.—Treatment record, borehole TW-4 (18).

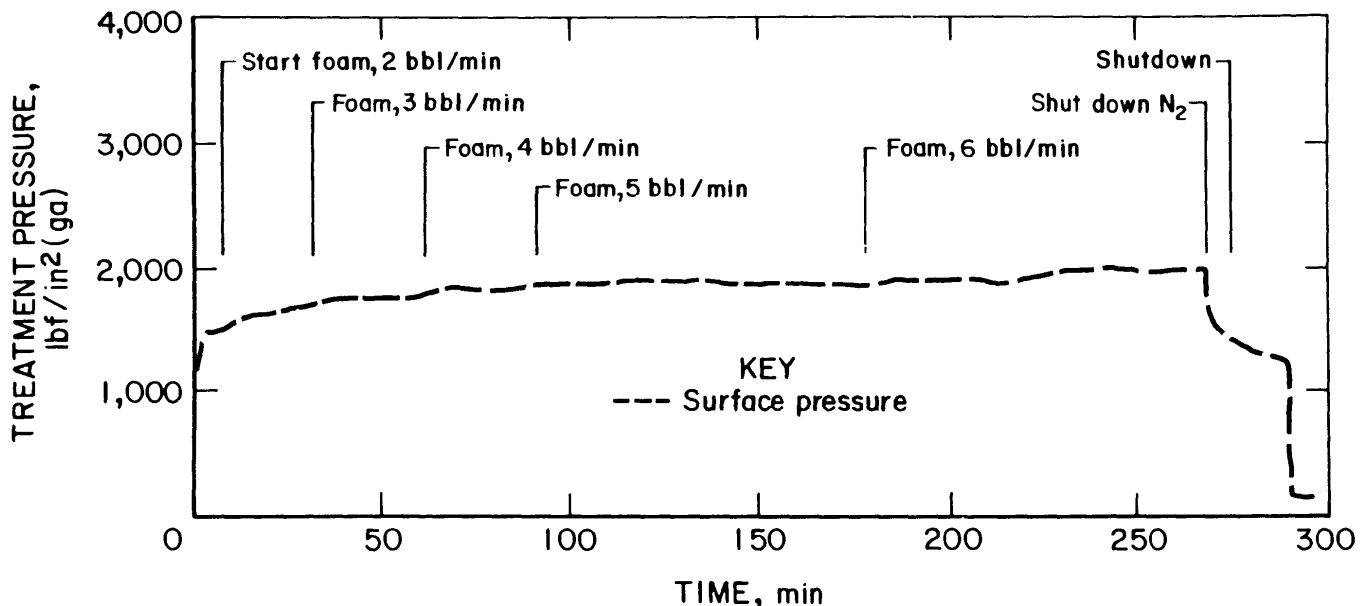
Figure 13.—Treatment record, borehole TW-5 (19).

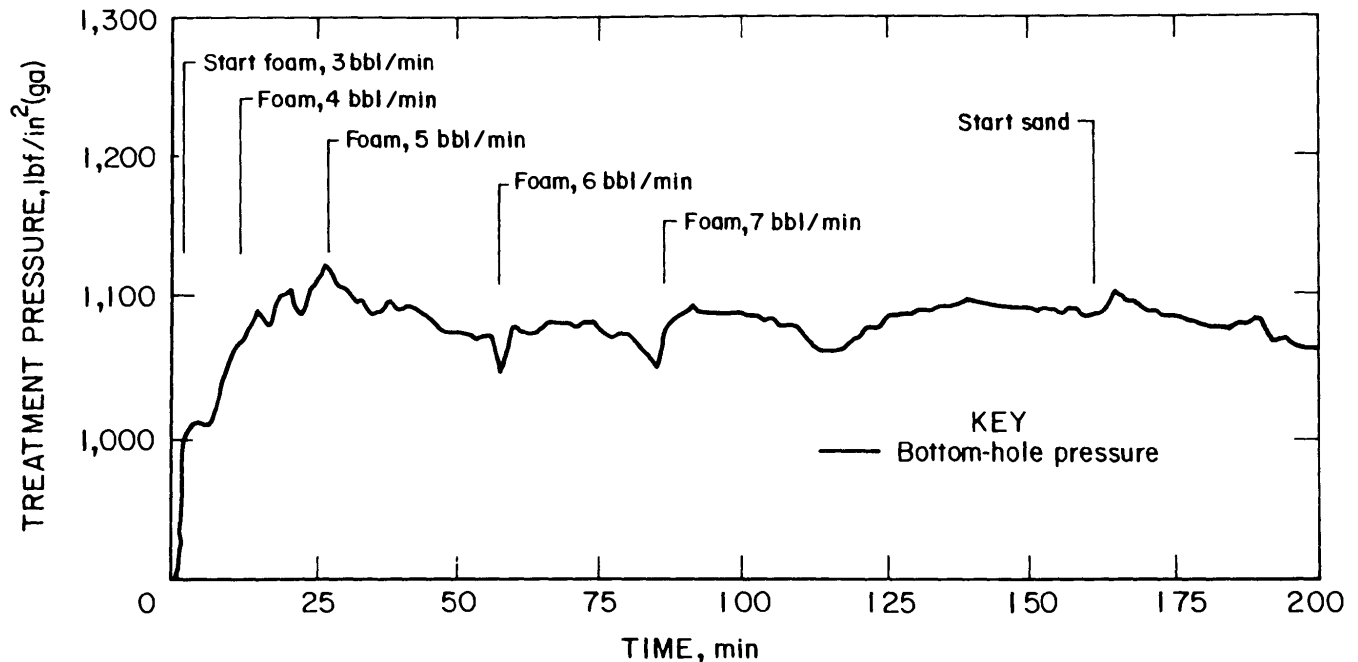
Figure 16.—Treatment record, borehole DHM-6 (17).

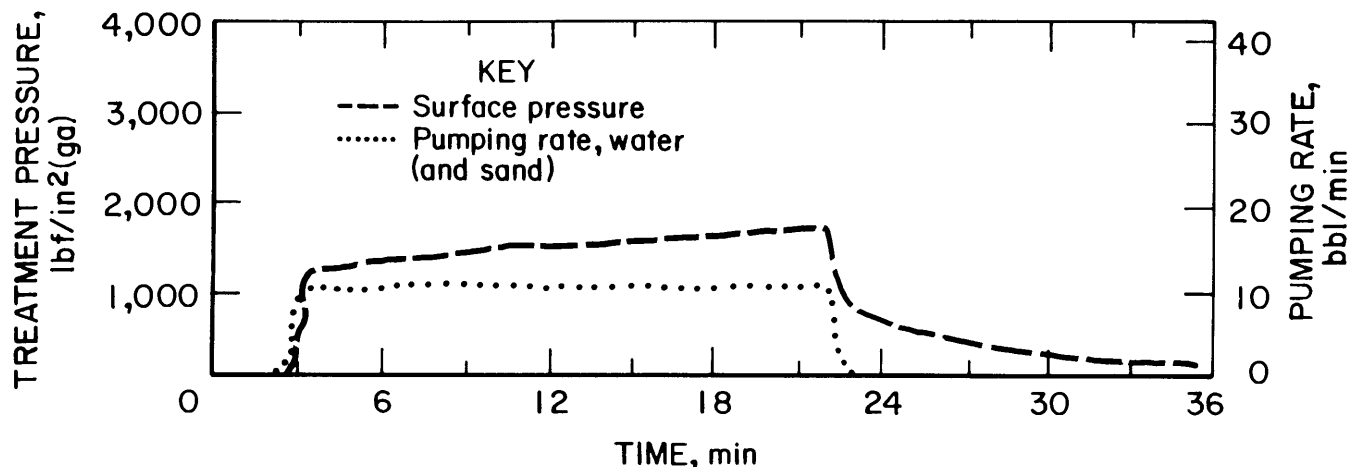
Figure 17.—Treatment record, borehole USBM-4. (Modified from Elder (8))

total sand weight reported in his text. The discrepancy may have resulted from inaccurate rates and/or volumes for the various stages as determined at the blender. A total of 7,300 gal of 75 lb per 1,000 gal gelled fluid was used in the treatment. Surface treatment pressures averaged about 1,550 lbf/in²(ga) with a maximum surface pressure of nearly 1,800 lbf/in²(ga) recorded.

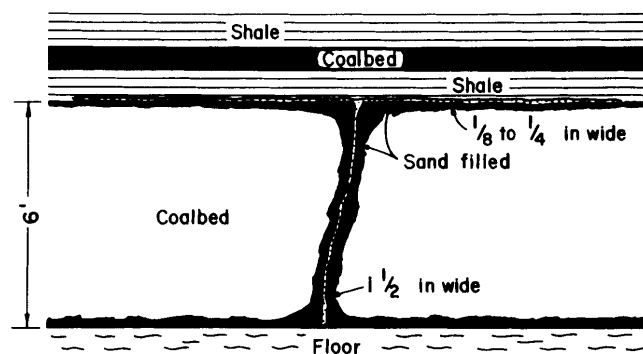
A fracture wing from borehole EM-5 was intercepted by mining on July 21, 1978, approximately 2 yr after stimulation. The borehole location itself was not exposed by mining. The area of the fracture interception is shown in map view on figure 22. At the rib closest to the borehole, a single vertical sand-filled fracture up to 1½ in wide was observed extending from the floor to the roof (fig. 23). At the interface between the top of the coalbed and the overlying hard shale, the vertical fracture became horizontal. The sand-filled horizontal fracture was ⅛ to ¼ in wide, and at its maximum lateral extent was observed 50 ft from the presumed borehole location. The sand-filled vertical fracture could be traced across two entries of the mine, and at its maximum observed extent, it was approximately 140 ft from the presumed borehole location. The vertical fractures were propagated along face cleats, which averaged N 68° W in orientation. The width of the vertical sand-filled fracture varied from 1½ in at the exposure nearest the borehole to only a hairline at its maximum extent, where it was only partially filled with sand. No evidence of penetration of the roof strata was observed associated with the stimulation treatment at borehole EM-5.

Figure 23.—Cross section of fractures on rib closest to borehole EM-5. (Modified from Lambert (9))

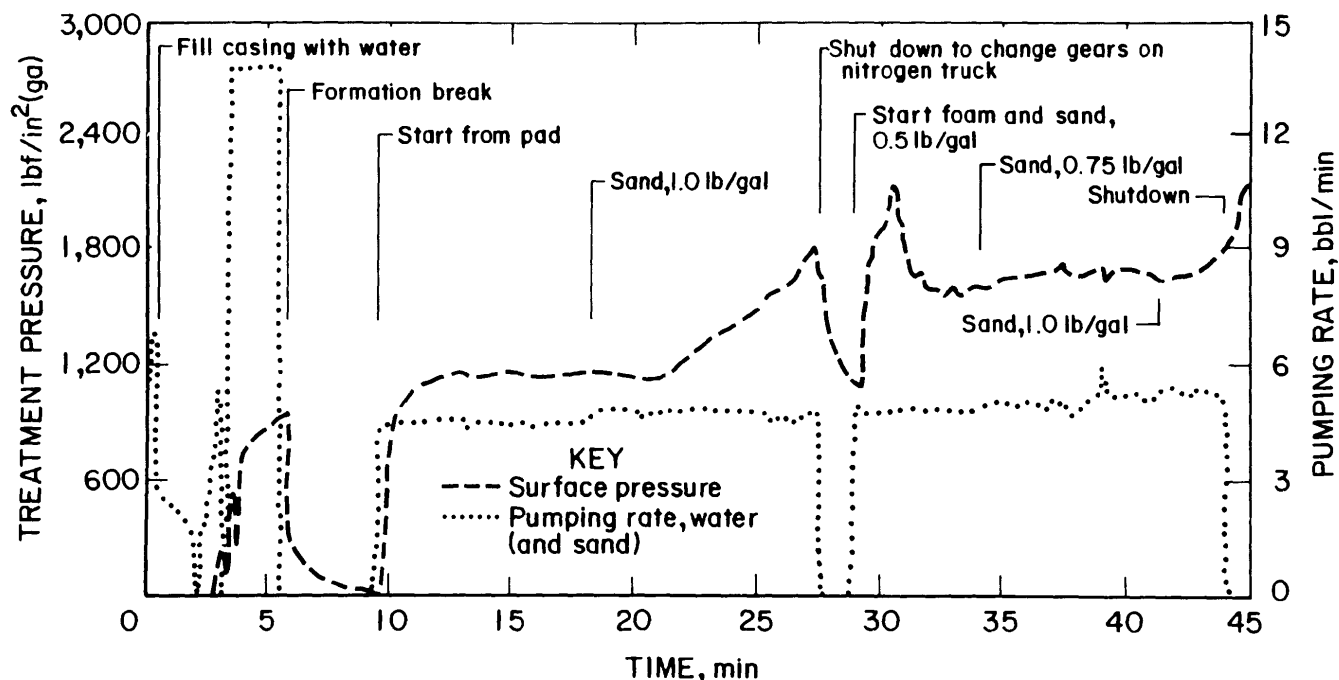
Figure 24.—Treatment record, borehole EM-6.

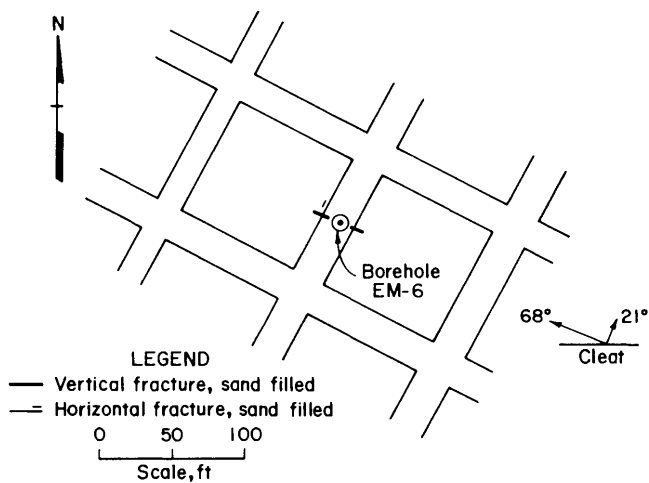
Borehole EM-6 was mined through on November 9, 1978, approximately 2½ yr after stimulation. The area of the borehole interception is shown in map view in figure 25. A single vertical sand-filled fracture, approximately 2½ in wide and extending from the base of the coalbed to a point about 3 ft above the base was observed on the west rib, 10 ft away from the intercepted borehole (fig. 26). The vertical fracture was propagated along face cleats and several discontinuous sand-filled fractures extended to the top of the main coal bench. Several additional thin discontinuous sand-filled vertical fractures paralleled the main fracture and were also developed in face cleats. The average orientation was N 68° W. One of the short vertical fractures penetrated the thin roof shale above the main coal bench and terminated at the base of the rider coal.

An inclined fracture split off from the main vertical fracture and stairstepped its way up to the top of the coalbed where it became horizontal for a short distance before inclining through the thin (8-10 in) roof shale and finally becoming horizontal at the base of the rider coal. The sand-filled horizontal fracture on top of the main coal bench was about ½ in thick and the horizontal fracture at the base of the rider coal was ¼ to ½ in thick. No additional exposures were observed for the fractures seen on the ribs adjacent to the borehole. The extent of the fractures into the ribs is unknown. No adverse mining conditions were encountered due to the penetration of the

Figure 25.—Mine map, borehole EM-6, with fracture orientations. (Modified from Lambert (9))

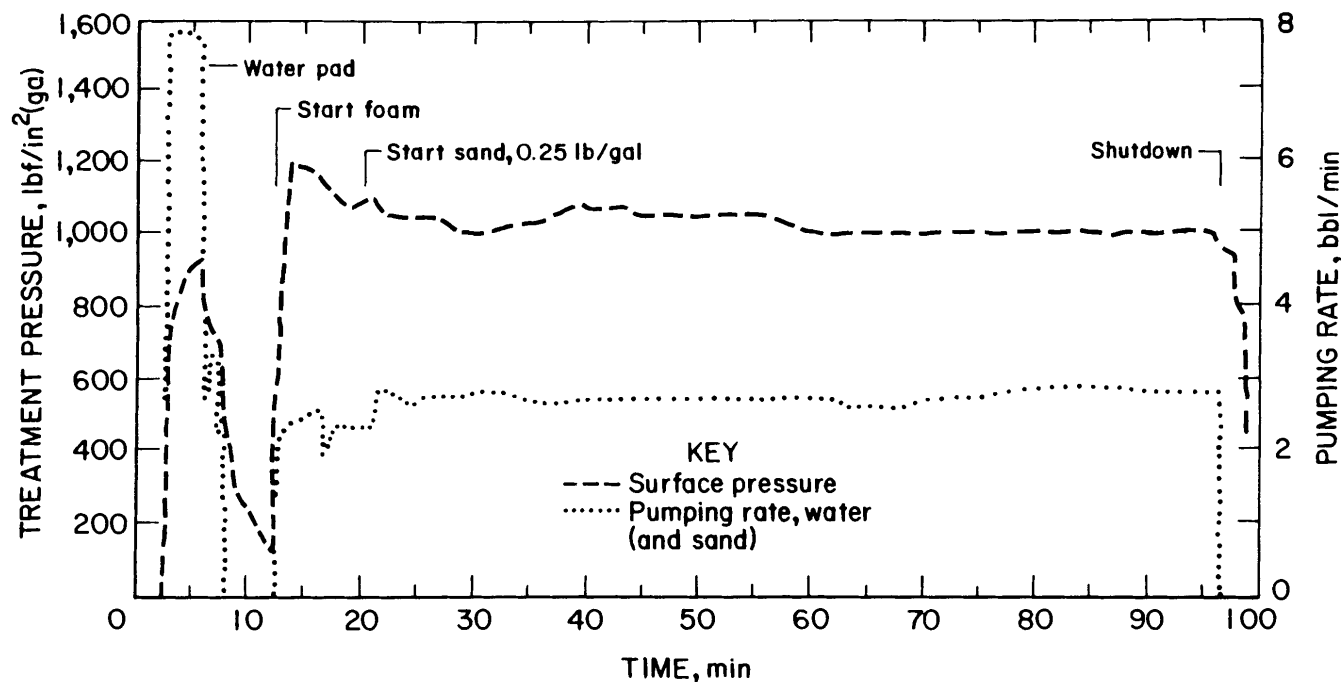
Prestimulation strata characterization tests included gamma ray and neutron wireline geophysical logs. The continuous stimulation treatment record for this borehole is shown in figure 27. The treatment was initiated with a 900-gal water pad followed by 600 gal of 75-pct-quality nitrogen-generated foam. A formation break was not reported. A total of 42,000 gal of foam with 12,800 lb of sand (10/20- or 20/40-mesh) were injected into the coalbed. The average foam injection rate was 10.8 bbl/min, with

Figure 27.—Treatment record, borehole EM-8.

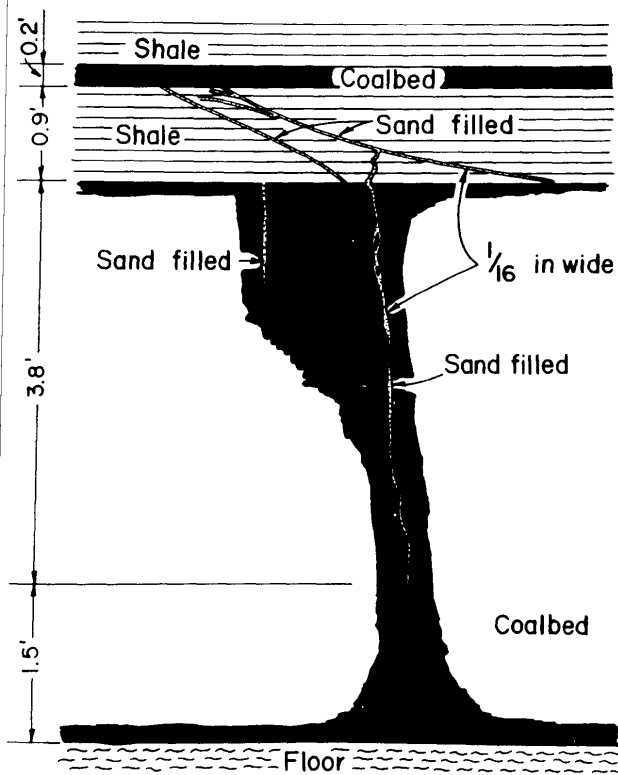
Figure 29.—Cross section of fractures on rib at location 1 near borehole EM-8.

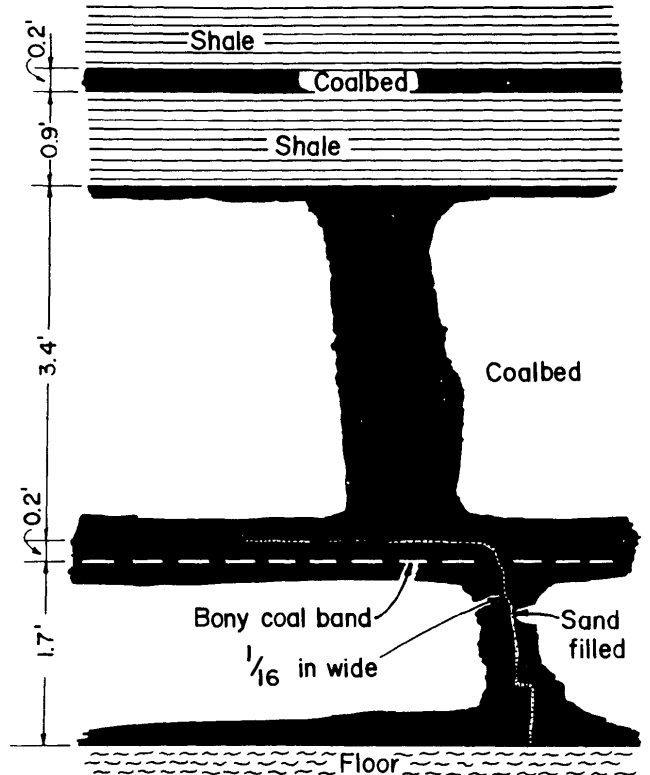
Figure 30.—Cross section of fractures on rib at location 2 near borehole EM-8.

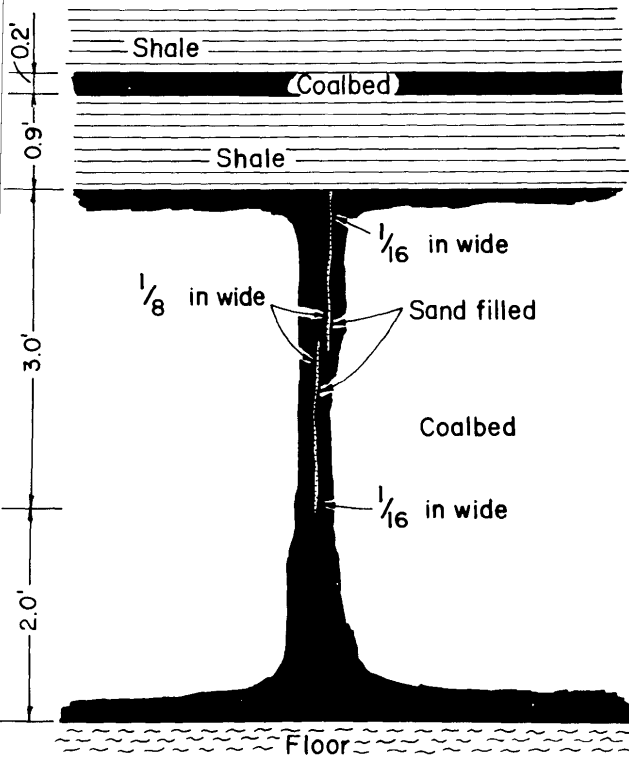
Figure 31.—Cross section of fractures on rib at location 3 near borehole EM-8.

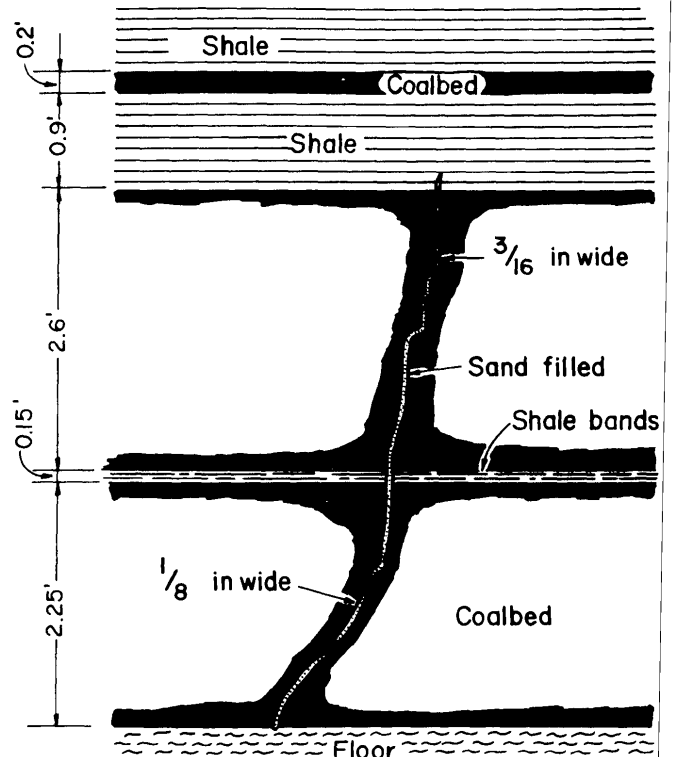
Figure 32.—Cross section of fracture on rib at location 4 near borehole EM-8.

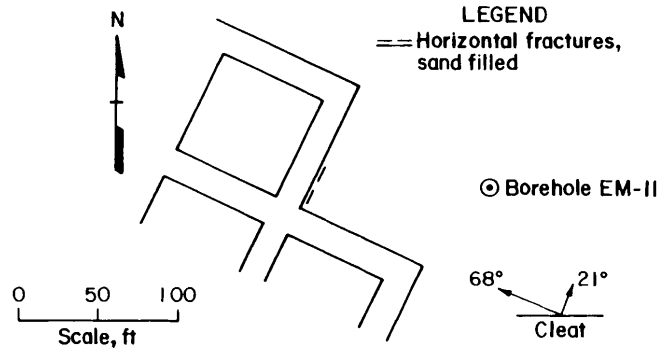
Sand-filled fractures from borehole EM-11 were intercepted in June of 1978, approximately 1 yr after stimulation. The borehole was not mined through. The area of the fracture interception is shown in map view in figure 33. The only observed fractures were horizontal to slightly inclined and were located in the rider coal above the main bench of the Pittsburgh Coalbed (fig. 34). One of the fractures curved up into the shale overlying the rider coal.

Figure 33.—Mine map, borehole EM-11, with fracture orientations. (Modified from Lambert (9))

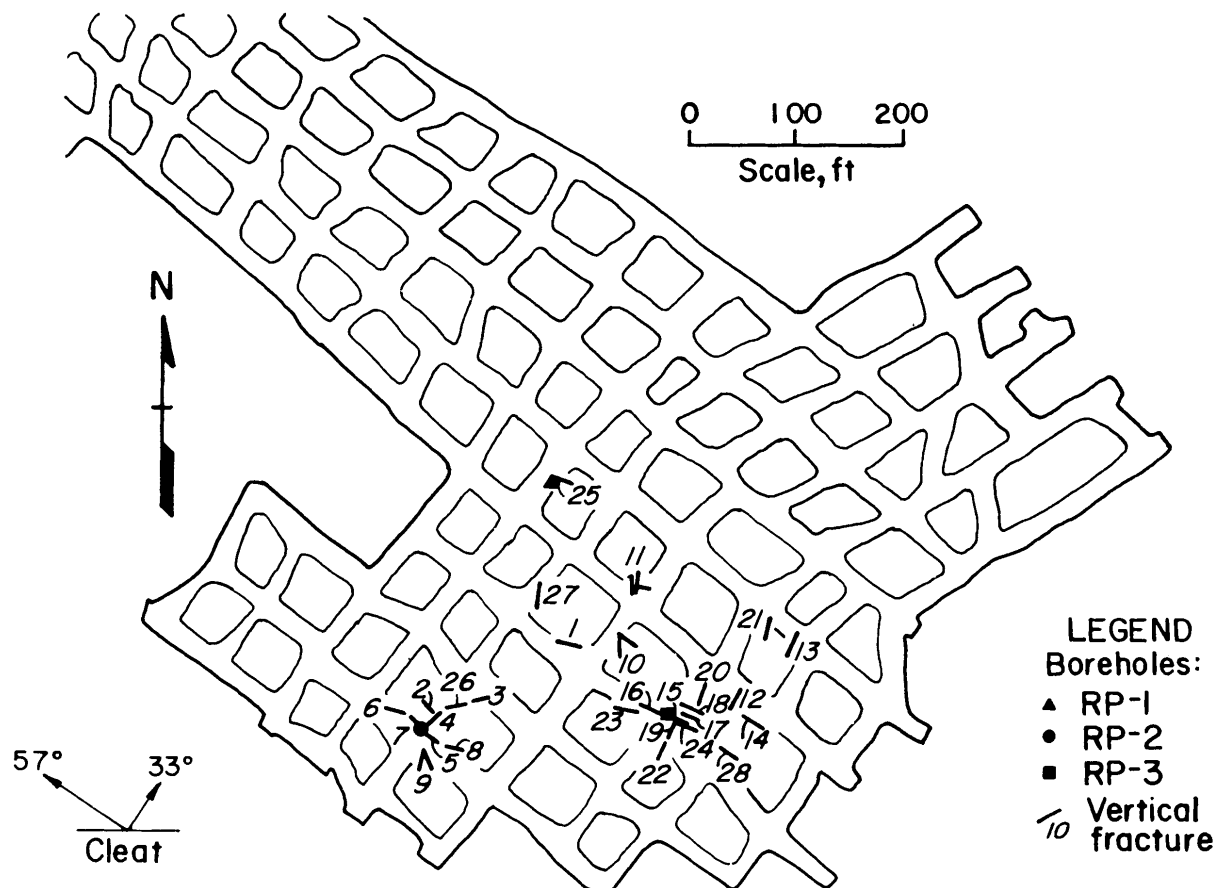
Figure 37.—Mine map, boreholes RP-1 through RP-3, with fracture orientations (12).

Vertical fractures (25)⁵ from borehole RP-1 were found in the southeast rib adjacent to the intercepted borehole (fig. 37). Nine vertical fractures in a zone 8½ in

wide were present in the lower bench of coal below the shale parting (fig. 38). Two fractures contained sand that is assumed to have come from the sand placed at the bottom of the hole to protect the coalbed from cement invasion during the casing and cementing operation, since no sand was injected as part of the treatment.

Several of the vertical fractures extended through the shale parting and into the upper bench. Pink-paint-tagged grout that had been used to plug the hole for abandonment was found in the upper portion of fractures whose lower portion contained sand. All of the fractures were aligned parallel to the face cleat (N76°W) and were coated with green paint. Fractures that contained only paint were visible using the ultraviolet light. They appeared to be no wider than the face cleat itself. The sand-filled fractures were approximately $\frac{1}{16}$ in wide. The most prominent vertical fracture could be traced with the ultraviolet light laterally across a small patch of roof coal remaining around the borehole. The fracture in the roof coal extended laterally from the borehole approximately 6 in to the nearby rib and 19 in into the entry in the opposite direction. The fluids followed a stairstep path alternating along the face and butt cleat in the roof coal, and did not travel along a single face cleat for more than 1 or 2 in. A summary of the orientation and fracture observations is given in table 8.

The vertical fractures either terminated at the roof or before reaching the roof. No evidence of roof penetration by the stimulation was observed. A small roof fall did occur at an intersection approximately 25 ft southwest of the borehole several days after being mined. The roof fall was attributed to the presence of compactional slips in the black shale roof. Examinations of the area with the ultraviolet light failed to detect any paint on any surface associated with the fall or around the fall. Similar roof falls related to slips are common in this area of the mine.

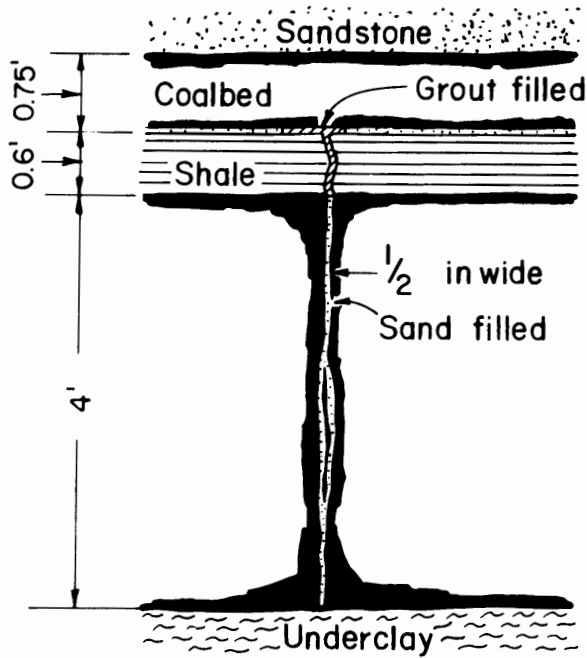
Figure 41.—Cross section of fractures at location 7 on the northwest rib near borehole RP-2. (Modified from Murrie (12))

Vertical fractures in the face cleat direction were observed as the borehole was mined through. One fracture (7) on the northwest rib (fig. 41) and one (5) to the southeast contained sand. The fracture on the northwest rib was closest to the borehole and was approximately ½ in wide and filled with sand proppant to the bottom of the parting. A second vertical fracture split off the main fracture approximately midway in the main bench of coal and rejoined near the base. Yellow and orange paint were found in the sand. The upper section of the fracture through the shale parting was filled with grout tagged with pink paint used to plug the hole for abandonment. The grout also extended a few inches horizontally along the interface between the shale parting and the upper bench of coal (fig. 41). Sand was found beyond the grout on the same horizontal plane in the rib for a maximum distance of 17 ft from the borehole to the northeast (fig. 42). The vertical sand-filled portion of the fracture narrowed to approximately ¼ to ⅛ in where it extended to the southeast rib (5). Grout from the plugging operation was again found in the vertical fracture through the shale parting. Sand was present for a short distance horizontally at the interface between the top of the shale parting and the upper coal bench. A summary of the vertical fracture observations is given in table 8.

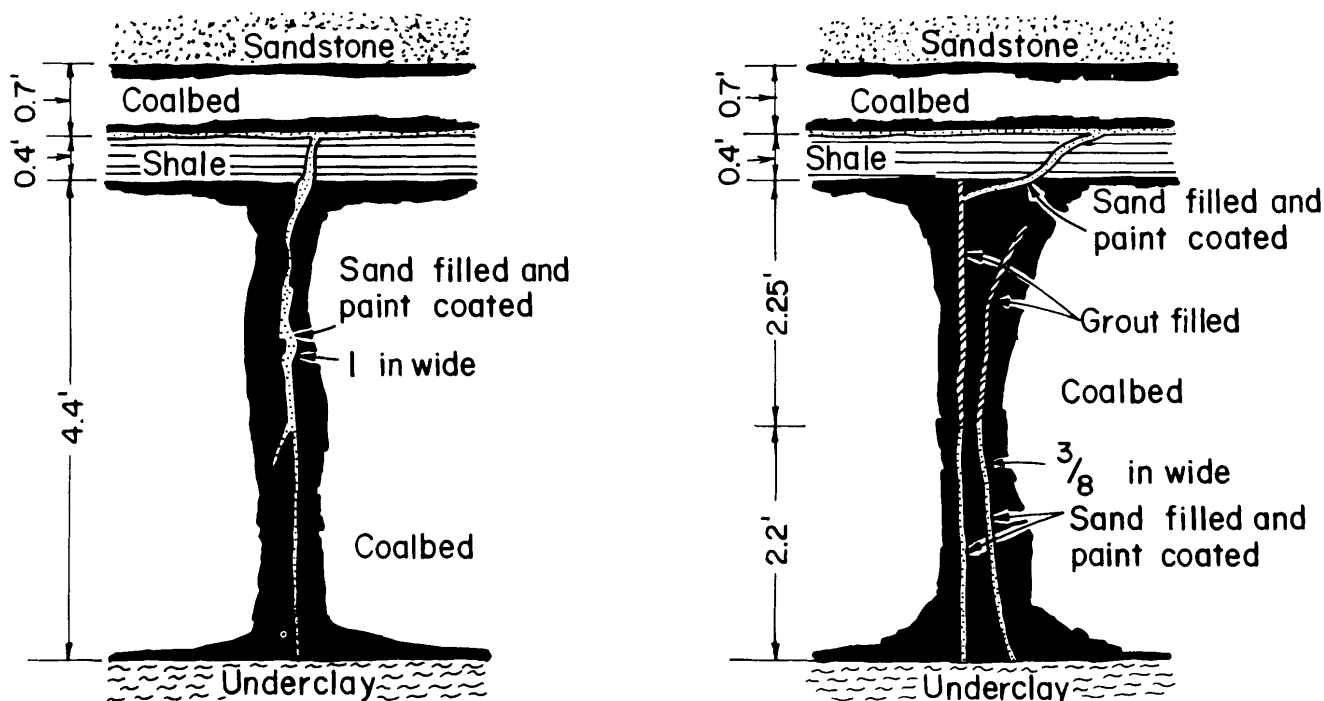
Figure 44.—Cross section of fractures at location 15 on southeast rib (right) and location 16 on northwest rib (left) near borehole RP-3. (Modified from Murrie (12))

The vertical fracture on the northwest rib (16) was filled with sand, had a maximum width of approximately 1 in, and tapered to the width of a cleat at the base. This sand-filled fracture extended upward through the shale parting and became horizontal on top of the parting. Orange and yellow paint were found in the fracture (16) nearest the hole in the northwest direction and only red was found further out (23) in this direction. The sand-filled wing of this major fracture (15) on the southeast rib (fig. 44) was slightly more complex than that on the northwest rib. Two nearly parallel vertical sand- and grout-filled (from the plugging operation) fractures were present. The sand filling extended from the floor to about halfway up the main coal bench, and the grout filled

the remainder of each fracture up to its maximum vertical extent. Maximum width was $\frac{3}{8}$ in. The shorter vertical fracture terminated approximately 2 in below the parting. The other fracture terminated at the bottom of the shale parting, but a horizontal sand-filled fracture split off from it 2 in below the parting. This split intercepted the parting at a shallow angle and then cut through it at approximately 45° and became horizontal on top of the parting. Orange and yellow fluorescent paint were found in the fractures (15) closest to the borehole in this direction, red only slightly further away (24), and finally yellow only at the furthest extent of this fracture on the next rib (28). A summary of the vertical fracture observations is given in table 8.

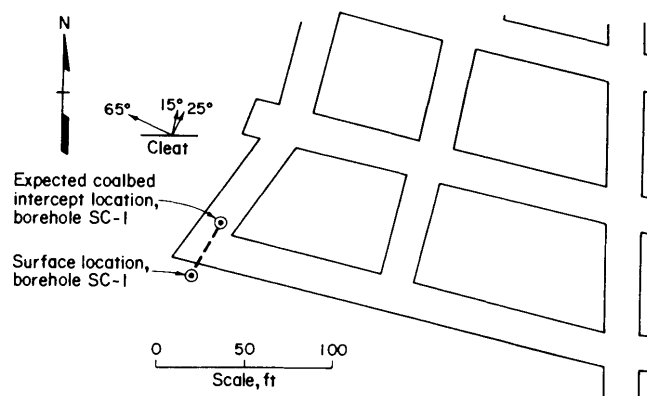
Figure 53.—Mine map, borehole SC-1.

The area around the presumed location of the borehole was mined through in April 1985. A directional survey run on the borehole was used to plot the coalbed intercept point, which was calculated to be approximately 35 ft north-northeast of the surface location and near the center of an entry (fig. 53). A thorough examination of the roof and ribs at the expected underground borehole location and all accessible entries in the area failed to reveal the borehole or any of the sand proppant used in the stimulation.

If the borehole was located within the general area expected, and if the stimulation generally followed the face cleat orientation (N 65° W) as would be assumed, then a wing of the fracture would have a high probability of being intercepted by the available entries at the time of observation (fig. 53). The obvious incorrect presumed location of borehole SC-1 points out the need for accurate surveys (surface, underground, and borehole deviation) and the advantages of actually mining through the borehole in interpreting underground observations.

naturally occurring fluorescent material at this location, or that it was more noticeable because of the fresh, unweathered exposures. In any case, it would be advisable to check for any naturally occurring fluorescence before selecting a paint color for use in a stimulation treatment.
