Reinforcing Coal Mine Roof with Polyurethane Injection: 4 Case Studies

Gregory Molinda

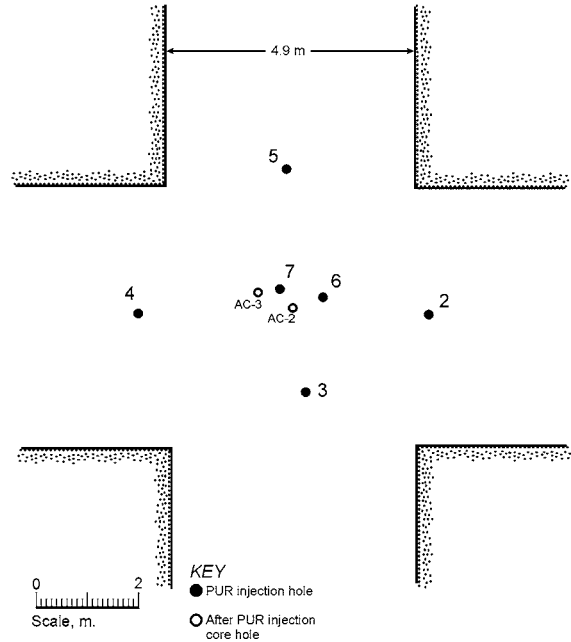
Fig. 12 Injection and monitoring holes at the Safety Research Coal Mine

hole from 0.9–2.4 m (3–8 ft.). Injection pressures went as high as 8.3 MPa (1,200 psi) and averaged about 3.5 MPa (500 psi).
