## Poisoning Deaths in a Workshop for Ceremonial Papermaking — China, May 2025

On May 14, 2025, a county-level Chinese Center for Disease Control and Prevention (China CDC) in southwestern China received a report of the sudden death of four employees of a small workshop for ceremonial papermaking, which was operating without required safety and environmental approvals. The first person who died was a woman who lost consciousness while cleaning a wastewater tank. During the next 20 minutes, three of the woman's family members, also employees, entered the tank to attempt to rescue her. All four persons, including the workshop operator's wife, the workshop operator's son, the workshop operator, and the workshop operator's daughter, died. The county China CDC launched an immediate investigation, and the Intermediate Chinese Field Epidemiology Training Program and provincial and city China CDC staff members conducted a joint, on-site investigation that included identification of cases, analysis of the gas composition, and interviews of residents of the town and physicians to identify the cause of the apparent toxic exposure. Analyses revealed that levels of the highly toxic gases hydro

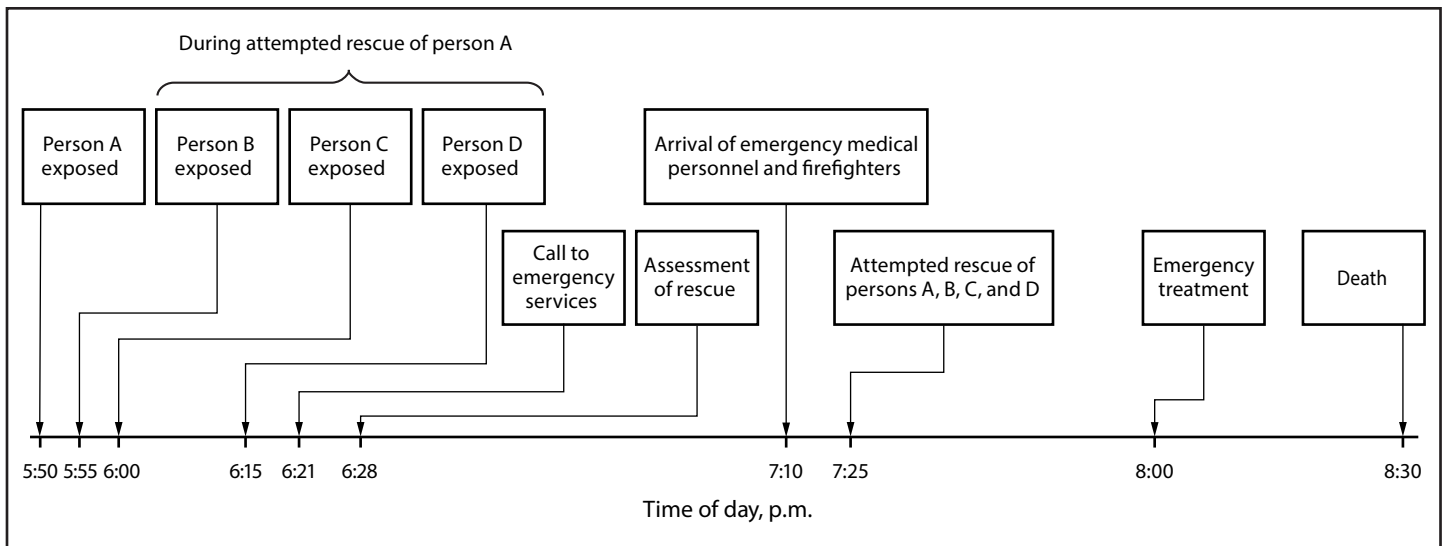
At approximately 5:50 p.m., the operator's wife descended approximately 7.3 ft (2.2 m) by ladder, without PPE, into the underground tank (Figure 1) to perform the first drainage and sediment removal operation in at least 1 year. Because the tank contained no drainage system, she used an electric water pump to extract and discharge the wastewater. Within minutes, she lost consciousness while in the tank. Her son, the operator (her husband), and her daughter attempted to rescue her, also without using any PPE. These three persons also rapidly lost consciousness in the tank. At 6:21 p.m., the operator's daughter-in-law asked a neighbor to call medical emergency

**FIGURE 1. Timeline of events in deadly poisoning of four persons\* in a ceremonial papermaking workshop — China, May 14, 2025**

\* Person A = workshop operator's wife; person B = workshop operator's son; person C = workshop operator; person D = workshop operator's daughter.

Because the tank where the exposure occurred had not been cleaned in at least 1 year, toxic gases had accumulated to critical concentrations. On-site gas sampling suggested that the combined effects of multiple toxic gases likely caused these deaths.
