WORKER DEATHS BY FALLS

A Summary of Surveillance Findings and Investigative Case Reports

U.S. DEPARTMENT OF HEALTH AND HUMAN SERVICES
Public Health Service
Centers for Disease Control and Prevention
National Institute for Occupational Safety and Health

DHHS (NIOSH) PUBLICATION No. 2000-116

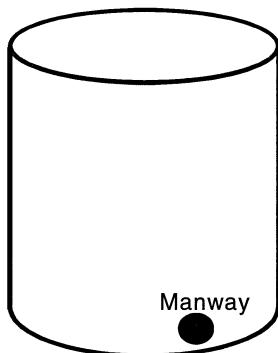
Exterior of 40-foot-diameter by 40-foot-high water tank.

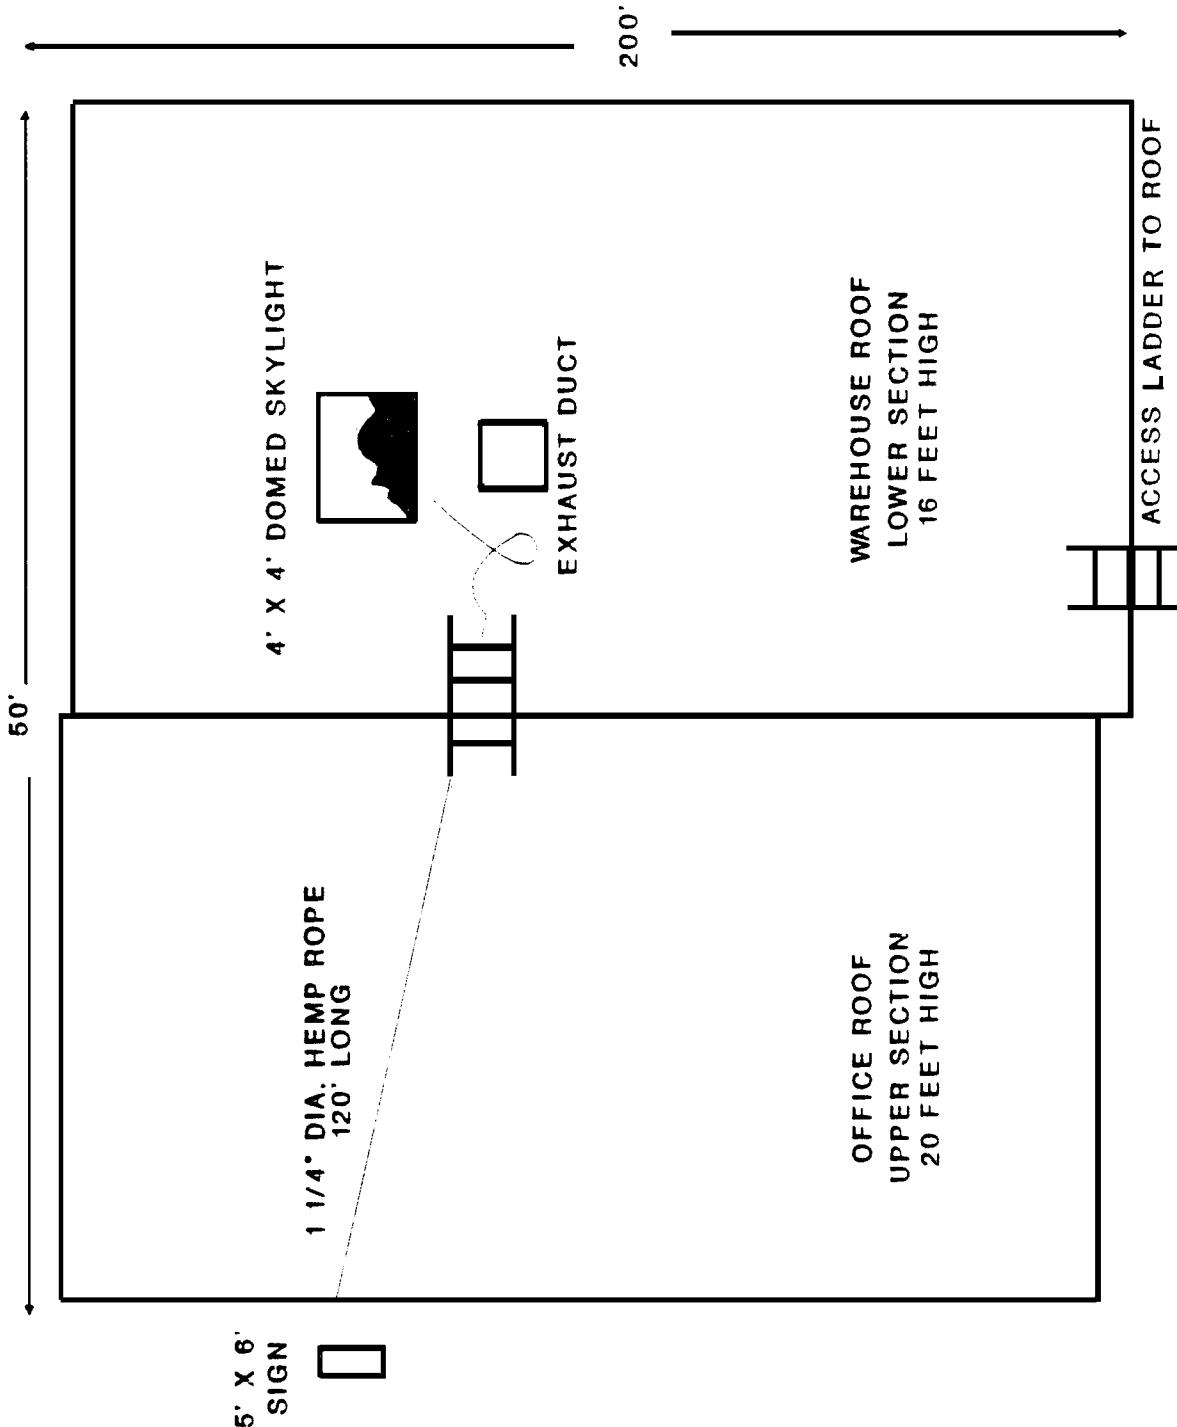
Figure 1. A Diagram Showing the Roof Area of the Industrial Building

INDUSTRIAL BUILDING
TAR AND GRAVEL COVERED FLAT ROOFS
(not to scale)

a result of workers falling through these skylights. Skylight manufacturers should voluntarily affix accident prevention signs (Figure 3) at conspicuous places on the skylights. Also, owners of building where skylights have been installed should voluntarily affix similar signs (Figure 4) at or near points of access to areas containing these skylights. These signs would visually warn individuals of the potential fall hazard posed by stepping, standing, or sitting on a skylight. Characteristics of accident prevention signs and tags (i.e., classification, design, color, layout, finish, lettering, placement, illumination, and symbols), should comply with the American National Standards Institute (ANSI) standards Z35.1-1972, and OSHA standards (general industry and construction industry) 29 CFR 1910.145 and 1926.200.

Discussion: Skylight materials may weaken due to age and/or environmental conditions. As a result, the probability that a person could exert sufficient pressure to break through skylights may increase. Designers/manufacturers should consider design modifications to skylights which would strengthen these units sufficiently to enable them to support a person should that person step, sit or fall onto a skylight. If the smoke venting effectiveness of the skylight would be adversely affected by such changes, consideration should be given to development and utilization of other alternatives for increasing the strength of skylights, e.g., a dome-shaped wire cover to fit over the skylight.

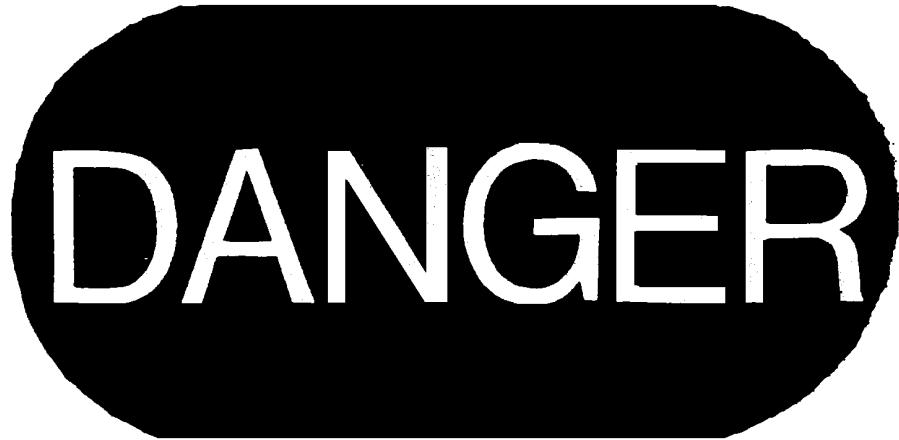
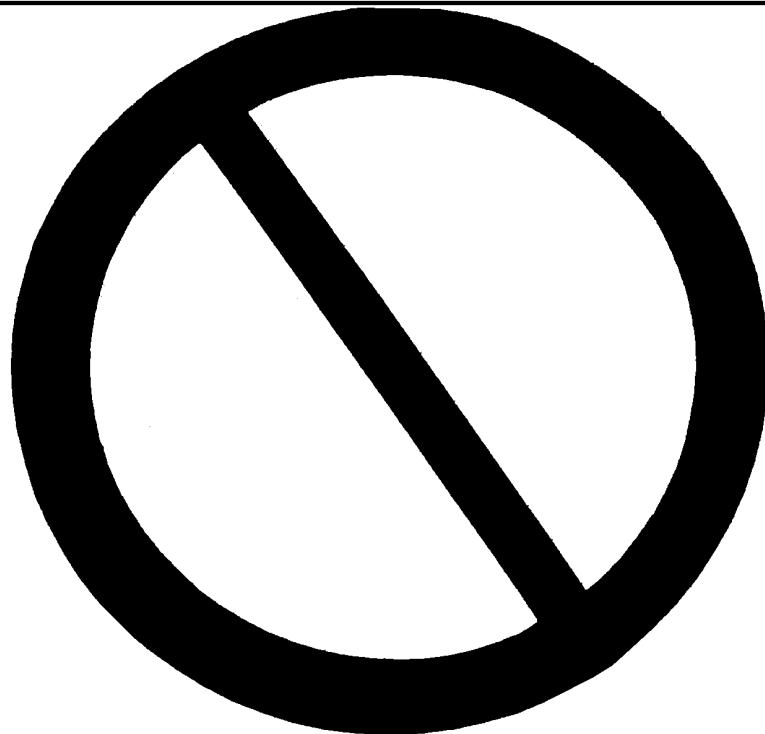
Figure 4. Recommended Accident Prevention Sign to be Applied to Skylights.

**NO STEPPING -
STANDING OR SITTING
ON SKYLIGHT**

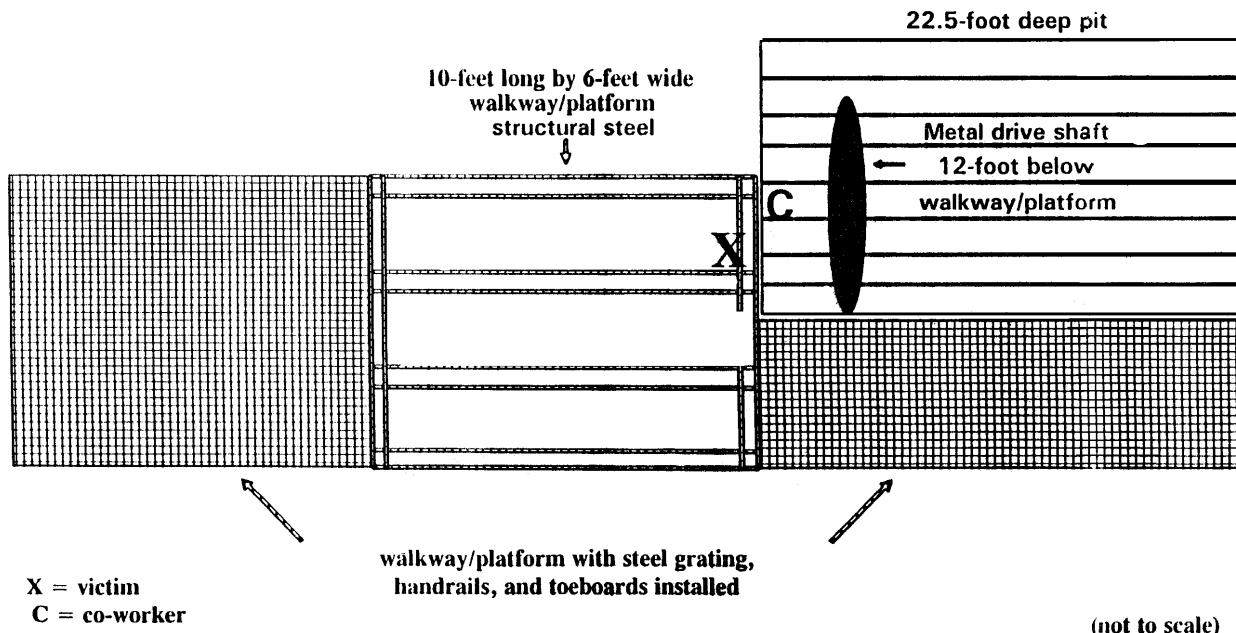
***Figure. Walkway/platform
(Top view)***

On the day of the incident, the victim and a co-worker had been assigned to continue their work installing additional sections of the walkway platform. The walkway platform section being worked on was approximately 6-feet wide by 10-feet long. Supports for the section were being welded by the victim, while the co-worker was welding brackets in a pit below the walkway platform. The victim was positioned on the structural steel supports next to a pit about 22.5 feet deep, while the co-worker welded brackets in the pit area about 8 feet below him (Figure). Although both workers were wearing safety belts and lanyards, neither worker was tied off.

Recommendation #1: Employers should comply with existing OSHA regulations regarding fall protection for workers.

Discussion: 29 CFR 1926.28(a) states, "The employer is responsible for requiring the wearing of appropriate personal protective equipment in all operations where there is an exposure to hazardous conditions or where this part indicates the need for using such equipment to reduce the hazards to the employees." Both workers were wearing safety belts and lanyards. However, neither worker was tied-off to a secure point, and no lifeline was present to use as a tie-off point.

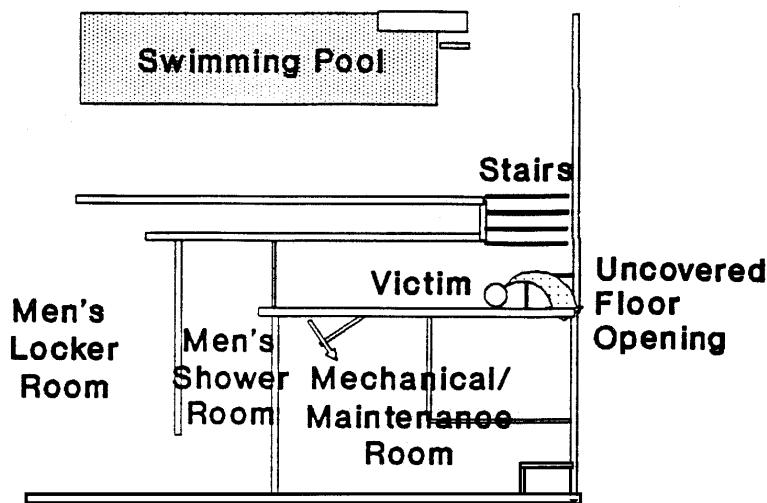
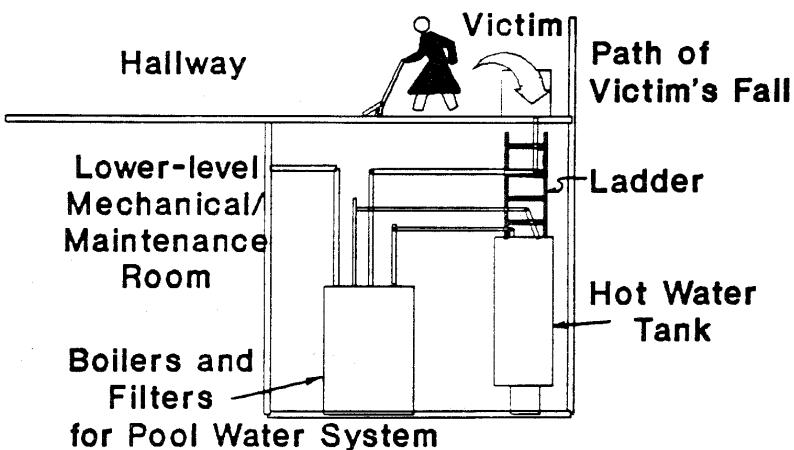
Plan View

As the victim was mopping backwards down the hall, she backed into a access opening in the hall floor that had been left open by the mechanic as he traveled to-and-from the pool from the lower-level mechanical room. The victim fell through the opening, and landed on the concrete floor of the mechanical room, 12 feet below. The mechanic, who was working in the mechanical room at the time, heard the fall and immediately summoned the other cleaning maid to call for help. The local emergency medical service (EMS) was called to the scene. Because of the victim's condition, EMS elected to transport the victim by helicopter to a trauma center at a regional hospital. The victim died 7 days later from injuries sustained from the fall.

Recommendation #1: Village and municipal administrations should implement 29 CFR 1910.23 (a)(3)(i), which requires that every hatchway floor opening shall be guarded by a hinged floor opening cover of standard strength and construction equipped with standard railings or permanently attached thereto so as to leave only one exposed side. When the opening is not in use, the cover shall be closed or the exposed side shall be guarded at both top and intermediate positions by removable standard railings. (1)

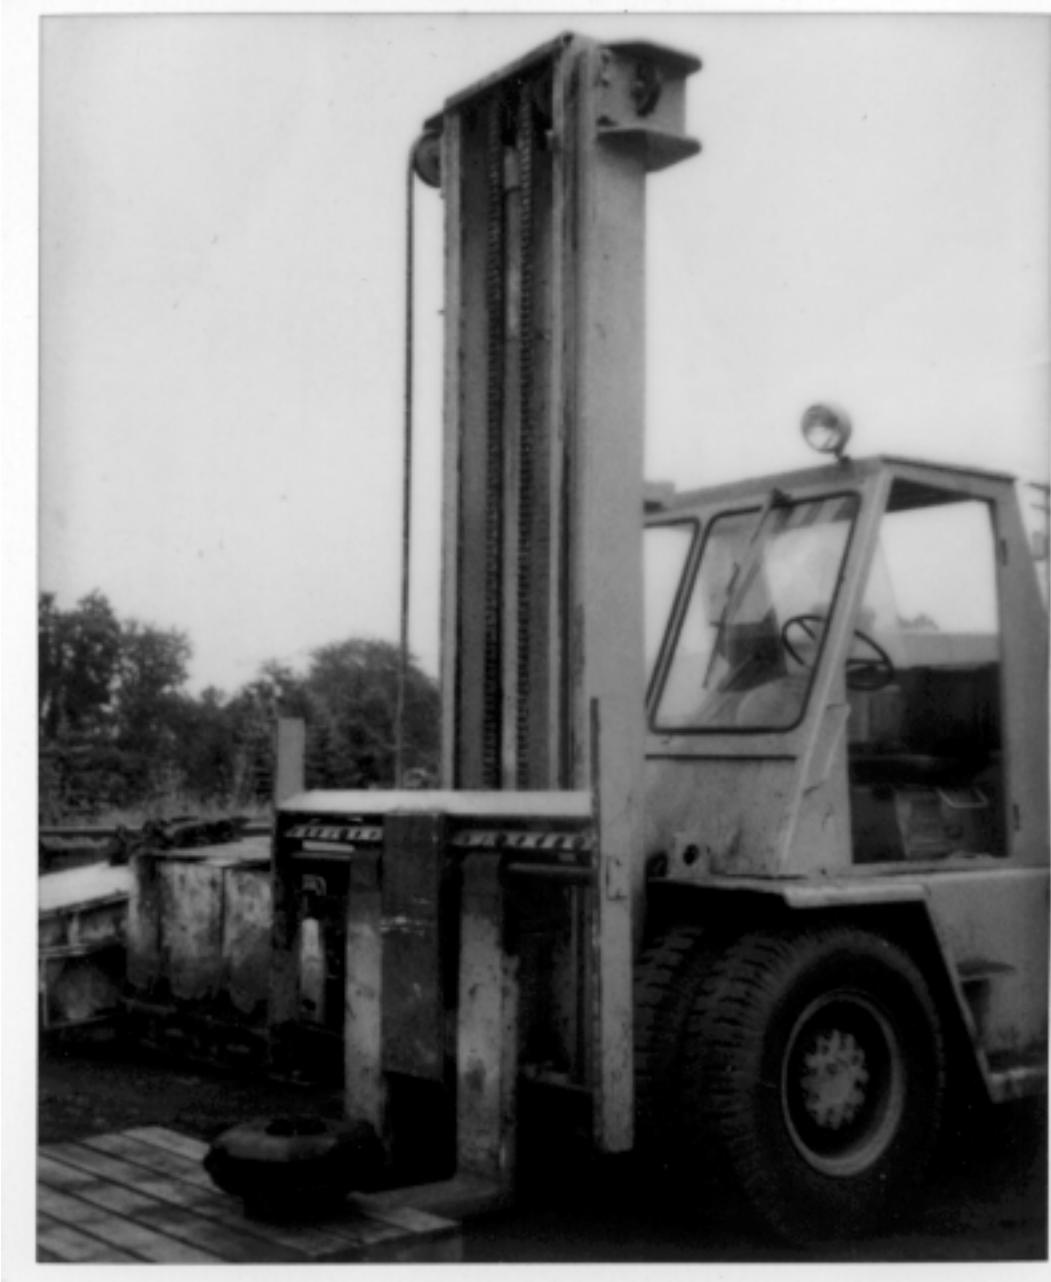
Discussion: Unscheduled maintenance by unauthorized personnel can and does lead to injury and even death. Apparently the two workers (the victim and co-worker) did not perceive the 8-foot distance as a hazard associated with working on the fork lift, and a fatality resulted. If the standard operating procedure had been followed, this incident may have been avoided. Employers should ensure that all employees are aware of, and fully understand, the risks associated with not complying with established operating procedures.

Figure. Fork Truck Components: 1) fork carriage (assembly to which the forks or other attachments are mounted, and 2) mast (steel upright assembly consisting of hydraulic cylinders, inner channels, telescoping outer channels, chains, and guide rollers).

Recommendation #2: Employers should ensure that employees are aware of, and fully understand the risks associated with, failing to comply with established operating procedures.
