Assembler / Fabricator Dies When Struck by “L” Rack Loaded with Glass Mirrors in Washington State

Fatality Investigation

Washington State Fatality Assessment and Control Evaluation (FACE)

Date Issued: July 30, 2010
Report No.: 52-20-2010
Investigation No.: 08WA049

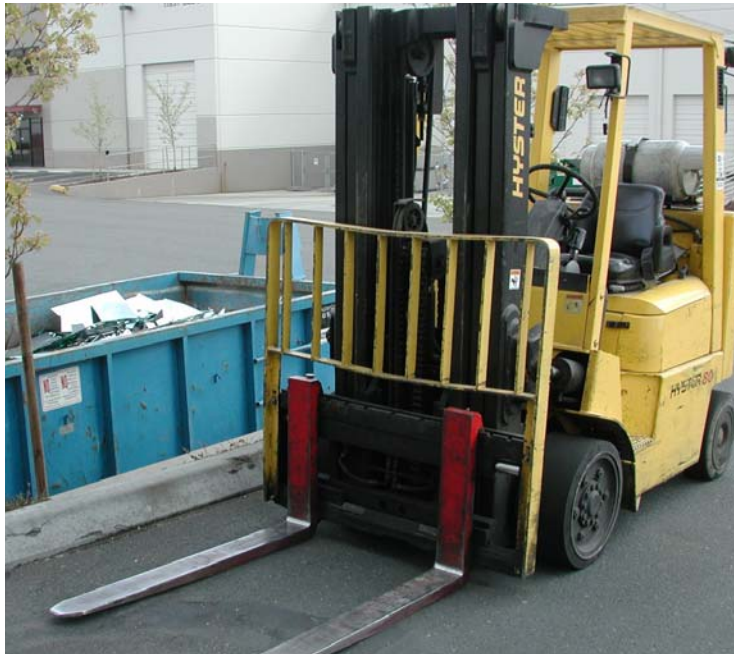
Photo1. Forklift used to transport “L” rack from truck in delivery area into work area.

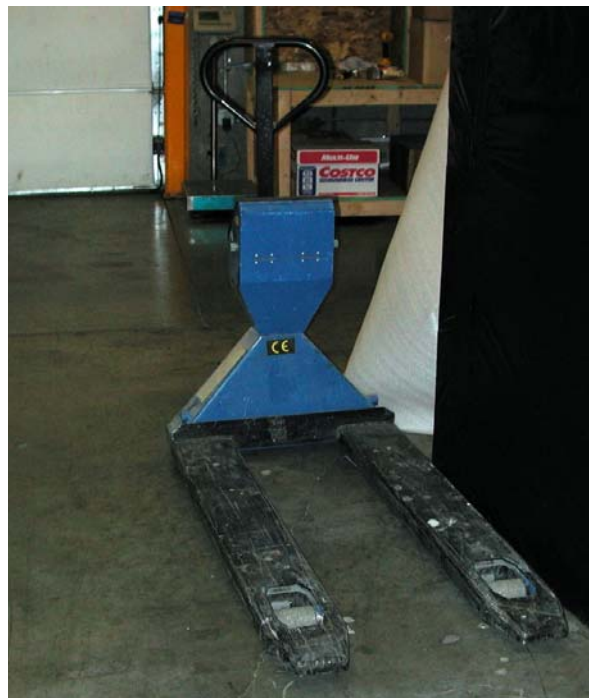
Photo 2. Manual pallet jack similar to the one used in incident.

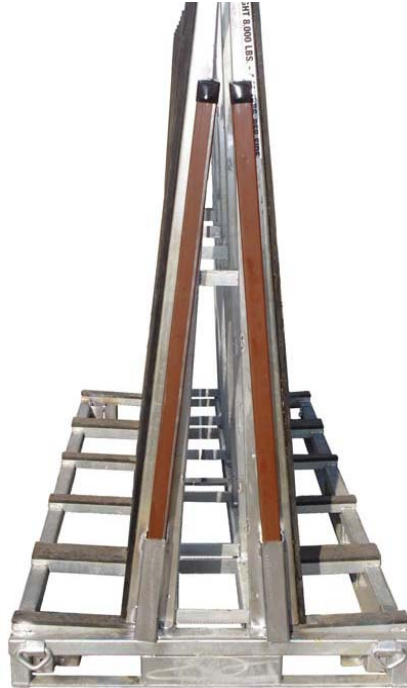
Photo 7. Example of “A” rack used to store and transport glass. Photos courtesy of <http://www.barkow.com/>

DISCUSSION: The FACE program recommends that this company and other companies that use similar “L” racks investigate options for safer transportation and handling of large plate glass, mirrors, granite or concrete slabs, and similar size and weight materials. Alternate methods to the “L” rack are stacking materials horizontally or vertically in a crate with spacers between each piece for protection and access for handling. A vacuum handling system with crane ways and forklift mounted vacuum units for the handling and movement of individual pieces would complement the transportation by crate method (see Photo 9). Vacuum systems are used effectively in many other industries including window, door, and glass manufacturing and have been used effectively in the newspaper business to move and handle paper rolls weighing 8000 pounds. Handlers of glass mirrors and similar flat heavy materials should refrain from using wheeled carts and wheeled dollies which also pose significant hazards.

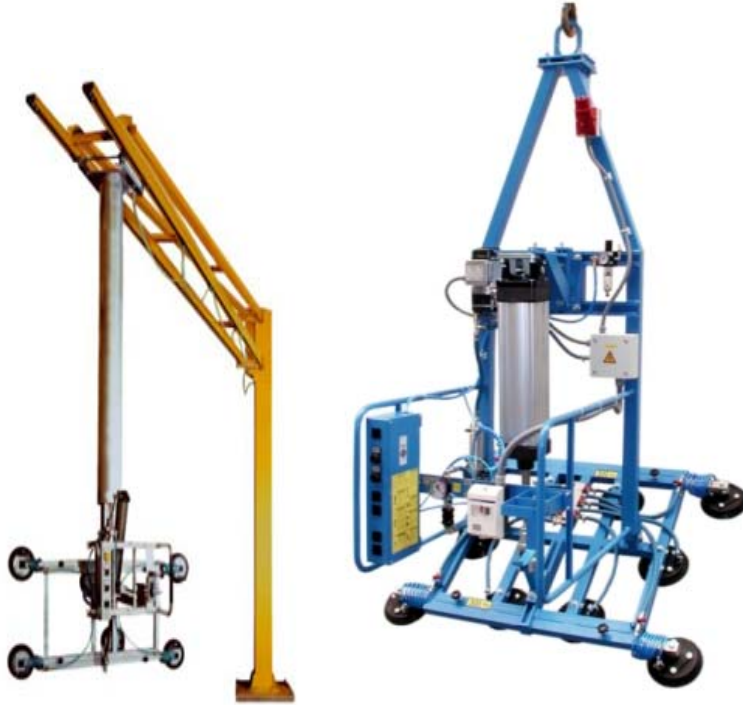
Photo 9. Examples of vacuum manipulators and crane used to handle and transport glass. Several models are available with safe working loads up to 1600kg (3520lb) with tilting and turning capabilities. Photos courtesy of <http://www.bystronic-glass.com/global/>
