Timber Harvester Operator Killed Following a Chain Shot Incident

Investigation: # 10WA04801
Release Date: 02-24-2014
SHARP Report: # 52-30-2014

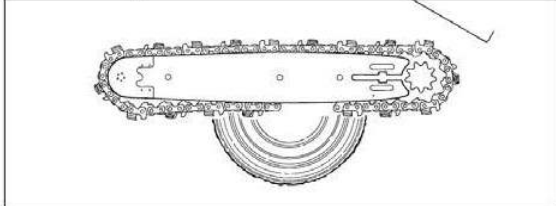
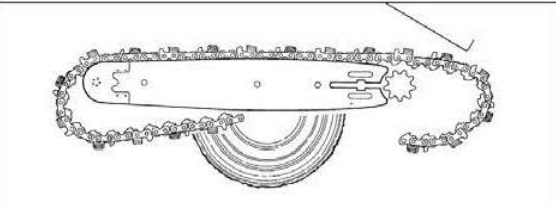
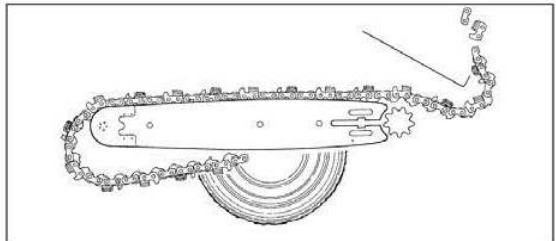
Figure 1: Diagram of chain shot from Oregon’s The Mechanical Harvesting Handbook.
http://www.oregonproducts.com/pdf/harvester/MechanicalHarvesting_2005.pdf

The free end of the chain begins to whip away from the break.

If the chain is not contained by the saw box or an energy-absorbing guard, the broken chain’s free end can speed up rapidly and carry immense dynamic energy.

At the peak of the whip, chain parts may break loose and be ejected at high speed, especially if the free end of the chain strikes the saw box. Chain shot can cause chain parts to be thrown in many directions, especially along the plane of the saw bar.	Fragments have been measured at between 180 and 310 m/s under laboratory simulated conditions.

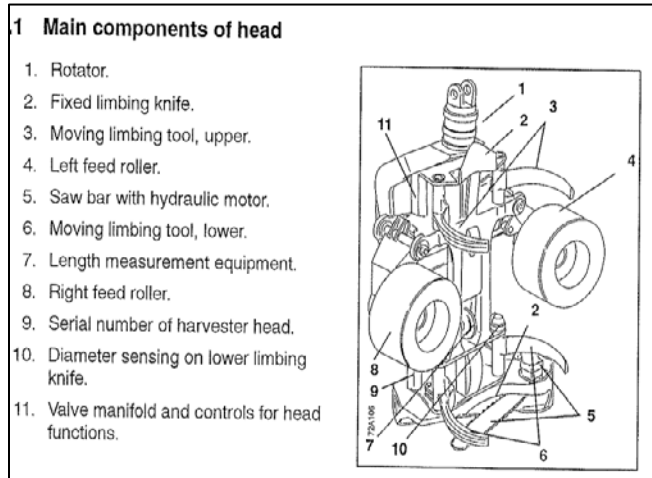
Figure 2: Timberjack 762C cutting head diagram from operator’s manual.

The 762C cutting head can be used for late thinning, final felling of trees, and as a processor (see photo 3 and figure 2). The operator’s manual for the cutting head had no mention of chain shot or how to prevent it. The Oregon Mechanical Timber Harvesting Handbook does warn to never allow anyone to stand in front of a rotating chain, or allow anyone within a risk zone of at least 70 meters/230 feet. It states, “Watch especially the area in line with the saw bar!”

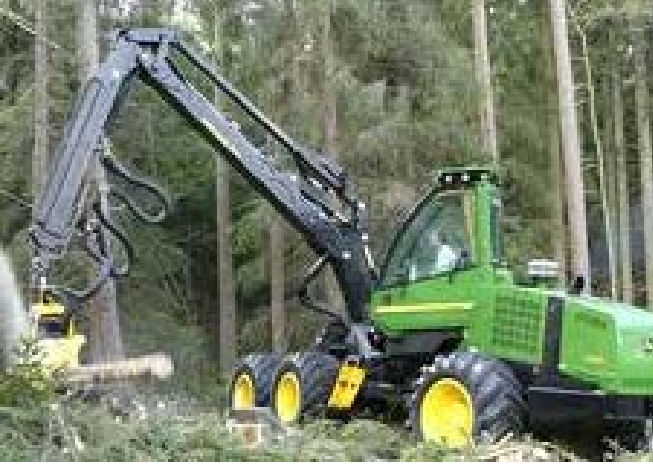
Photo 5: Photo of a harvester in the action of processing a tree with a cutting head. This particular harvester is designed so that the cab and boom with attached cutting head articulate independently. This allows the operator to position the cab so that it is not in line with the cutting bar while processing. (Not the harvester involved in the incident.)

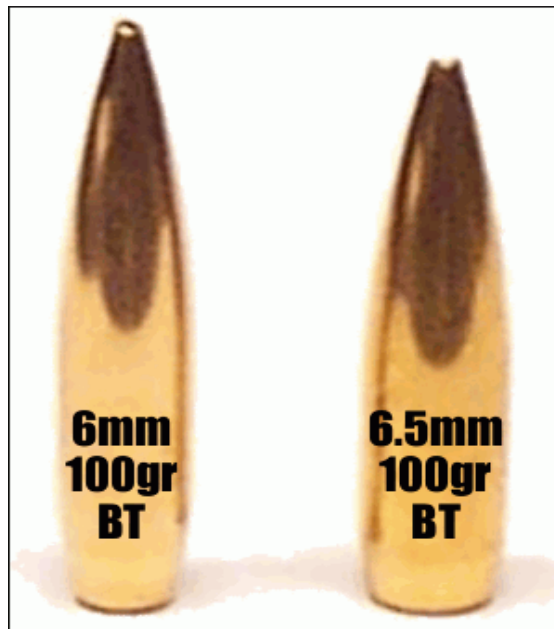
Photo 8: Example of 2 bullets weighing approximately the same weight of the driver and 2 strap links that struck the operator.

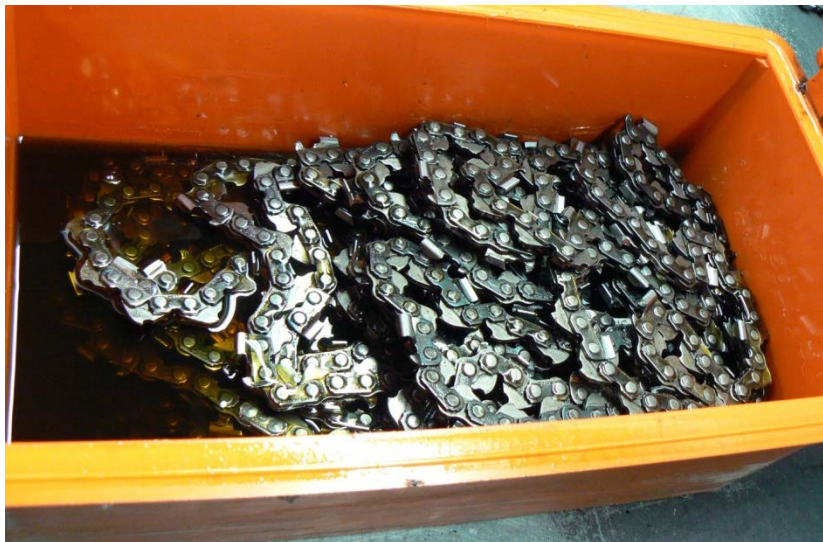
Photo10: Photo showing the inside of the orange bins with motor oil used to pre-lube chains.

Machinery operators and maintenance personnel now have designated areas to pick-up and drop-off the chains. The chains that are used for processors are put in orange bins with a designated machine number (see photo 10). These orange bins have motor oil in them to pre-lube chains as well as keep the chains clean and help prevent weathering. The employer initially used bar oil, but found that the employees didn't like the "stickiness" of the bar oil and were less likely to follow this procedure. The employer spoke with a chain manufacturer to see if motor oil would be an acceptable replacement. The manufacturer said that motor oil would work just as well as the bar oil for the pre-lube. Bar oil is still required to be used in the processor head during operation. Machinery operators pick-up the numbered orange bin, from underneath the maintenance table, which corresponds with the equipment they will be using in the field. Maintenance personal only put the chains in the bins after they have been cleaned, inspected and serviced.

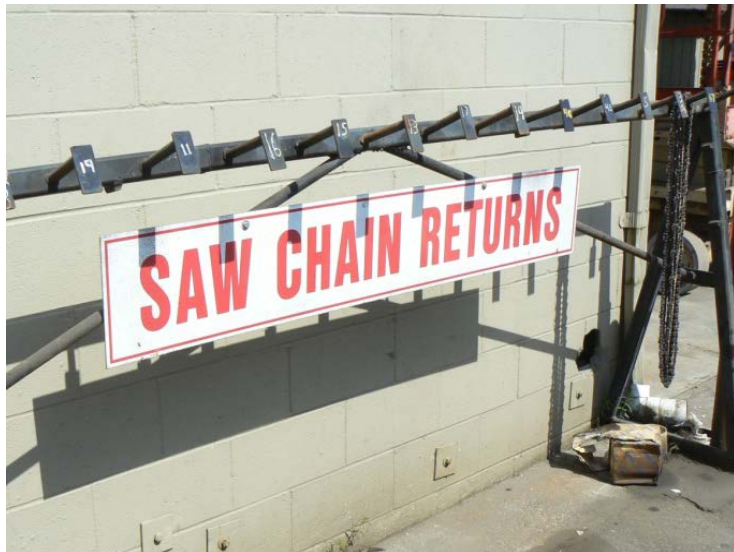
Photo 11: The numbered chains return rack used by equipment operators.

When the machinery operator returns from a job the chains are put on the return rack (see photos 11 and 12). The maintenance personnel pick-up, clean, and inspect the chains, discarding worn or damaged chains. The chains that are still in operational condition will be serviced, sharpened, and stored in bins of motor oil before being used again.

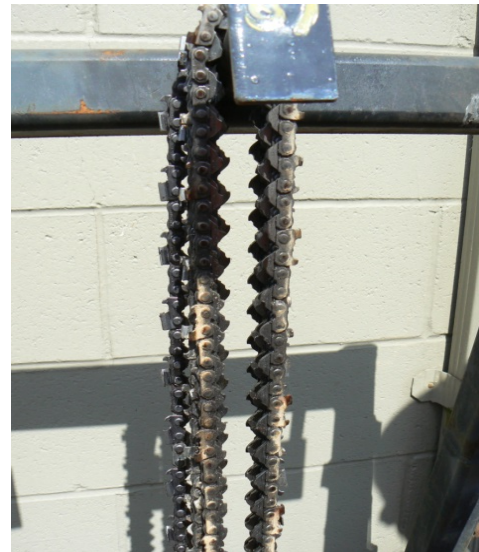
Photo 12: Close-up of chains returned to numbered rack.

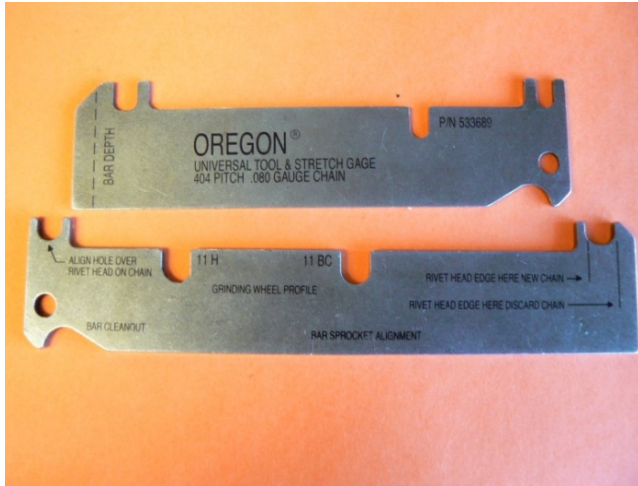
Photo 13: Tools used for inspecting chain stretch and bar depth.

Maintenance personnel have an area and tools specifically used for inspecting and maintaining chains. The maintenance staff cleans and inspects chains, checking for structural wear, cracks, and other damage that would make the chain more likely to break. If the chain is still in good condition, maintenance personnel services and sharpens and places the chain back into the appropriate orange bin.

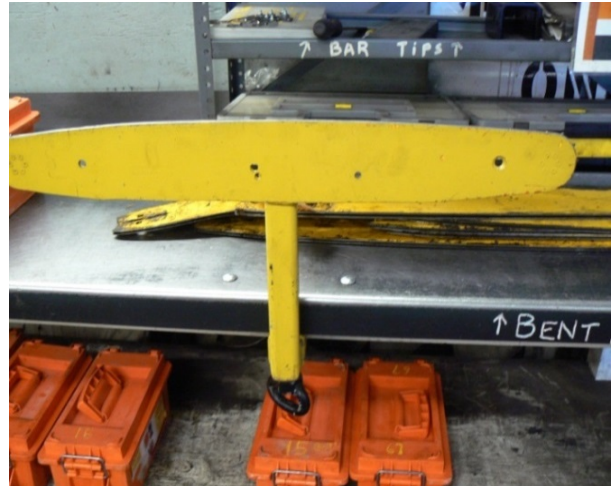
Photo 14: Mounted bar used to inspect and perform maintenance on chains. Underneath the bar is the orange bin pick-up location for machinery operators.

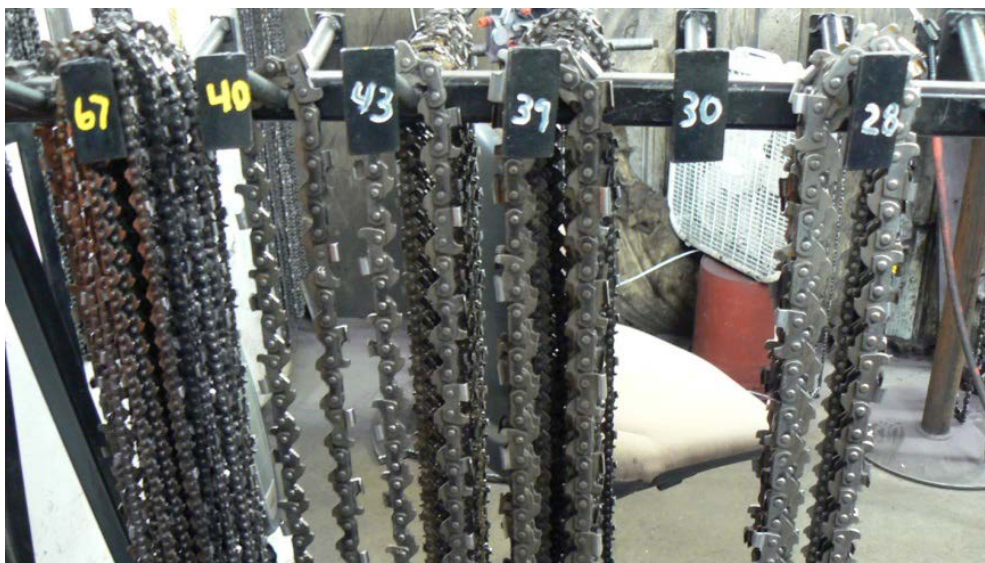
Photo 15: Numbered rack in maintenance shop. Chains on rack have been inspected and are waiting to be put into orange bins with motor oil. Rack is locked to ensure that equipment operators cannot take chains from rack.

To ensure that the chains go into the correct bin, the employer has two racks in the maintenance area that match the machinery operators' return rack. One rack is located on the walls of the maintenance shop and is used to put the chains that have been returned by operators. The second rack is used to store chains that have gone through the service and maintenance procedures and will be used in the field (see photo 15). This rack has a lock on it to prevent machinery operators from taking the wrong chain into the field. After cleaning, inspecting, and maintenance of chains that can be reused in the field has been completed, the chains are put back into the orange bin or on the chain rack that has the corresponding number of the machine that will use those chains.
