MIFACE INVESTIGATION REPORT #13MI102

SUBJECT: Airport Manager Killed When Homemade Drag Struck Him While Smoothing a Runway

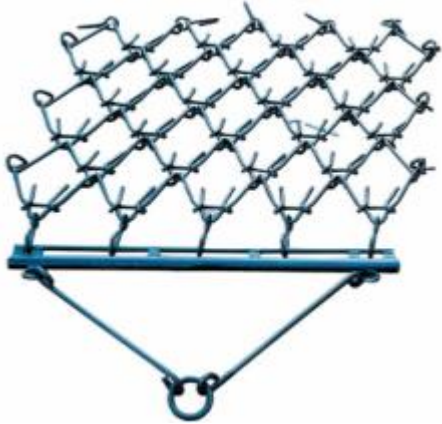
Figure 4. Trailed chain harrow. Photo courtesy of Fierui Trade Company: (<http://www.drag-harrow.com/>)

After discing the area, the ground conditions were still quite rough. Due to the ground conditions, a different tool such as a chain harrow (trailed or mounted), a ground/soil pulverizer, or a tractor box blade (See Attachment 1, Figures 4-7) would have been a better choice to smooth out and break up the soil/grass mounds than the home made drag. The construction of the drag made it ill-suited to the task at hand. Some of the issues were: 1) the front steel beam did not have at least a 45-degree angle to funnel excess clods of soil away from it, 2) the front beam area did not have tines/shanks to assist in breaking up the soil, 3) the rigidity and weight of the drag did not permit it move easily over the rutted ground, and 4) using chains as the attachment points on the tractor permitted tension to build up on the chains, causing the driver's left chain to break and the drag to flip up toward the decedent.

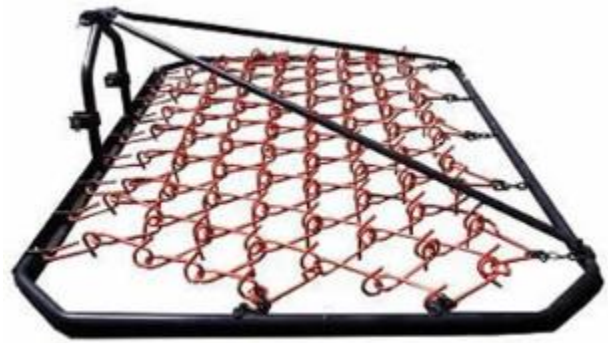
Figure 5. Mounted trailed chain harrow. Photo courtesy Fierui Trade Company: (<http://www.drag-harrow.com/>)

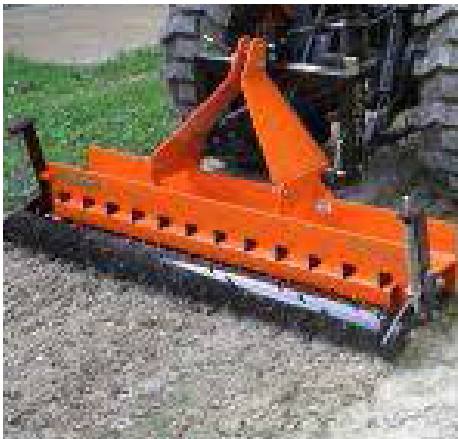
Figure 6. Soil pulverizer. Photo courtesy of Land Pride: (<http://www.landpride.com/products/dirtworking/soil-pulverizers>)

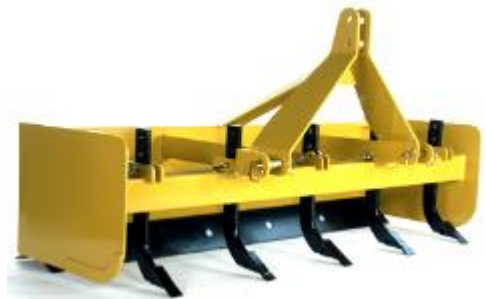
Figure 7. Tractor box blade. Photo courtesy of Tractor Box Blades: (<http://www.tractorboxblades.com/>)
