Heavy Equipment Mechanic Dies when an Elevated Dump Truck Tag Axle Pins Him to the Concrete Floor

Incident Number: 13KY041

Kentucky Fatality Assessment and Control Evaluation (FACE) Program

Subject: Mechanic Dies when an Elevated 1800 lb. Tag Axle Pins Him to the Concrete Floor.

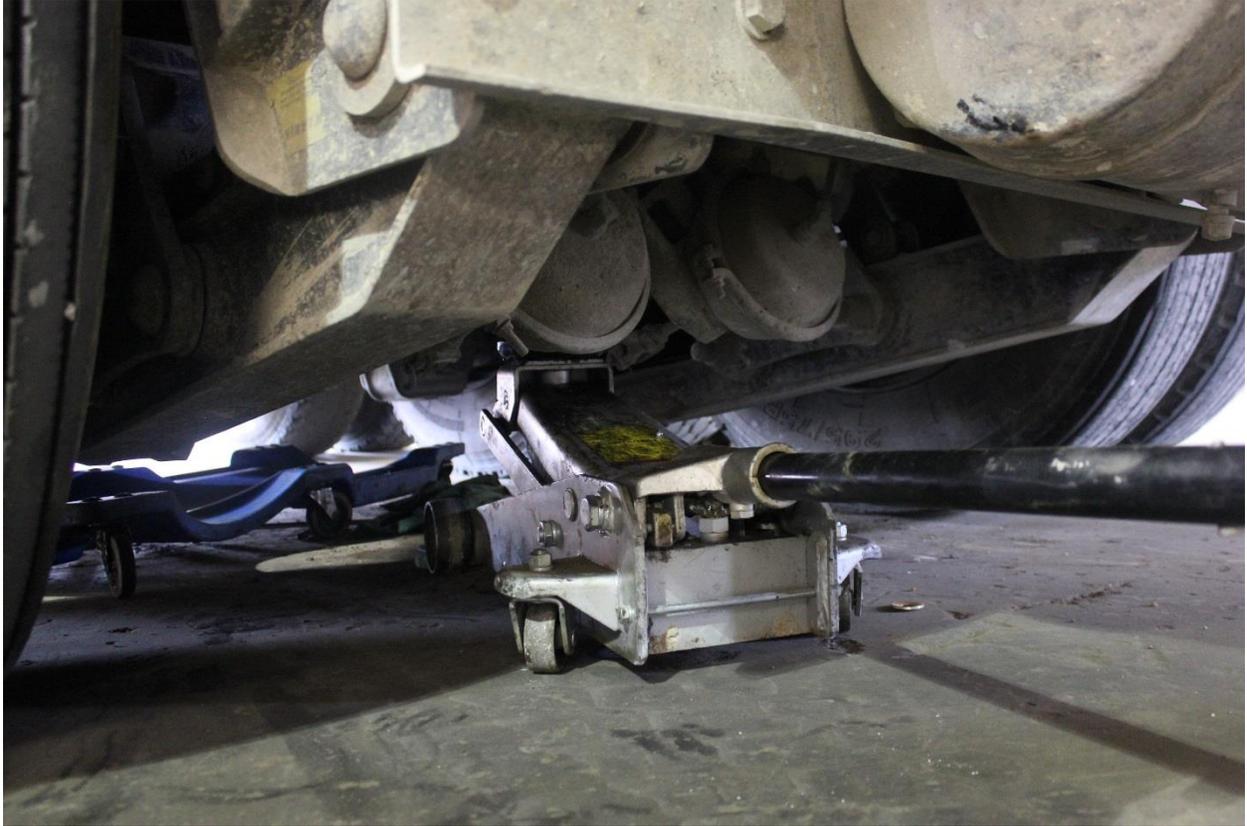
On the afternoon of September 19, 2013, a dump truck was brought into the maintenance shop and was leaking air. After a head mechanic assessed the truck, it was determined that an air bag was blown on the left side of the tag axle. An air bag allows a truck driver to raise or lower the tag axle during transportation of loads on roadways, in order to balance the load on curves. The

Recommendation No. 1: Employers should ensure employees using jacks must crib, block or otherwise, secure the loads immediately after they have been raised.²

All hydraulic jacks will leak off and it's important that you never get under any type of vehicle that is only being held up by hydraulics.

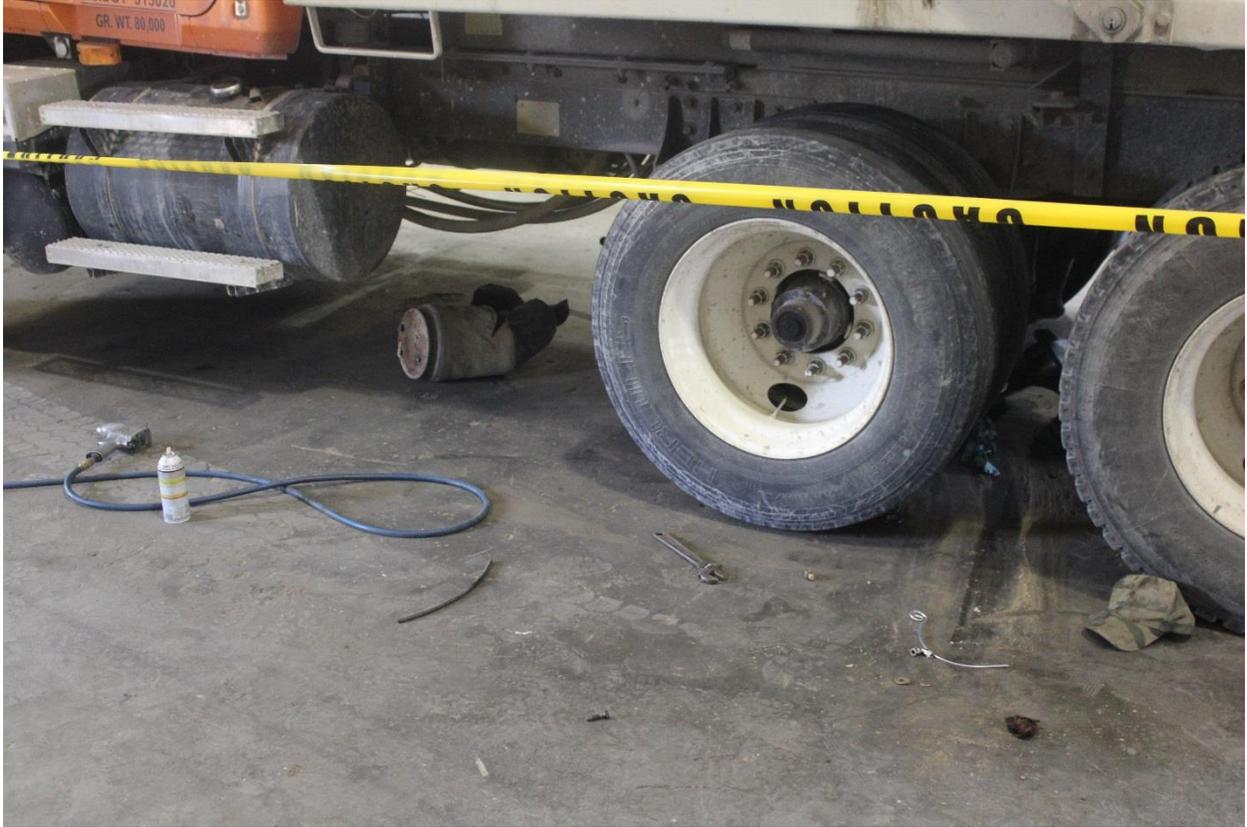
head mechanic spoke with the victim about performing the air bag job and the victim replied he had done many similar jobs. The head mechanic then walked outside to work on another vehicle for about 5 minutes. After the head mechanic repaired the other truck, he returned to the shop to get ready to leave for the day. He yelled for the victim but received no answer. The head mechanic observed the victim's legs and called out his name again, with no response. The head mechanic walked around the truck to the passenger side and observed the victim's left hand on the handle of the jack. The head mechanic removed the victim's hand from the jack and shook him without getting a response. He yelled for other employees to dial 911 for assistance. The victim's head was pointed toward the jack which was on the front side of the tag axle. The victim was lying on his right side with 1/3 of his body on the creeper. The head mechanic started jacking the jack but it would not move. He then turned the handle and the jack started working. Once the axle was lifted off the victim, another employee pulled the victim out from under the truck on the creeper. Employees trained in first aid and CPR, started CPR and put an AED device on the victim. EMS and the Sheriff arrived at 4:57 p.m., and the victim was transported via ambulance to the hospital where he succumbed to his injuries on September 21, 2013 at 1:50 a.m.
