Hispanic Laborer is Crushed by Gantry Roller Press While Retrieving a Dropped Hammer

Incident Number: 14KY012

Kentucky Fatality Assessment and Control Evaluation (FACE) Program
Incident Number: 14KY012
Release Date: August 6, 2014
Subject: Hispanic Laborer is Crushed by Gantry Roller Press While Retrieving a Dropped Hammer

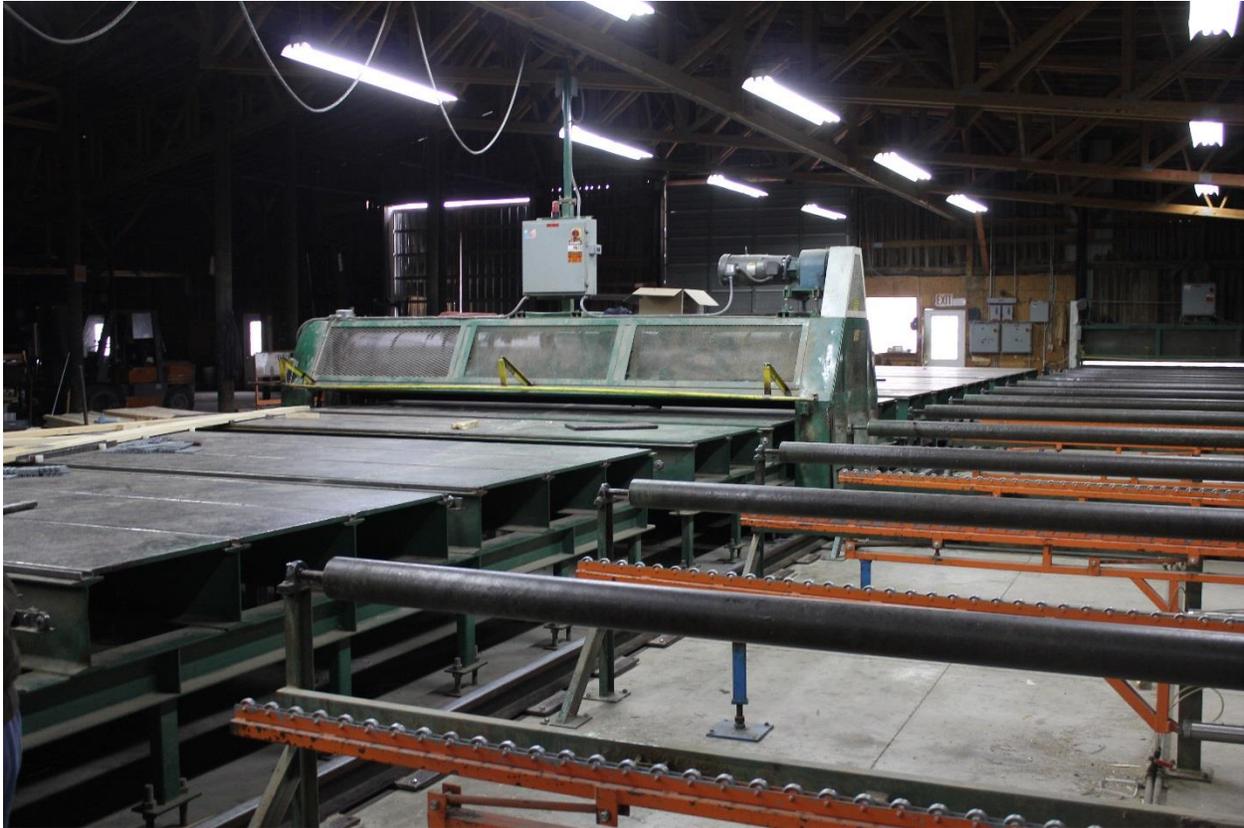
March 11, 2014 at 8:20 a.m. a 31- year- old Hispanic laborer working on a gantry roller press dropped a hammer he was using to tap the trusses into place. As the victim bent down to retrieve the hammer, the three other employees working with him did not see him and started the press. As the press came down the line, the victim raised up and became caught between the roller press and the legs of the press. This caused the press to jam. It wasn't until this occurred that the co-workers discovered the victim pinned by the roller carriage. The Sheriff stated that when he arrived, he found the victim face down with his legs over the guide-rail and his chest up against the table leg.

While investigating the scene, the detective of the Sheriff's department and the coroner came to the conclusion the victim had dropped the hammer he had been using to set the trusses and had gone down to retrieve it. This placed the victim in the direct path of the rolling gantry press. A hammer was found alongside the victim which led to this conclusion. Witnesses could not confirm this conclusion since no one saw the victim prior to the incident, but there would have been no other reason for the victim to be in that area of the press.

The cause of death was blunt force injuries from machine crush.

Recommendation No. 1: Employees should ensure the work area is clear before operating moving equipment. Hazardous areas should also be marked clearly on the floor so employees are away from the danger zones when the press is in use.

Recommendation No. 2: Manufacturers should consider the redesign of the roller carriage guard to extend the guard and prevent the roller press from contacting employees or other objects in its path.

Recommendation No. 3: Manufacturers should consider the installation of light curtains to detect movement near the roller press before start up.

Recommendation No. 4: Manufacturers should consider the installation of an audible and visual warning device to provide sufficient work area clearance time before roller press operation commences.
