Bark Company Owner Dies After Being Crushed By Ecology Block Wall

Investigation: # 15WA02901

Release Date: December 19, 2016

SHARP Report: 52-39-2016

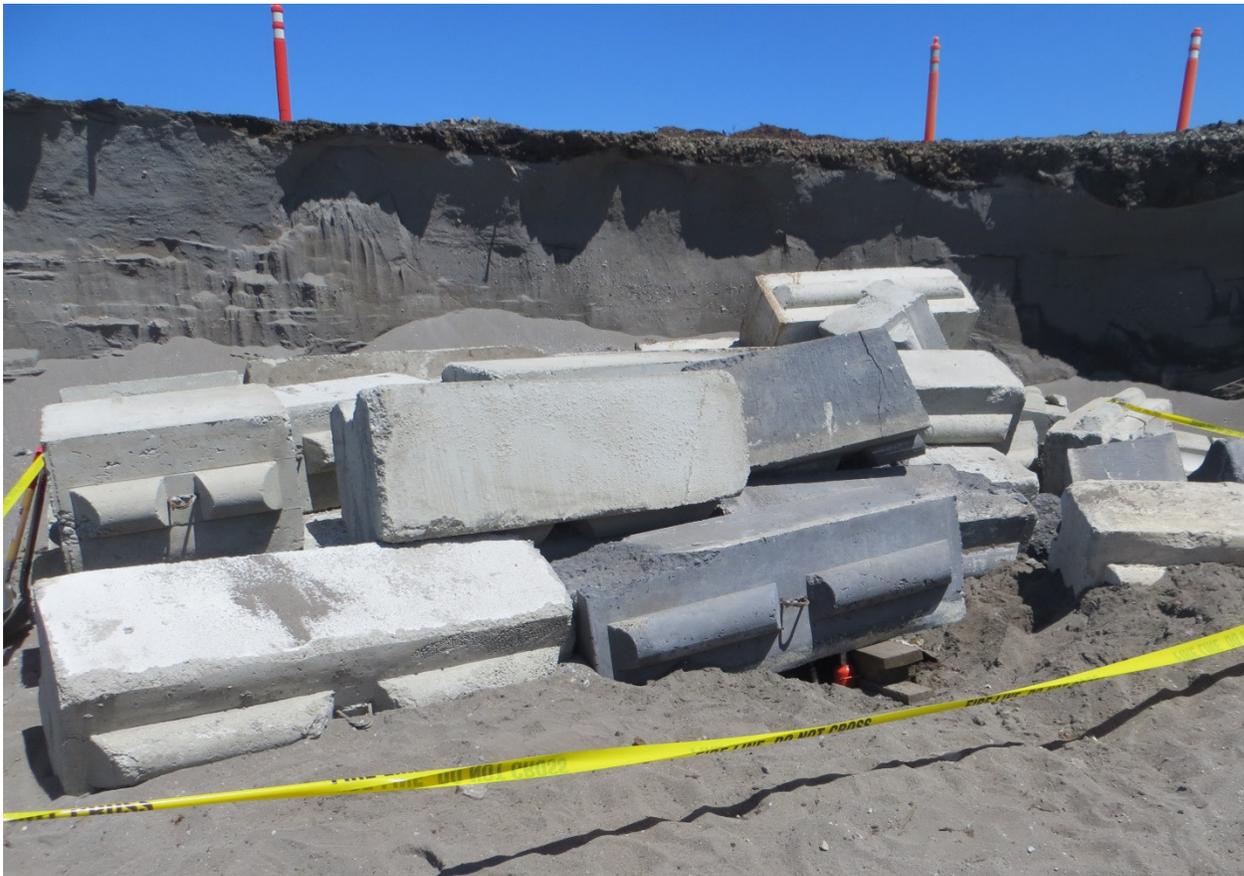
In July of 2016, the 70-year-old owner of a bark and wood wholesale and retail company died from surgical complications resulting from injuries he sustained when a wall being constructed from concrete “ecology blocks” collapsed, and a 3600lb. block fell onto him, crushing his legs.
