**FATALITY ASSESSMENT AND CONTROL EVALUATION PROGRAM
(CA/FACE)**

A stationary engineer died when the multi-piece tire
and wheel he was disassembling exploded

Case Report: 19CA002

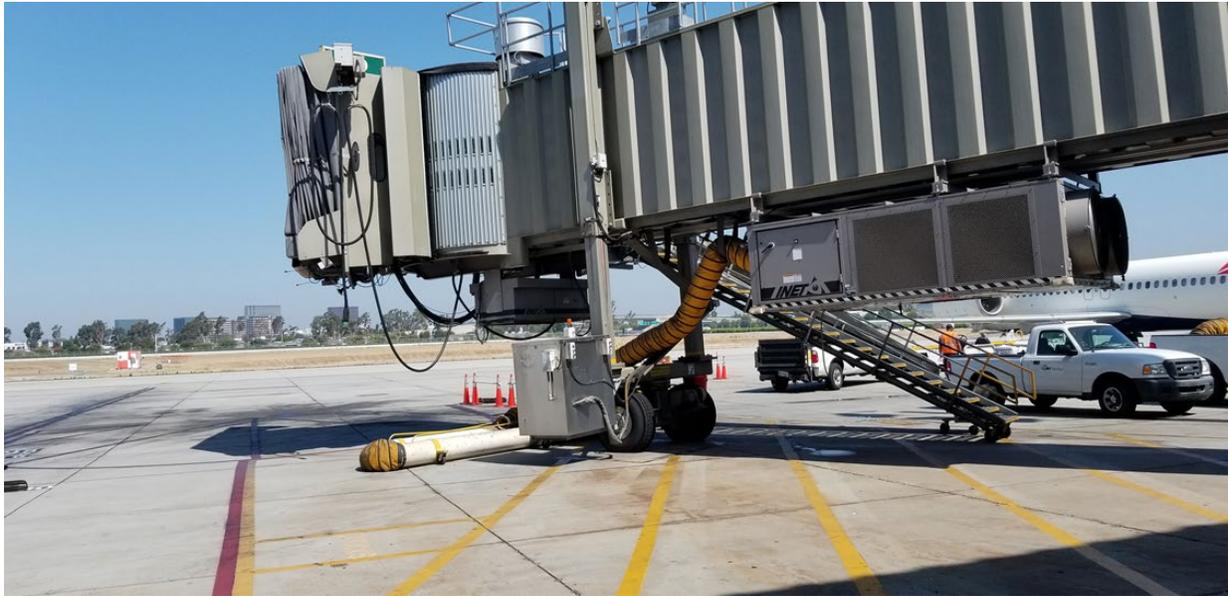
The tire assembly involved in this incident was removed from a passenger jet bridge (boarding bridge) used to load and unload passengers from arriving and departing flights (Exhibit 2).

Exhibit 2. A mobile bridge similar to the one in the incident used to load and unload passengers.
