## ***Hispanic worker falls from residential roof – North Carolina***

### **SUMMARY**

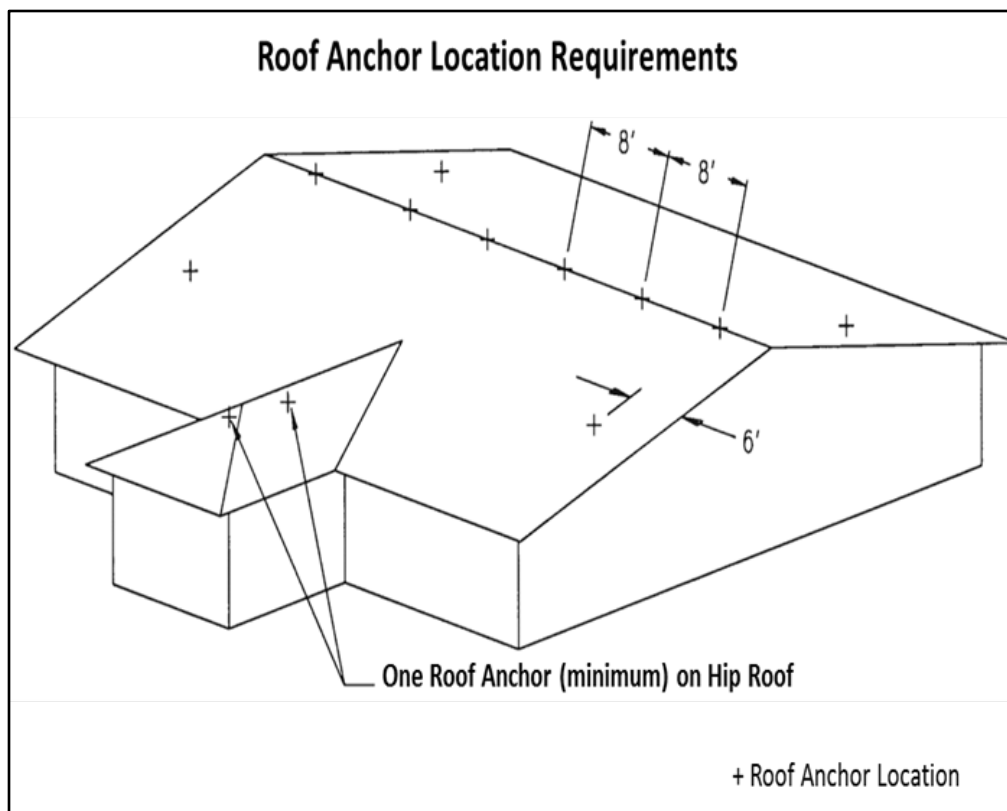
**Photo 7. Proper installation of PFAS anchor**  
*(Photo courtesy of NAHB)<sup>2</sup>*

According to 29 CFR 1926.502(d)(15)<sup>6</sup> the anchorage points used for attachment of personal fall arrest equipment shall be independent of any anchorage being used to support or suspend platforms and capable of supporting at least 5,000 pounds (22.2 kN) per employee attached, or shall be designed, installed, and used as part of a complete personal fall arrest system which maintains a safety factor of at least two under the supervision of a qualified person. The anchor for the PFAS used in this incident is believed to have been installed horizontally along the ridgeline of the roof, secured with 3 roofing nails into the sheathing (Photo 3). To meet the 5,000 pounds per employee support requirement, the manufacturer recommends installing the anchor over the ridgeline, with a minimum of 10 to 12, 3-inch, 16d nails through the holes, into the truss (Photo 7).

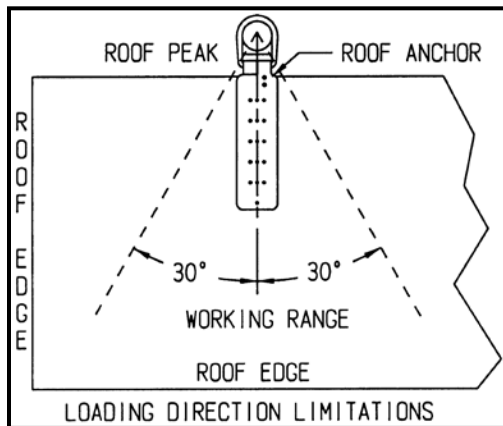
**Diagram 1. Example of typical roof bracket installation on residential roof**  
*(Diagram courtesy of DBI-SALA/Capital Safety)<sup>2</sup>*

According to 29 CFR 1926.502(d)(16)(iii)<sup>6</sup> the PFAS should be rigged such that an employee can neither free fall more than 6 feet (1.8 m), or contact any lower level. There was only one anchor installed across the ridgeline, the manufacturer recommends anchors be installed a minimum of 5 feet from the ridge ends and a maximum of every 8 feet along the peak (Diagram 1). The laborer's lifeline was rigged at 25 feet with a 6-foot lanyard, which gave him 31 feet of rope and the PFAS system was anchored approximately 29 feet from the ground. He was also working laterally away from the anchor point allowing the swing effect in the event of a fall (Diagram 2 & Diagram 3). In order to minimize the swing effect workers should work directly below the anchor and not extend their work area beyond 30 degrees from the anchor point<sup>7</sup>.
