Death in the line of duty...

A Summary of a NIOSH fire fighter fatality investigation

July 28, 2000

Career Fire Fighter Dies and Three Are Injured In a Residential Garage Fire - Utah

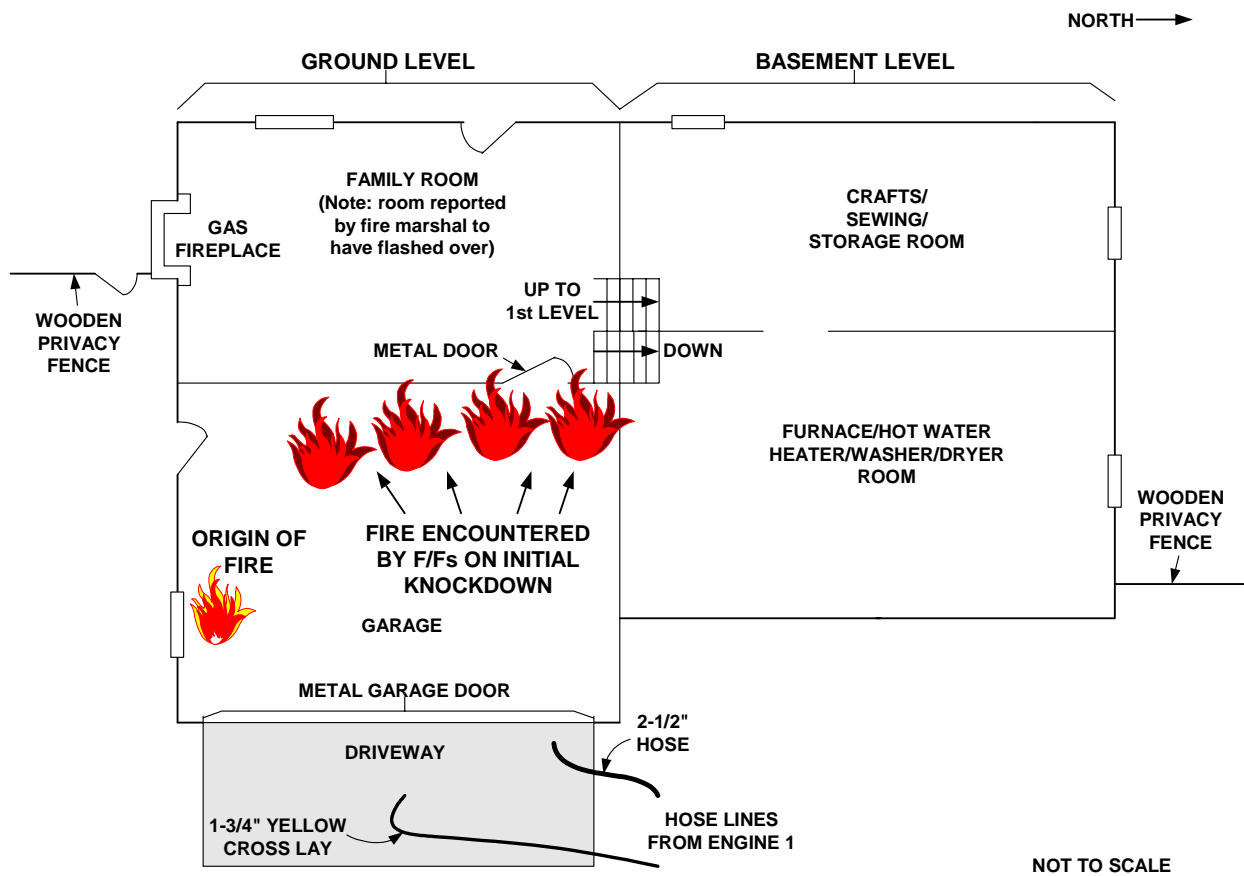
Diagram 2. Floor Plan

in and provide assistance for the two fire fighters (victim and Fire Fighter #1) who had just entered the structure. The search proceeded to the bathroom at the end of the hall and then on to the master bedroom. The IC also directed a fire fighter from Engine 2 to take a 1 3/4-inch preconnect and hit the remaining fire in the garage. The fire fighter from Engine 2 who was hitting the garage fire reported that the water running down the driveway was mixed with burning gasoline. He also reported that there were spot fires throughout the garage and that he was unable to see the back of the garage due to the thick, black smoke. The Lieutenant from Ambulance 3 directed one of his fire fighters from Ambulance 3 to man the Personnel Accountability Report (PAR) board while the other fire fighter from his crew put on his bunker gear. The fire fighter from Ambulance 3 reported only two tags were on the board (tags belonging to the Lieutenant and fire fighter from Engine 2). He then updated the board with the tags he was given. The victim's tag was not included, and it wasn't until the fire fighter from Ambulance 3 became aware that the victim was missing that he was able to add the victim's name to the board. The Lieutenant from Ambulance 3 reported to the IC and the IC informed the Lieutenant that the fire was hard to knock down and that it kept flaring up. The driver from Engine 2 charged the 5-inch supply line. He then took over as the Engine Operator E/O for Engine 1 and had difficulty getting an exact pressure, so he kept it between 160-165 psi.

of them exited the structure. The third crew reported to the IC that the stairs felt “spongy” and that they believed the top of the landing may have burned out. The Lieutenant from Ambulance 3 assembled a Rapid Intervention Team (RIT) with two fire fighters from Ambulance 1 who had just arrived on the scene. The IC, having received a report that the stairway may be compromised, was concerned about sending the RIT into the structure to look for the victim. The IC was also concerned about the stability of the roof over the garage, so he was hesitant about sending fire fighters in through the front bedroom windows above the garage. The Lieutenant from Ambulance 3 directed a fire fighter from Engine 3 and a fire fighter from Ambulance 3 to pull the 1 3/4-inch cross lay to hit the fire showing in the back of the structure. The E/O from Engine 3 and a fire fighter from Engine 3 accompanied them around to the back of the structure. They brought a ladder with them and began pulling siding down and hitting the fire on the southwest corner of the ground floor. While on the ladder, they did not hear any Personal Alert Safety System (PASS) device or low air bells (they were directly below the master bedroom window where the victim was found). The RIT stood by on the front lawn for approximately 2 minutes until the IC decided to have the RIT attempt a search through the upstairs bedroom windows over the garage. The IC instructed the RIT to stay near the edge of the garage roof and to use an ax to “sound” the roof for weak spots. The RIT threw a ladder to the garage roof in front of bedrooms #1 and #2 (see Diagram 1, Photo 1, and Photo 2). They used an ax to “sound” their way to bedroom #1's window. The window had been broken out by a water stream from the 2 1/2-inch line that was positioned in the driveway. As one of the fire fighters looked and yelled into the bedroom window, the other fire fighter proceeded toward bedroom #2's window. A fire fighter from Engine 2 climbed

onto the garage roof to assist the RIT. They continued to yell into the window but did not hear any verbal response or PASS device sounding. One of the RIT fire fighters had just broken out the window of bedroom #2 when he heard what he believed to be a PASS device going off. He yelled to the other RIT member, who was still at bedroom #1's window, that he could hear a PASS device. The RIT entered through bedroom #2's window while the fire fighter from Engine 2 stayed at the window and kept verbal contact with the RIT (see Diagram 1, Photo 1, and Photo 2). They immediately began searching the room when they realized that the alarm they were hearing was actually the audible alarm on the smoke detector in the house. They searched out into the hallway and to their right, which led them into bedroom #1. While searching bedroom #1, one of the fire fighters spotted a light on the floor of the room across the hall (the master bedroom). Believing it was the victim's flashlight, they proceeded immediately to the master bedroom. They located the victim's flashlight and his helmet on the floor near the wall. They both continued searching and simultaneously felt the air pack on the victim. The victim was in a crawling position with his face down in the corner. They never heard his PASS device sounding. The victim was found with his mask off. He apparently took his mask off and had turned his hood around, covering his face, in an attempt to filter out the smoke. The victim was unresponsive and not breathing. The two fire fighters immediately began dragging the victim by his shoulder harness across the hall toward the window in bedroom #2. One RIT member ran out of air and had to leave the other fire fighter to continue dragging the victim by himself. The fire fighter from Engine 2, still at the window, then entered and helped drag the victim to the bedroom window. The fire fighters who were waiting on the roof and in the driveway assisted in bringing the victim down from the garage roof. The victim

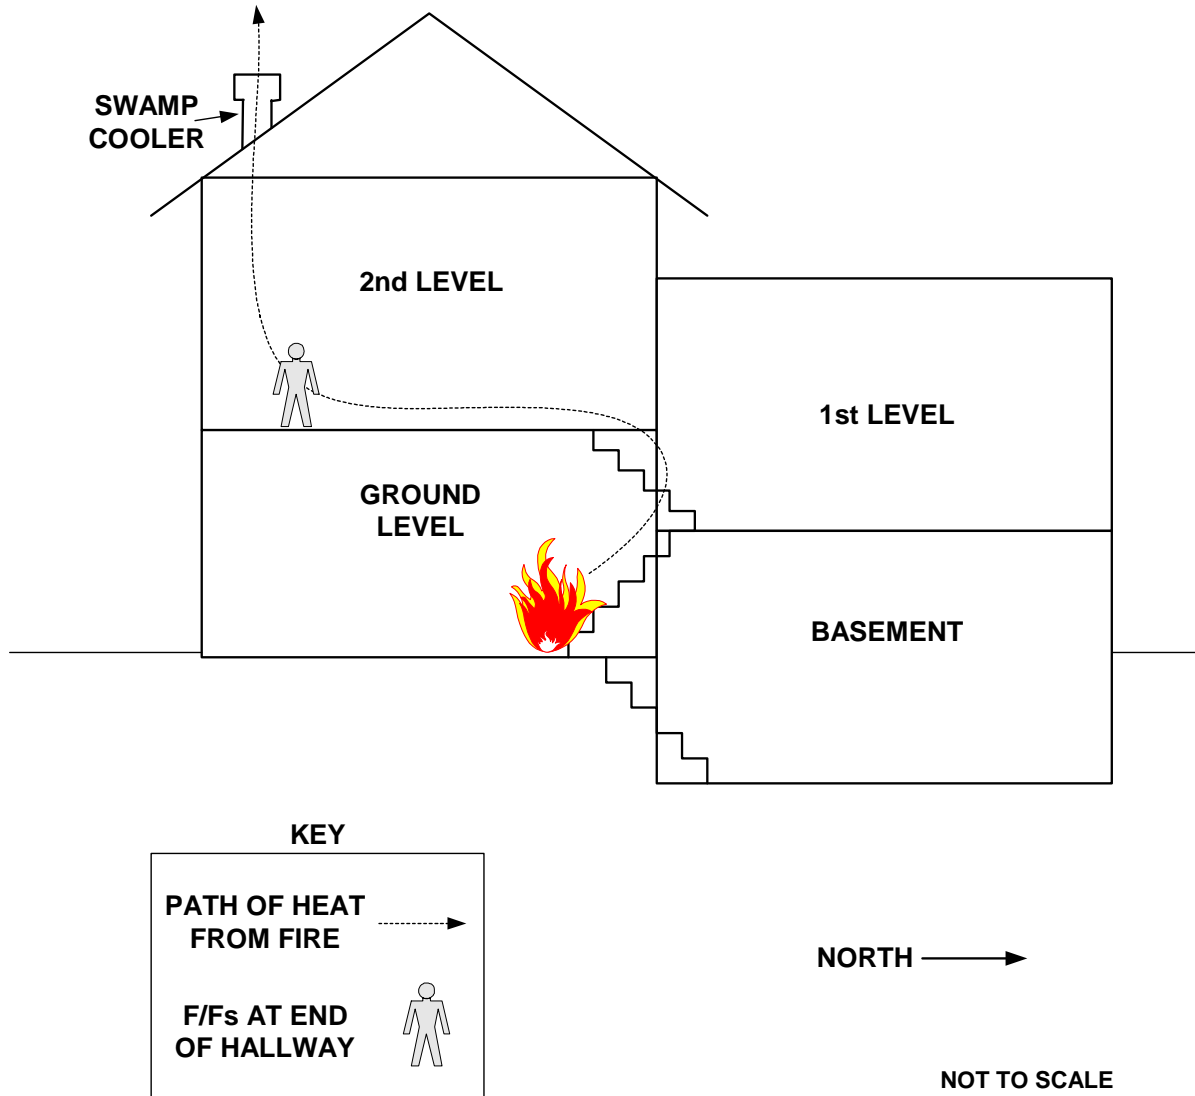
Diagram 3. Profile of Structure

over the positive pressure fan as he came out the front door followed by the Lieutenant. The third crew applied a straight stream with their 1 3/4-inch hose line down the stairs and then went to a fog stream to try and protect themselves from the heat. The Lieutenant asked the IC if the victim had come out behind him, and the IC replied that he hadn't come out. The Lieutenant and Fire Fighter #1 then received medical attention for their burns and for heat exhaustion. The IC then ordered a Personnel Accountability Report (PAR), and everyone was accounted for except the victim. The IC didn't know if the victim was still inside the structure or if he had possibly exited the building on the west side. The Lieutenant from Ambulance 3 directed a fire fighter from Engine 3 and a fire fighter from Ambulance 3 to do a search of the outside of the building for the victim. They didn't find the victim but reported to the IC fire showing on the back side of the structure. The initial third crew—one fire fighter and the E/O from Engine 3 along with one fire fighter from Engine 2—were directed by the IC to reenter the structure to search for the victim who might still be upstairs. *Note: This crew was never a designated Rapid Intervention Team (RIT).* The crew entered through the front door and proceeded to the stairway. The fire fighter from Engine 2, accompanying the third crew, tried to go up the stairs but was concerned about proceeding any further because the stairs felt “spongy.” The third crew found the nozzle from the first crew's hose line. The line felt charged but when they attempted to use it, the water would only spray about 3 feet. The third crew then proceeded with the hose line they originally had with them until they saw fire starting to move up the stairs. They applied water to the stairs leading toward the family room. The crew did not proceed any further due to their belief that the floor might collapse. The third crew then heard someone yell for everyone to get out, so all three
