NIOSH
Fire Fighter Fatality Investigation
and Prevention Program

February 28, 2002

Career Fire Fighter Dies After Falling Through the Floor Fighting a Structure Fire at a Local Residence - Ohio

Fatality Assessment and Control Evaluation Investigative Report #F2001-16

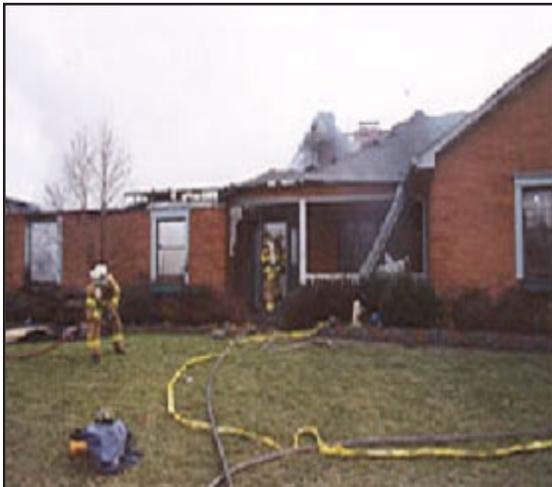
Fire fighter #3 and the victim were at the front entrance conducting a defensive attack as the third emergency evacuation signal was sounded. The neighbors were still insisting to the IC and fire fighters that the occupants were trapped inside, and one of the occupants was handicapped. The victim and one other fire fighter conducted another search of the structure. The heat and flames were now extending from the basement level to the first floor when the fire fighter's low air alarm sounded. The victim and the fire fighter were backing out of the structure when the floor beneath the victim gave way, causing him to fall through the floor and become trapped in the basement. Attempts were made from the first floor to rescue the victim by utilizing a handline

and an attic ladder, but they were unsuccessful due to the intense heat and flames. Two Rapid Intervention Teams (RIT #1 & RIT #2) were deployed simultaneously from separate entrances into the basement to perform a search and rescue operation for the downed fire fighter. The RITs were able to locate and remove the victim on their initial entry. He sustained third degree burns to over half of his body and died 12 days later.

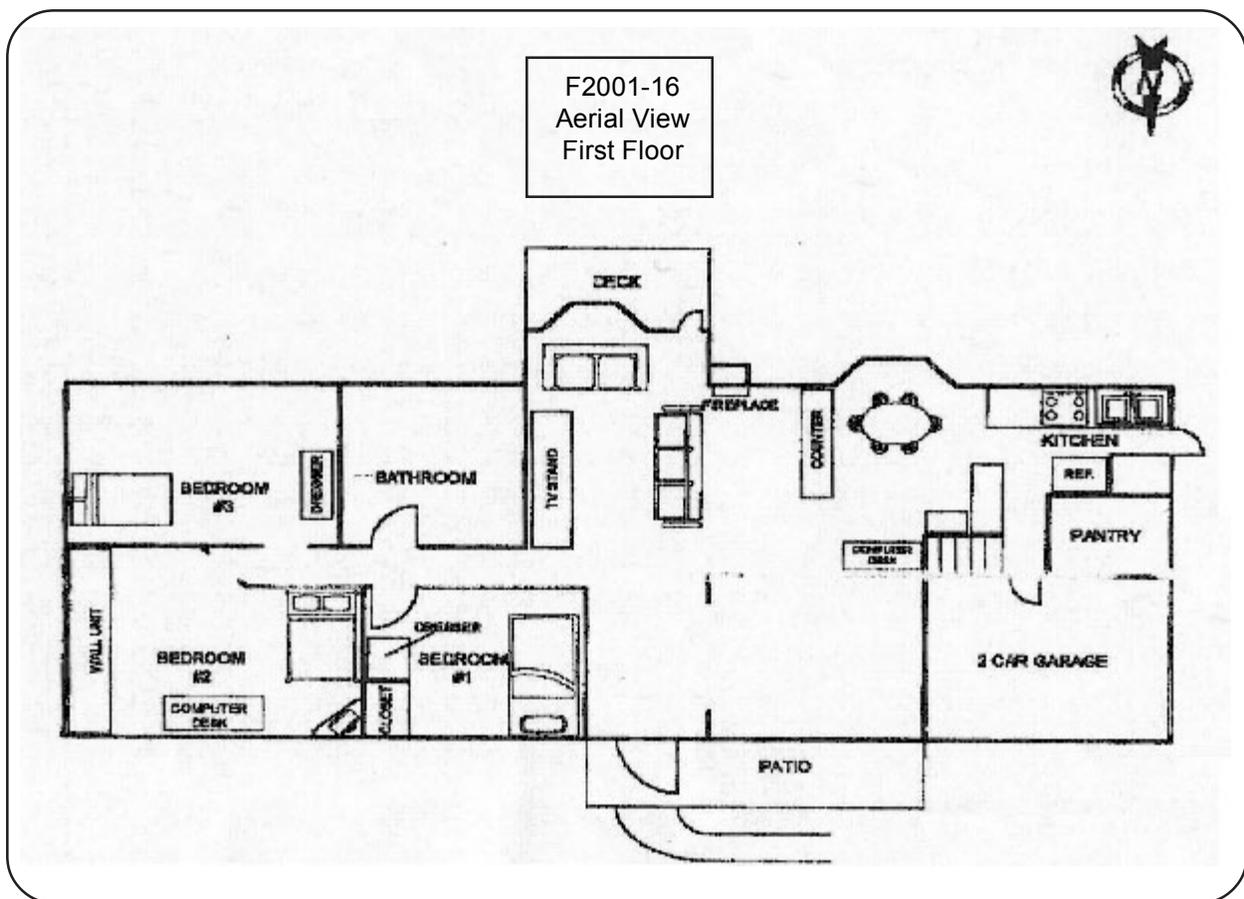
Drawing #2

visibility. RIT #1 found the victim in the furnace room between the two hallways. RIT #2 breached a wall to reach the victim and assisted in removal. The victim was found between a wall and the hot water heater, sitting on his hands in the upright position. The victim's portable radio was in the off position and located in the pants pocket of his turnout. His hood, turnouts, SCBA and face-piece were on with air remaining in his tank. His helmet and his gloves were not on at this time. Neither his low air alarm nor his personal alert safety system (PASS) was sounding. The victim became semi-responsive while in transit to the emergency transport helicopter. He sustained third-degree burns to over half of his body and died 12 days later from the injuries.
