Volunteer Captain Killed, Two Fire Fighters and Police Officer Injured When Struck by Motor Vehicle at Highway Incident - Minnesota

Fatality Assessment and Control Evaluation Investigative Report #F2002-38

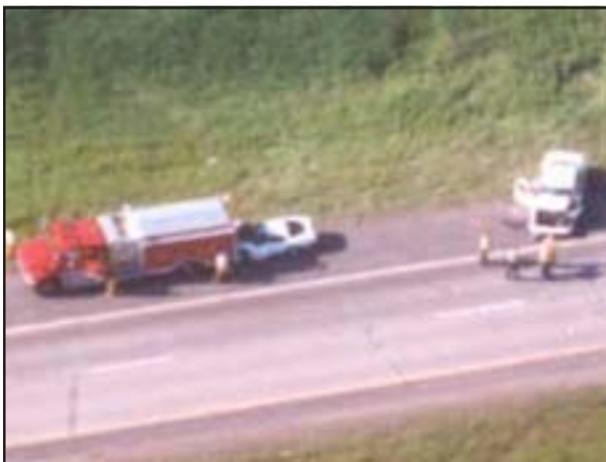
Incident Site

The victim was found unresponsive and lying on the right shoulder of the highway just north of where POV2 came to a stop. The injured municipal police officer was unconscious and lying near the right rear tire of POV2. Two fire fighters and the owner of the incident vehicle were thrown onto the grassy area to the east of the right northbound shoulder (Figure 1). All three were conscious but had suffered various injuries. Two fire fighters jumped clear of the vehicles and escaped injury.

Recommendation #1: Fire departments should ensure that fire apparatus is positioned to protect firefighters from traffic.¹⁻⁵
