One Career Fire Fighter Dies and Two are Injured in Apparatus Crash - California

SUMMARY

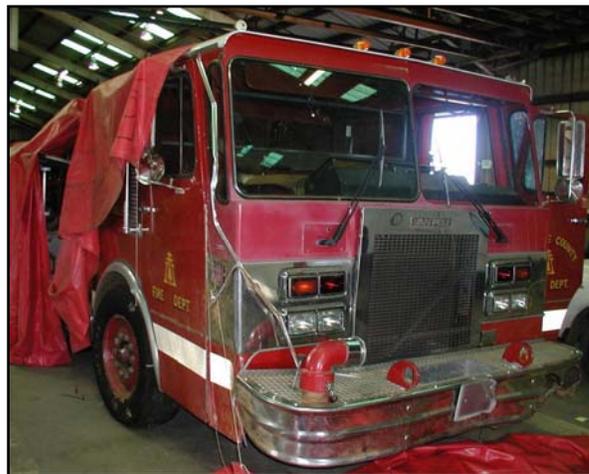
The apparatus involved in this incident was a 1987, 1,000 gallon-per-minute (GPM) engine with an automatic transmission and an auxiliary braking system (engine brake) (Photo 1). The engine’s gross vehicle weight rating was 40,000 pounds (16,000 gross axle weight rating for the front and 24,000 gross axle weight rating for the rear). The engine had two axles with six tires (two in the front and four in the rear) all in good condition. The 500-gallon rectangular-shaped water tank was filled to capacity at the time of the incident. This was an open-cab engine that was equipped to carry six passengers with two front seat positions and four rear-facing seating positions. All six seats had lap belt restraints. The vehicle had passed a safety compliance inspection (required by the state) conducted at an area service station on June 15, 2005 and had traveled approximately 21 miles since the inspection.

The apparatus was a reserve engine that had been placed into service on the day of the incident to replace the engine normally used by this crew which was being serviced. The driver/operator involved in this incident had completed an inspection of this vehicle prior to placing it in service. No defects were found during the inspection.
