Volunteer Deputy Fire Chief Dies after Falling Through Floor Hole in Residential Structure during Fire Attack—Indiana

Revised: October 19, 2007

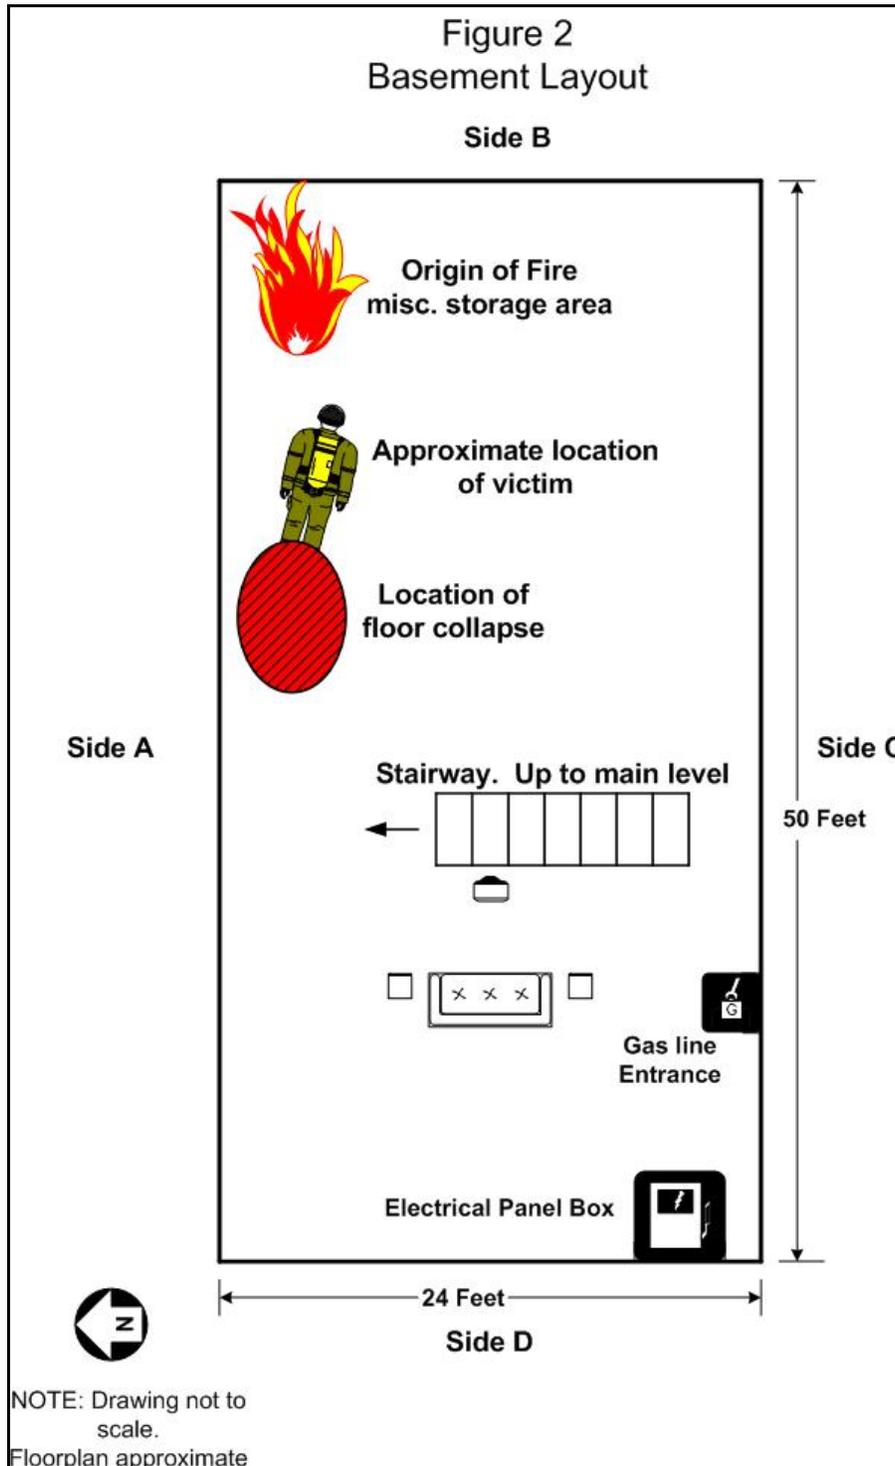
Photo 3 illustrates the floor failure area, viewed from the basement. Photo courtesy of the fire department

The basement area to the left of FF#1 (A-B corner in basement) as well as the unfinished ceiling and unprotected floor joists were burning and FF#1 had to use a handline to put water on the fire before descending. As soon as FF#1 reached the lower level, his low-air alarm went off. FF#1 immediately climbed out of the basement and went to replace his air bottle. FF#2 and the Assistant Chief then attempted to position the 14-foot ladder for safe access into the basement, but as a result of debris and clearance inadequacies, the ladder did not reach the lower level. Once the ladder was somewhat in place, the Assistant Chief and FF#2 descended into the basement and immediately found the victim near the hole in the floor. The victim was dragged to the area of the basement stairs. FF#2 stated that

Recommendation #1: Fire departments should ensure that fire fighters and incident commanders are aware that unprotected pre-engineered I-joist floor systems may fail at a faster rate than solid wood joists when exposed to direct fire impingement, and they should plan interior operations accordingly.

While objective time-to-failure studies of the various lightweight flooring systems being used today have been conducted only in limited cases, evidence from two FFFIPP investigations suggest and seems to support the fact that engineered I-joists quickly lose strength and integrity when damaged and weakened by heat exposure and flame impingement. (Photo 5) Often, the weakened I-joists can be difficult to detect from above as the floor surface above may still appear intact. Fire fighters who
