## **Career Fire Fighter Dies and Chief is Injured When Struck by 130-Foot Awning that Collapses during a Commercial Building Fire – Texas**

*Career Fire Fighter Dies and Chief is Injured When Struck by 130-Foot Awning that Collapses during a Commercial Building Fire – Texas*

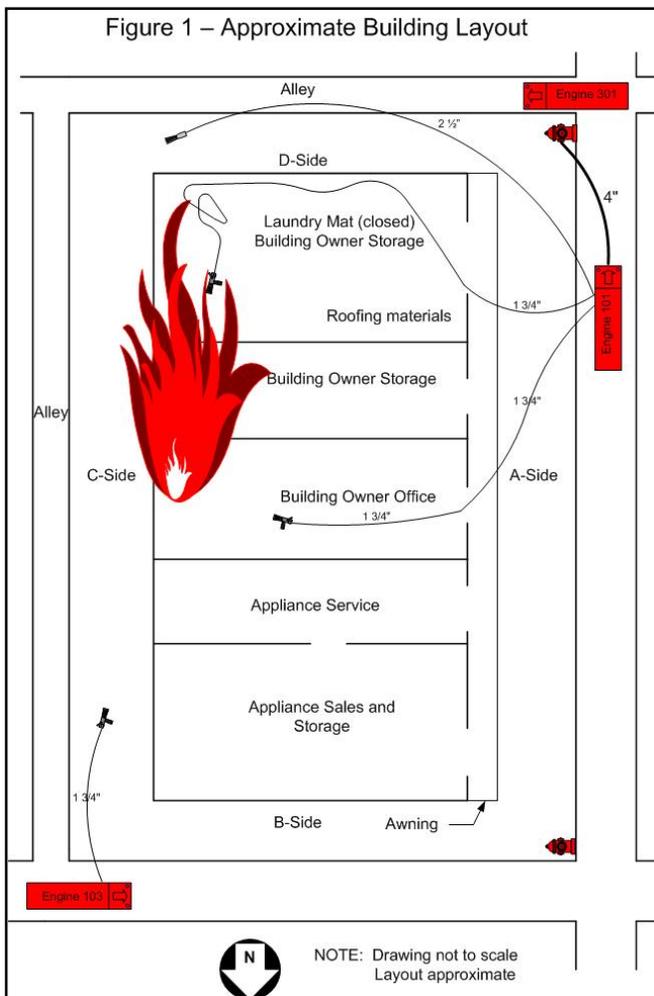
concrete block and bricks. The east (C-side) and south (D-side) walls were poured concrete. The majority of the rear wall (C-side) and the south end wall (D-side) were below grade. A triangular-shaped awning constructed of 2 X 4 framing lumber, plywood sheeting, and covered with asphalt shingles extended across the front of the building. The awning measured approximately 6 feet 8 inches by 6 feet 8 inches by 9 feet (see Figure 2). The awning was connected to 18 inch steel beams of various lengths that extended end-to-end across the front wall directly above the windows and doors and to concrete blocks stacked above the steel beams (see Figure 2 and Photo 3). The building had a flat roof constructed of plywood sheeting covered with layers of tar. The structure was approximately 16 feet high at the top of the awning. The roof was supported by open-web pin-connected metal trusses. The top and bottom chords of these trusses were constructed using wooden lumber measuring approximately 2 inch X 3 ½ inches. The metal webs were constructed from metal tubing of approximately one-inch diameter (see Figure 3 and Photo 4). The only static load on top of

the roof was an air-conditioning condenser unit located near the rear wall at the north end of the structure that serviced the retail facilities at the north end. The bottom side of the trusses supported a suspended ceiling system and electrical junction boxes. There were no fire walls in place separating the different businesses and the structure had a common truss void above the suspended ceiling. At the time of the incident, the building was divided into three separate areas (see Figure 1). The northern end of the building contained a large-appliance sales business and an appliance repair business. The center area was used by the building owner as office and storage space for a number of businesses operated by the owner. The south end of the building contained a laundry that was closed at the time of the incident and was used by the owner to store roofing materials and supplies. *Note: It is believed the fire originated somewhere above the suspended ceiling in the center office area. Falling burning ceiling material ignited materials stored in the structure which contributed to the fire load and may have accelerated the roof collapse.*

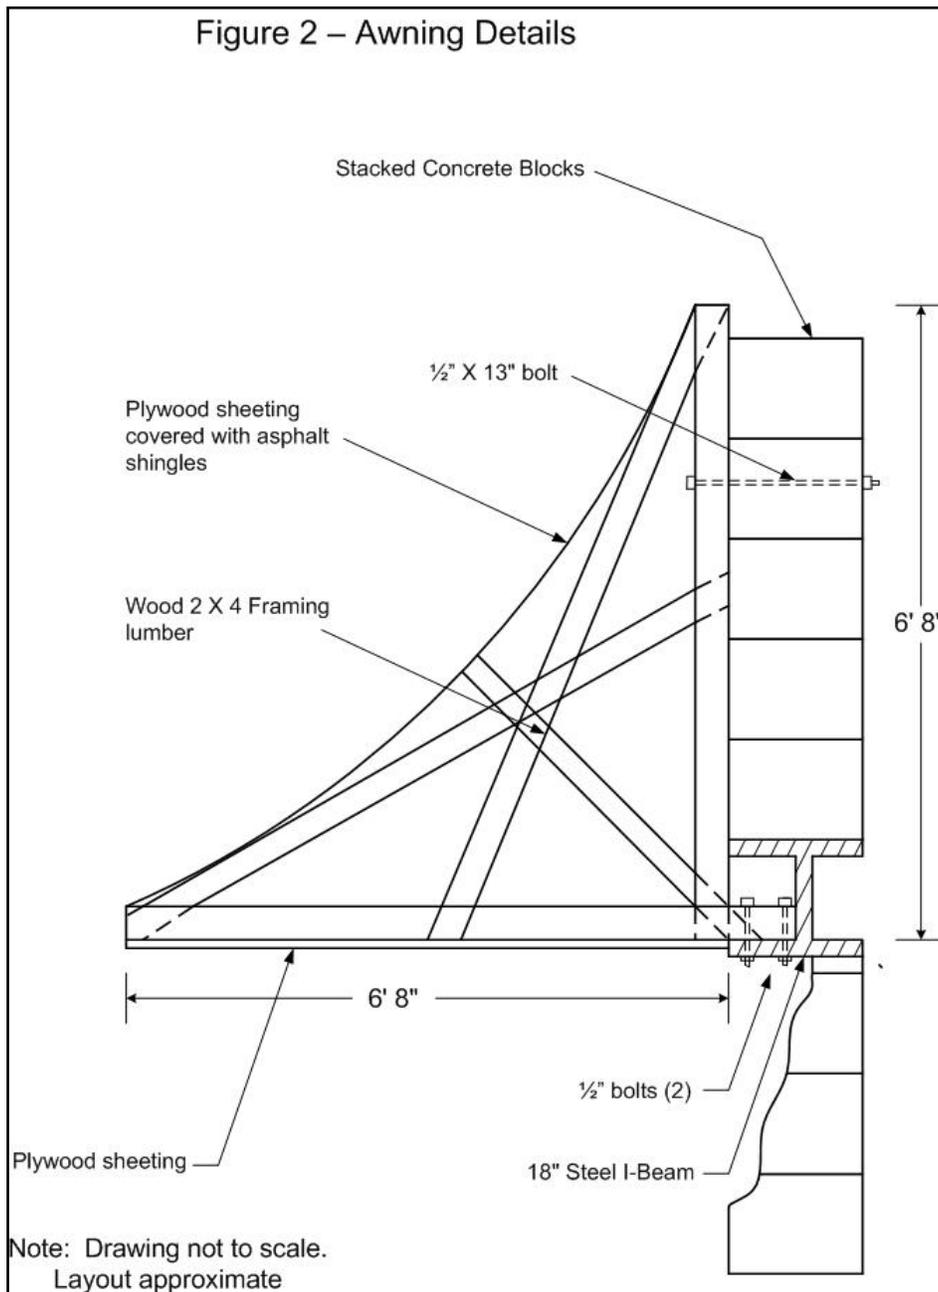
*Photo 3. Note steel I-beams running across front wall above windows and doors. Note wood fragments where awning frame was connected to the I-beam. Burn patterns also indicate location of awning frame. Photo courtesy of fire department.*
