Volunteer Fire Fighter Dies After Falling Through Floor Supported by Engineered Wooden-I Beams at Residential Structure Fire - Tennessee

Volunteer Fire Fighter Dies After Falling Through Floor Supported by Engineered Wooden-I Beams at Residential Structural Fire - TN

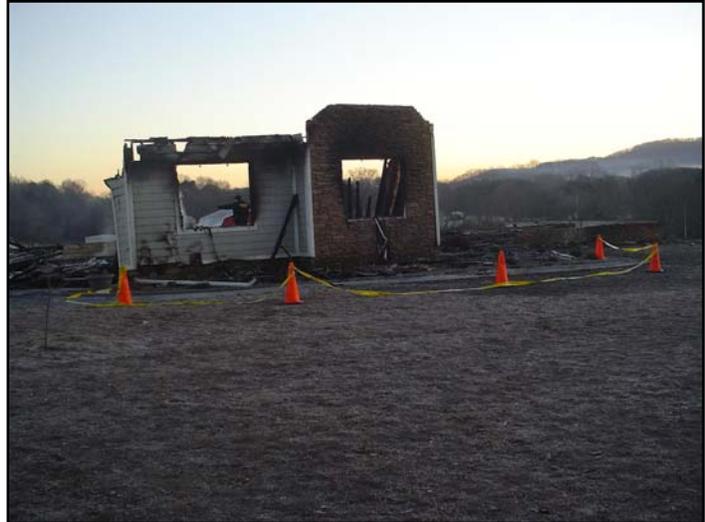
On January 26, 2007, a 24-year-old male volunteer fire fighter died at a residential structure fire after falling through the floor which was supported by engineered wooden I-beams. The victim's crew had advanced a handline approximately 20 feet into the structure with zero visibility. They requested ventilation and a thermal imaging camera (TIC) in an attempt to locate and extinguish the fire. The victim exited the structure to retrieve the TIC, and when he returned the floor was spongy as conditions worsened which forced the crew to exit. The victim requested the nozzle and proceeded back into

the structure within an arm's distance of one of his crew members who provided back up while he stood in the doorway. Without warning, the floor collapsed sending the victim into the basement. Crews attempted to rescue the victim from the fully involved basement, but a subsequent collapse of the main floor ceased any rescue attempts. The victim was recovered later that morning. NIOSH investigators concluded that, to minimize the risk of similar occurrences, fire departments should:
