## **Four Career Fire Fighters Injured While Providing Interior Exposure Protection at a Row House Fire – District of Columbia**

*Four Career Fire Fighters Injured While Providing Interior Exposure Protection at a Row House Fire – District of Columbia*

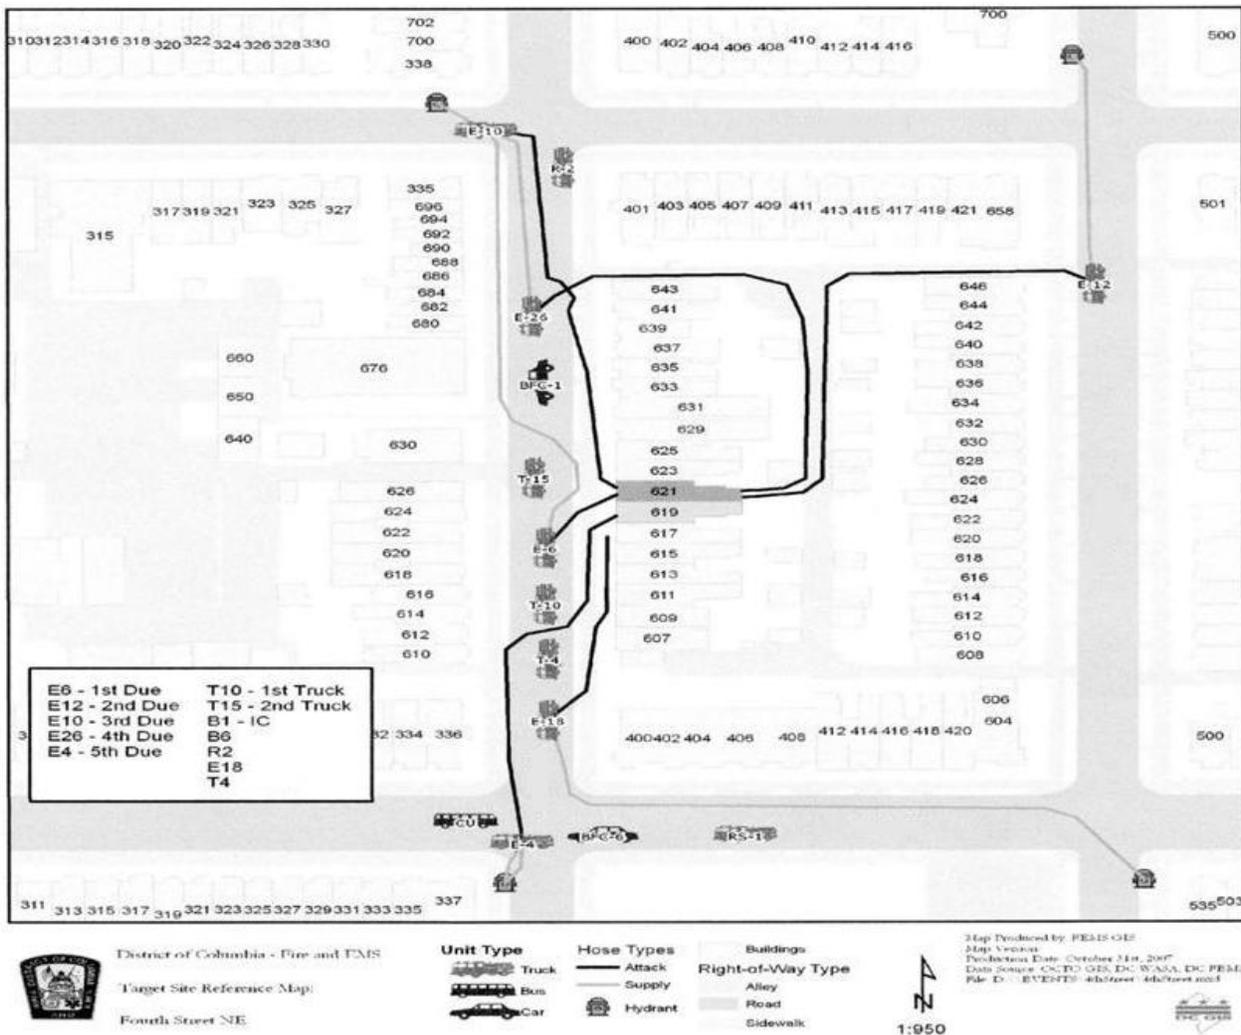
Diagram 1. Apparatus positioning layout. Adapted from diagram courtesy of fire department. Diagram indicates address box numbers for residences.

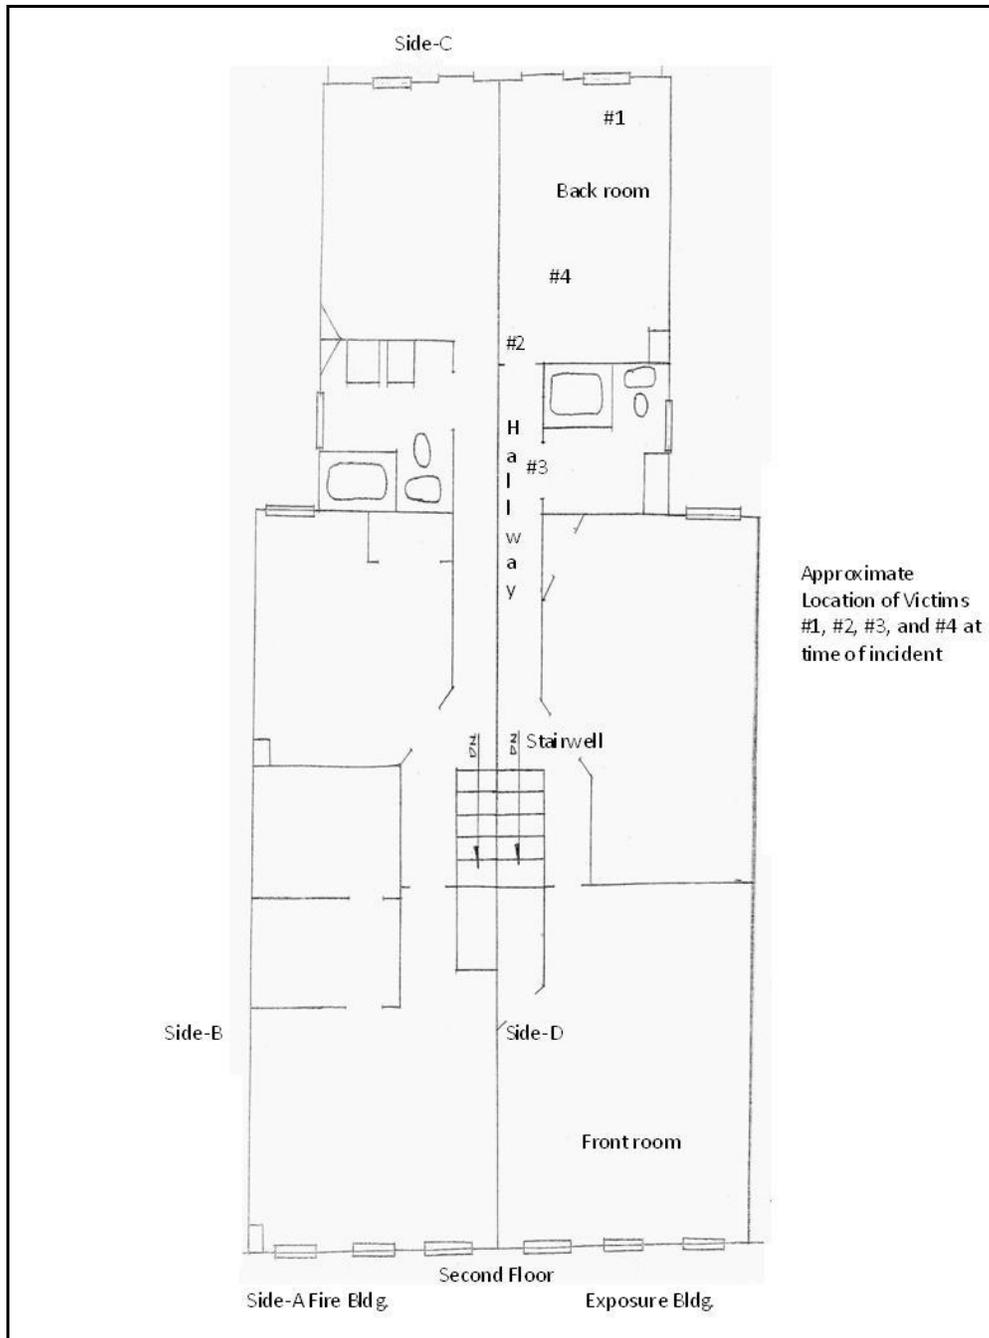
Diagram 3. Floor plan of second floor fire building and exposure building.  
(Diagram courtesy of the fire department.)
