Death in the line of duty...

A summary of a NIOSH fire fighter fatality investigation

August 17, 2009

Two Career Fire Fighters Die and Captain is Burned When Trapped during Fire Suppression Operations at a Millwork Facility – North Carolina

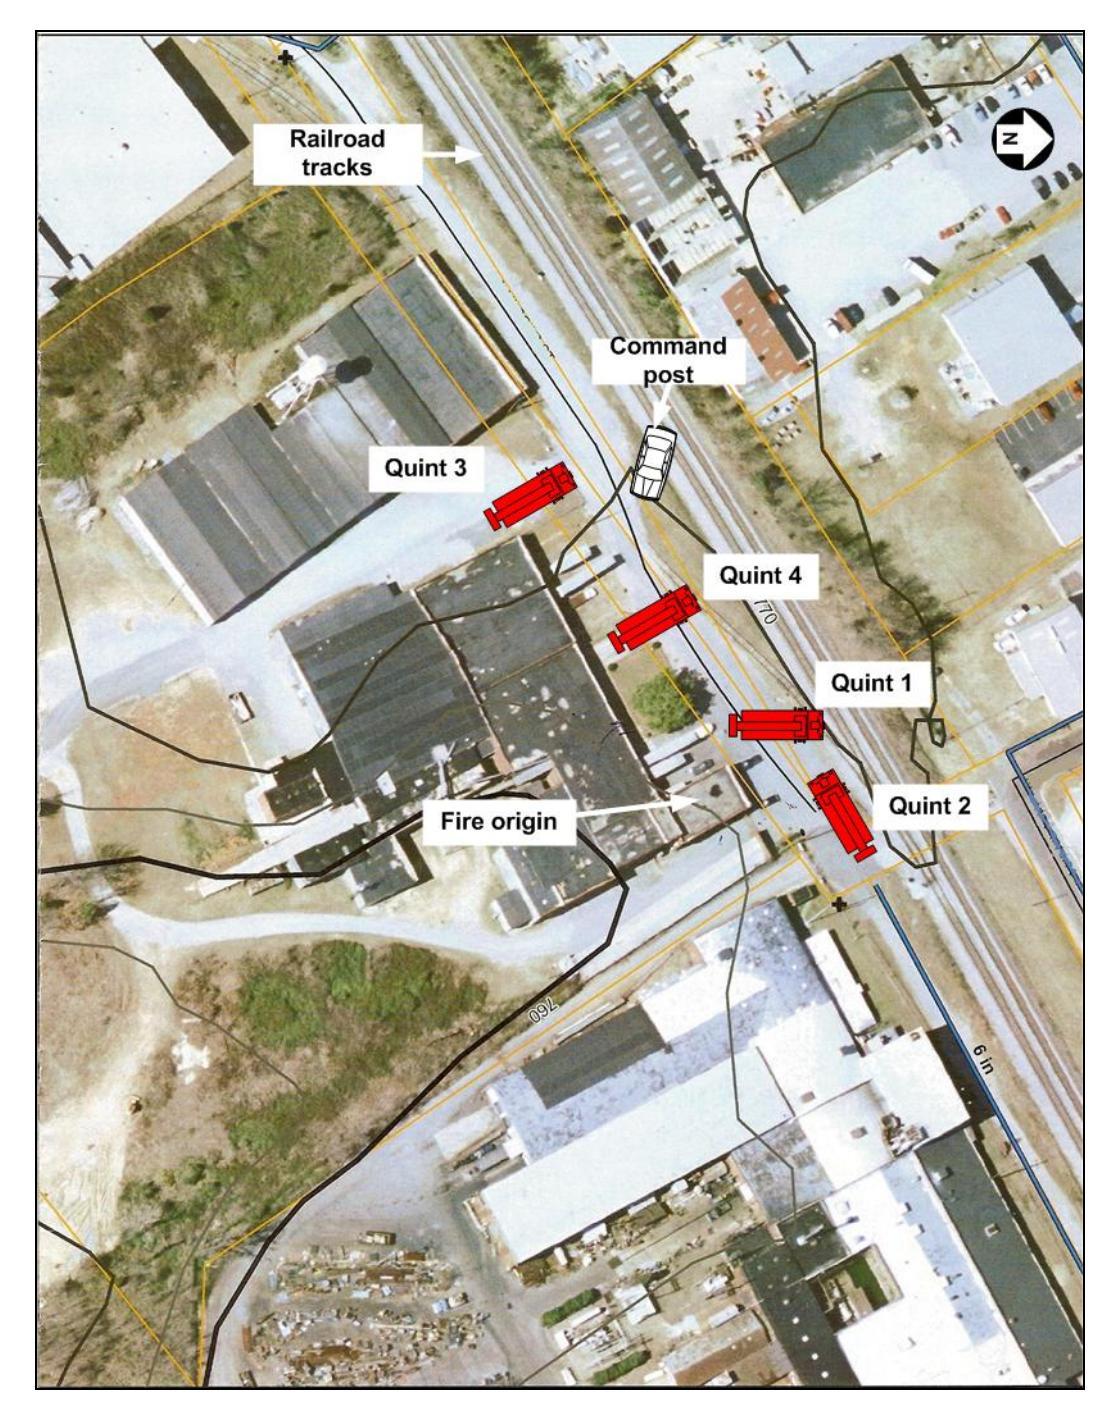
Diagram 1. Overhead view of incident site. Diagram adapted from aerial photograph taken in March 2006. Diagram not to scale. GIS aerial photograph provided by city water department.

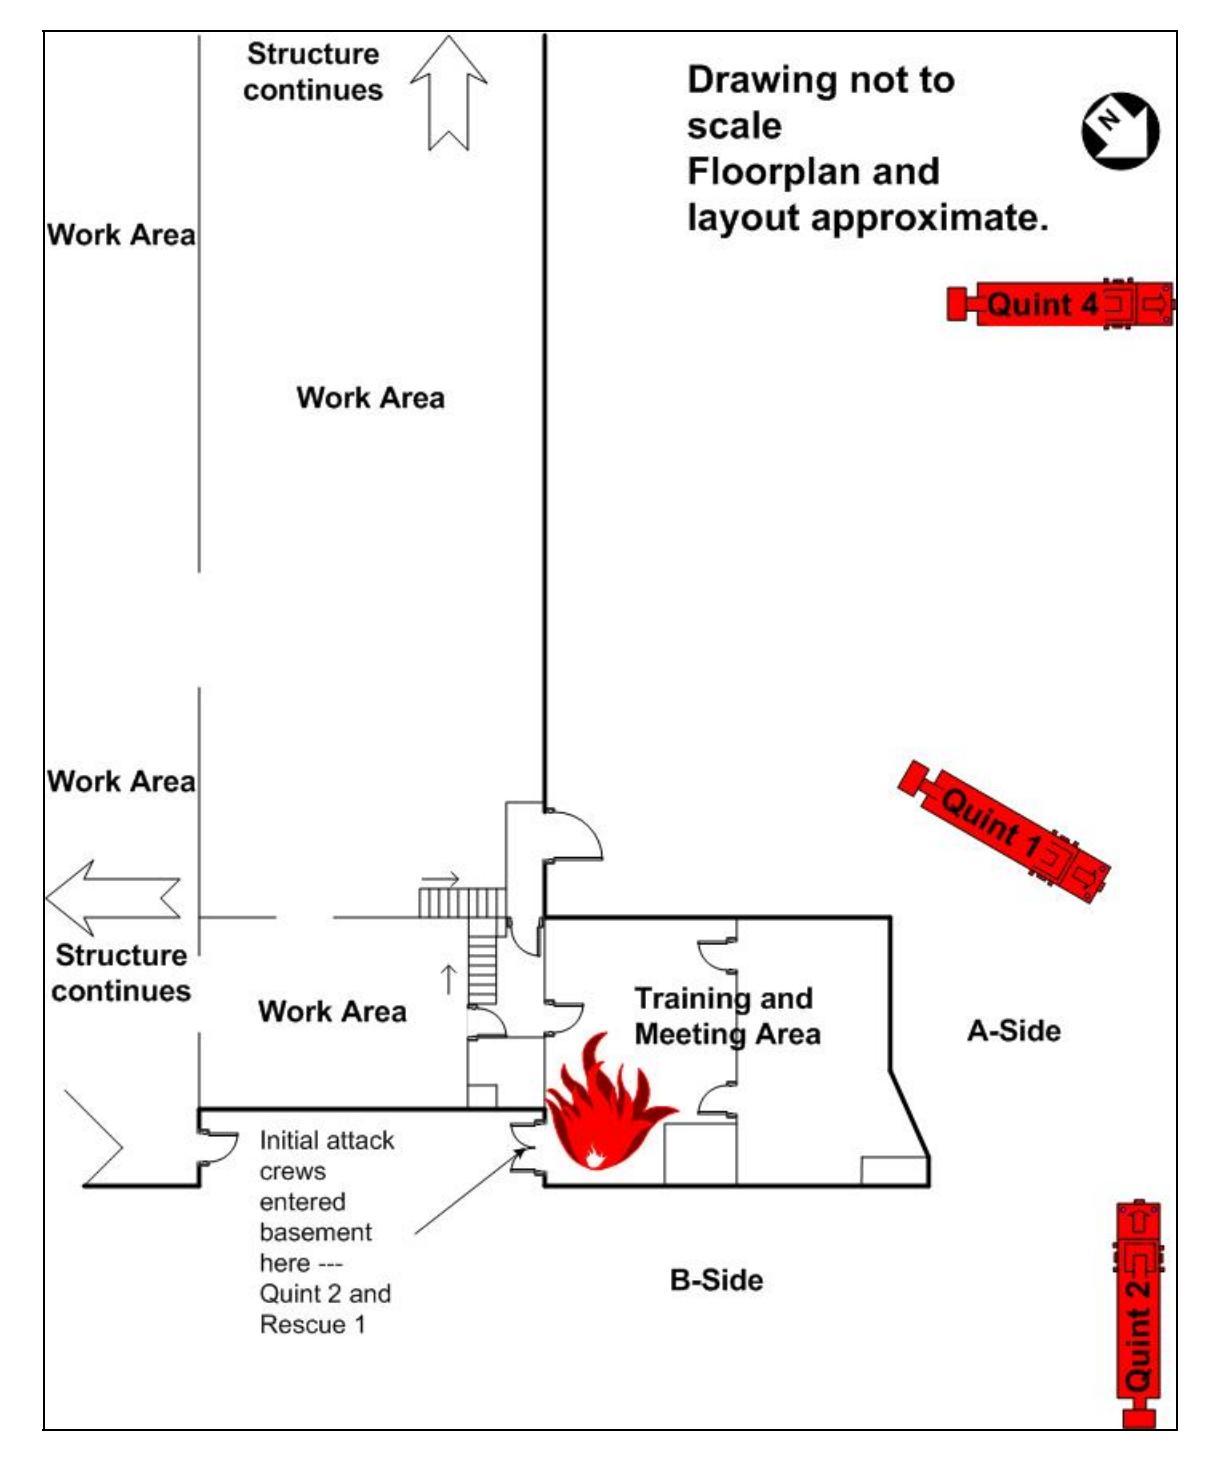
Diagram 2. Incomplete diagram of structure showing only the effected areas at the basement level of the A and B-sides

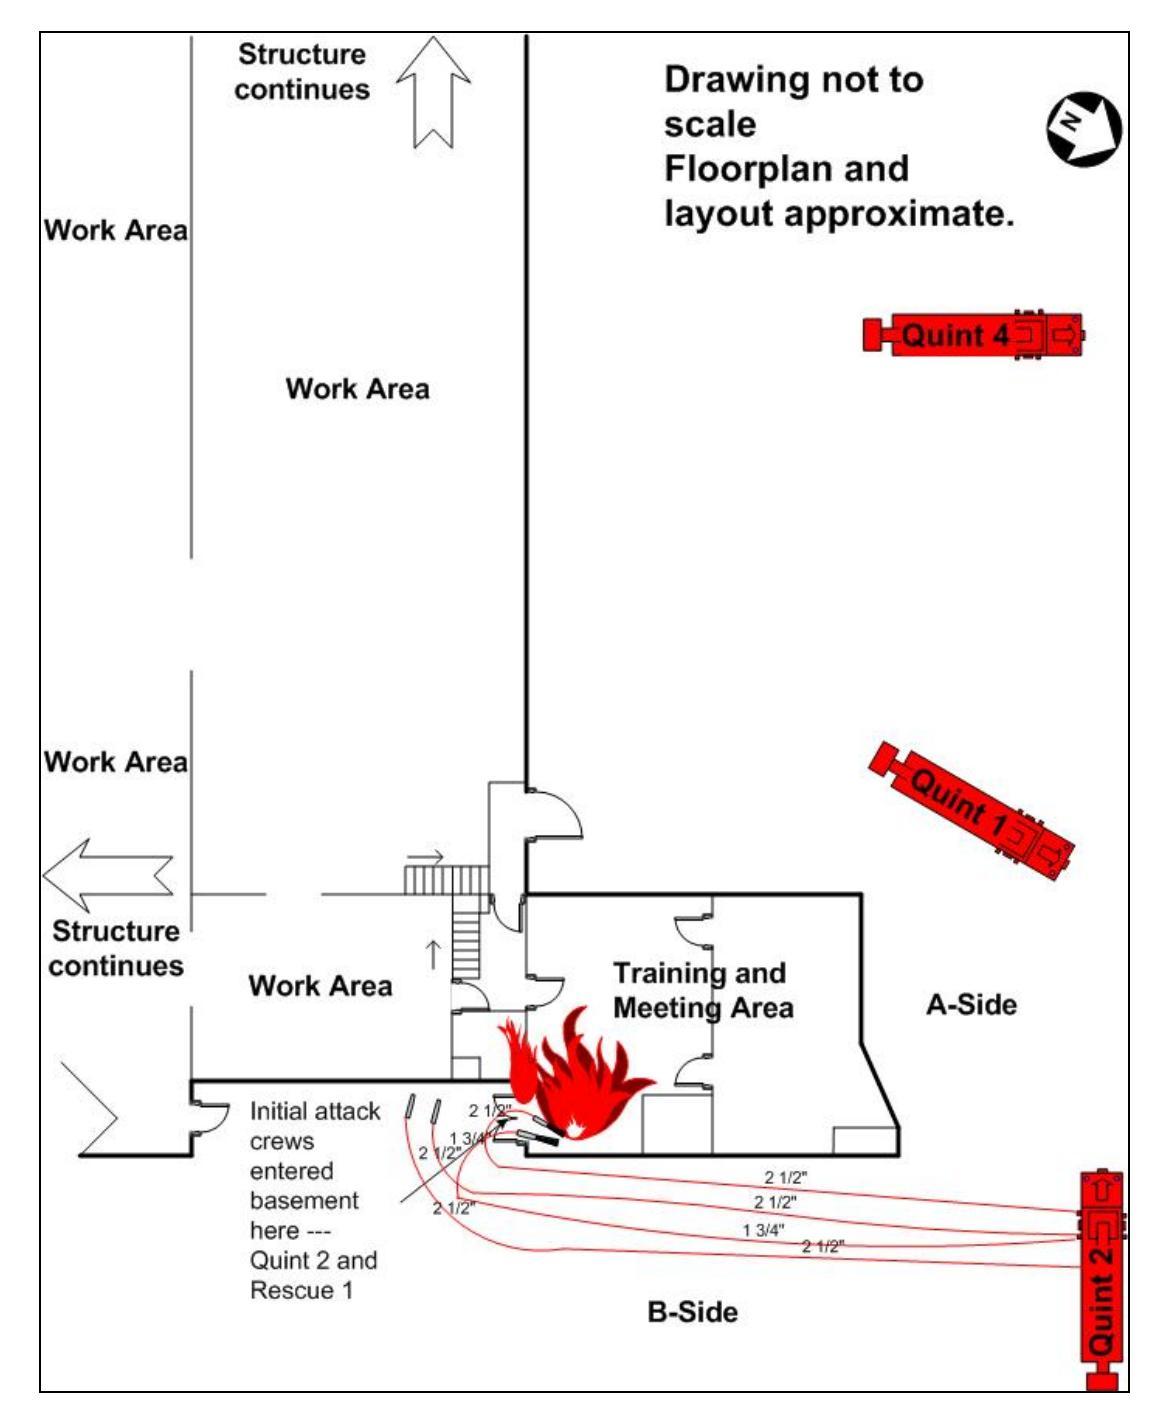
Diagram 3. Diagram shows location where initial attack lines were pulled from Quint 2 to the B-side basement door. Incomplete diagram of structure showing only the effected areas in the basement at the A and B-sides
