## Career Fire Fighter Dies While Conducting a Search in a Residential House Fire – Kansas

### Executive Summary

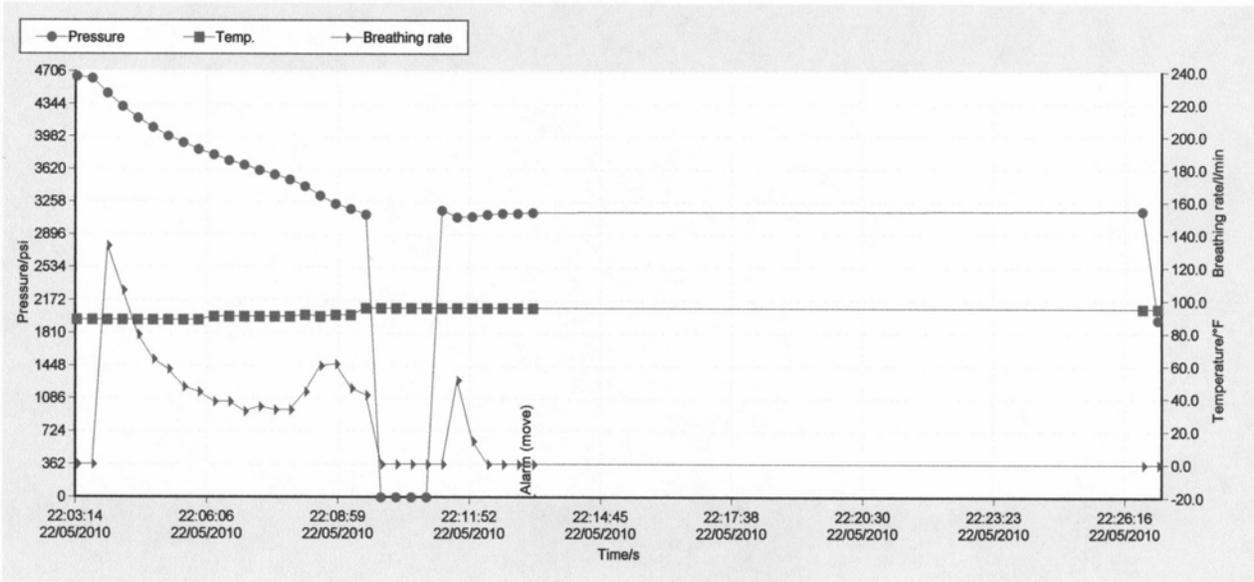
## Bodyguard IR-Link II Datalog report

Datalog from: [REDACTED]  
User Name: [REDACTED]  
Serial Number: [REDACTED]  
User ID: [REDACTED]  
Time in use (hh:mm): 02:25  
Date from/to: [2010/05/22 22:03:14] - [2010/05/22 22:27:05]
