Two Career Fire Fighters Die and 19 Injured in Roof Collapse during Rubbish Fire at an Abandoned Commercial Structure – Illinois

Executive Summary

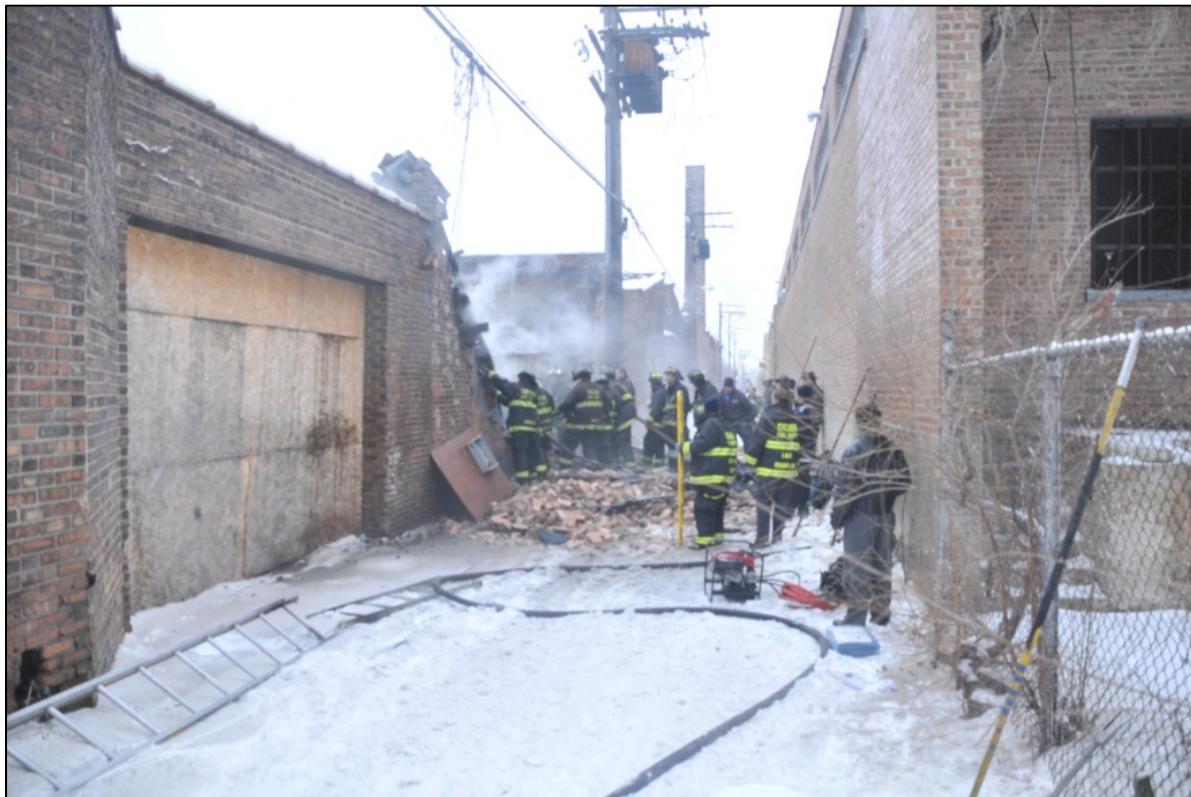
Photo 1. 12-foot wide public alley directly behind structure (Sector 3).
(Photo courtesy of fire department)

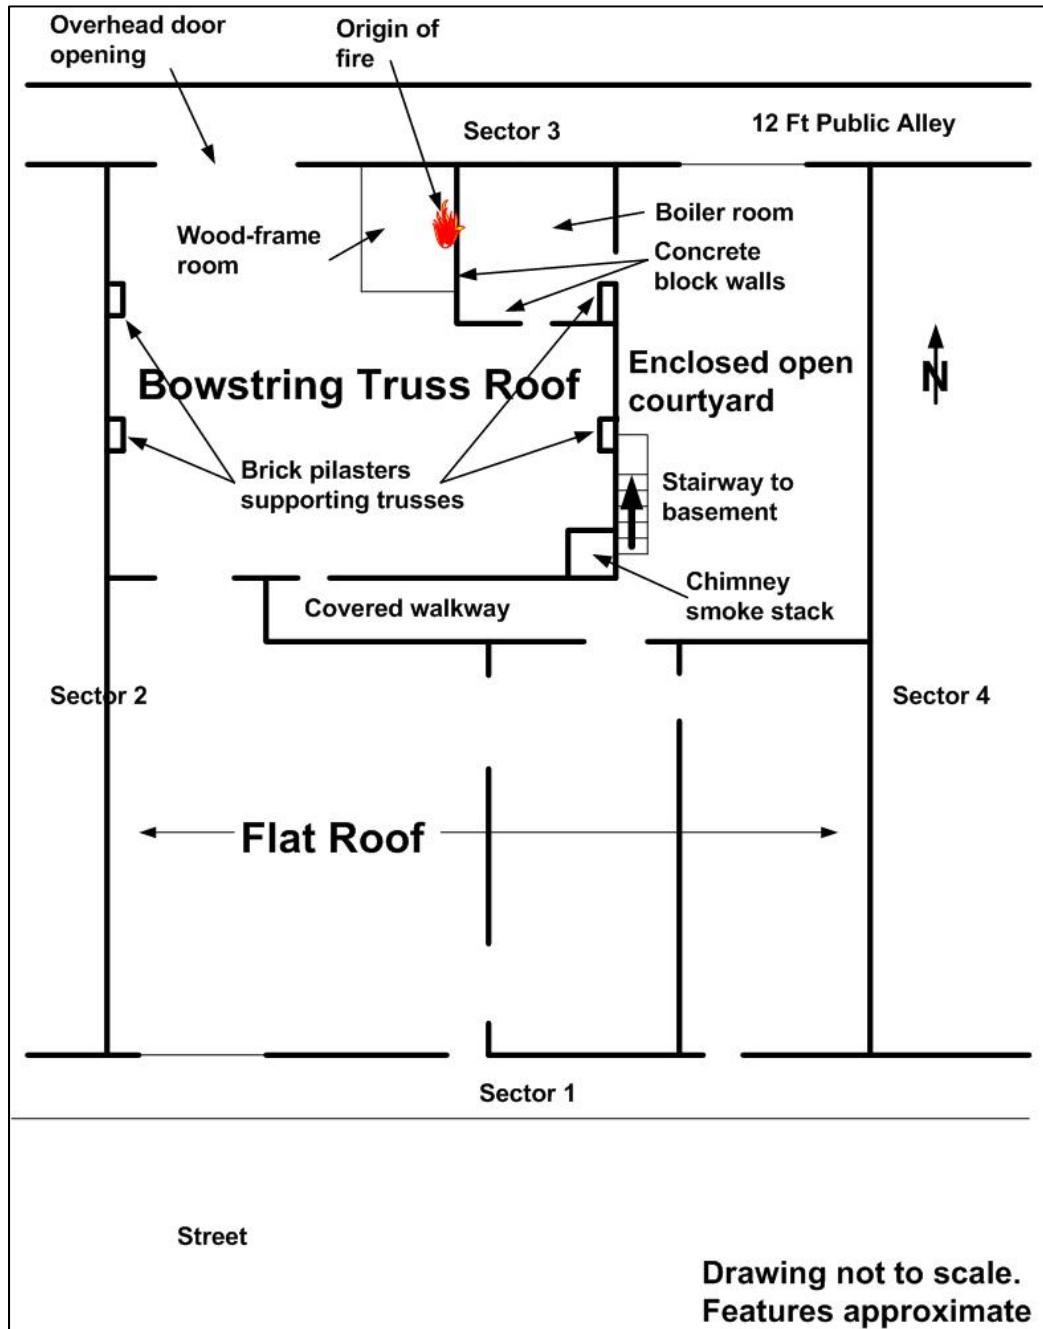
Diagram 1. Approximate layout of the fire building.

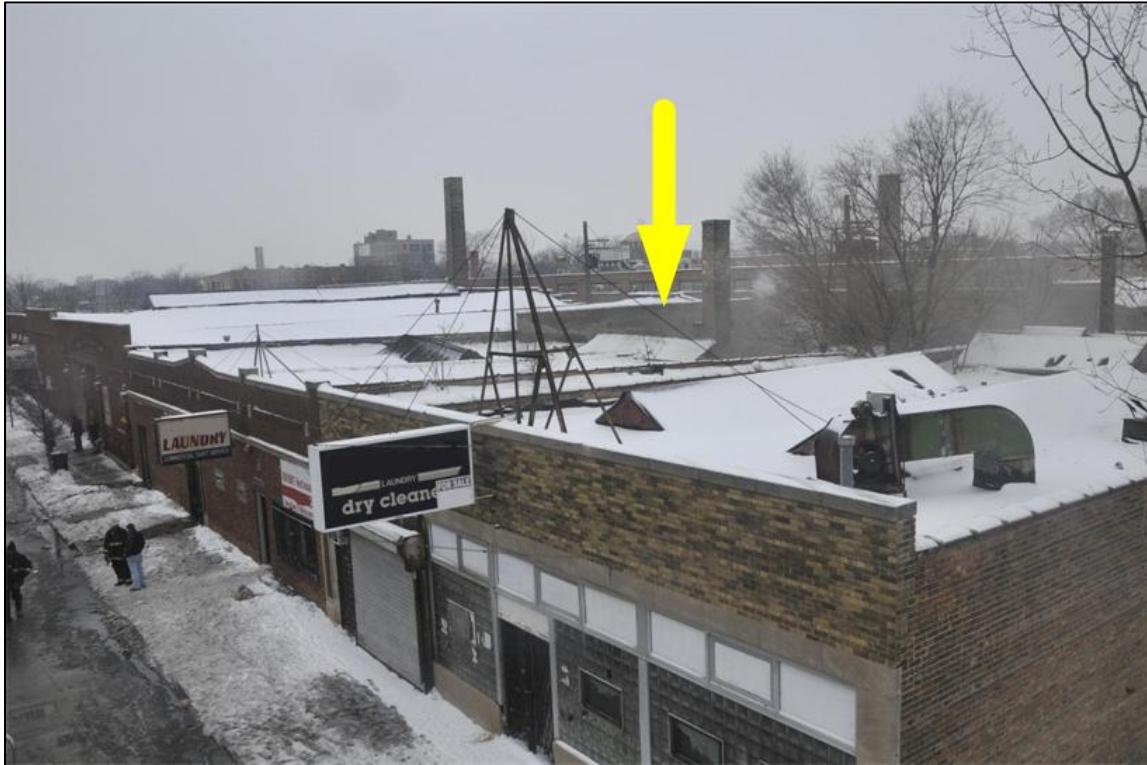
Photo 4. Elevated view of the block where the incident occurred, taken the day of the fire. The arrow marks the location of the collapse. The photo has been edited to remove names and identifying information from signs.
(Photo courtesy of fire department)

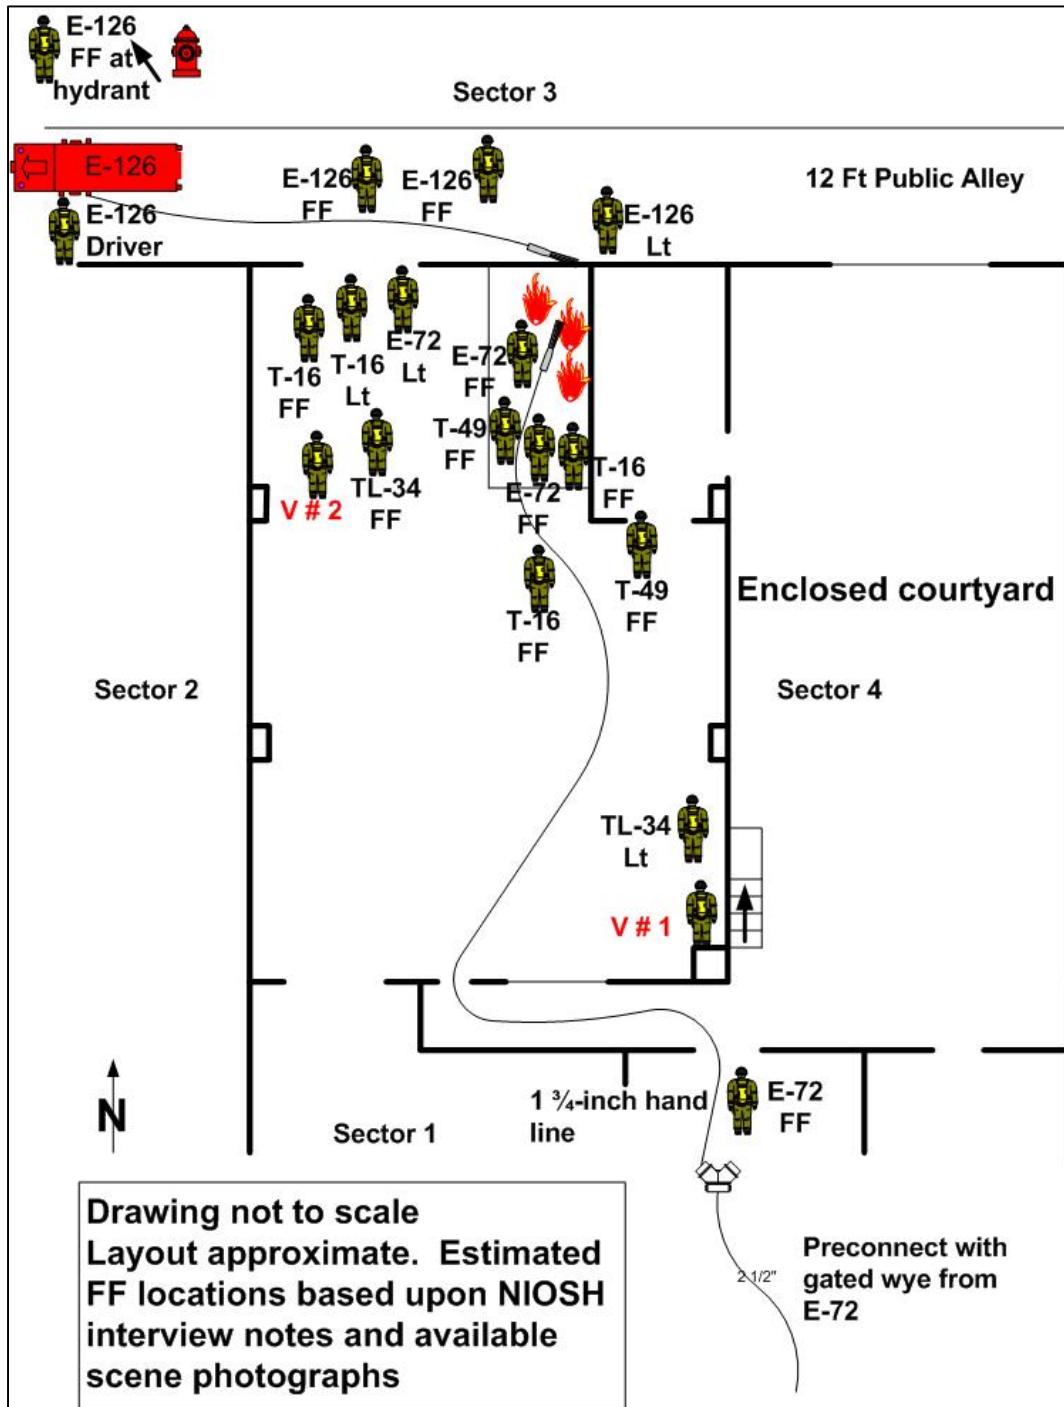
Diagram 3. Approximate location of the fire fighters inside structure and in alley at time of the roof collapse. Five fire fighters were also on the roof at the time of the collapse.
