Career Lieutenant Dies from Injuries Received after Vehicle Undergoing Maintenance Crushes Him – Massachusetts

Executive Summary

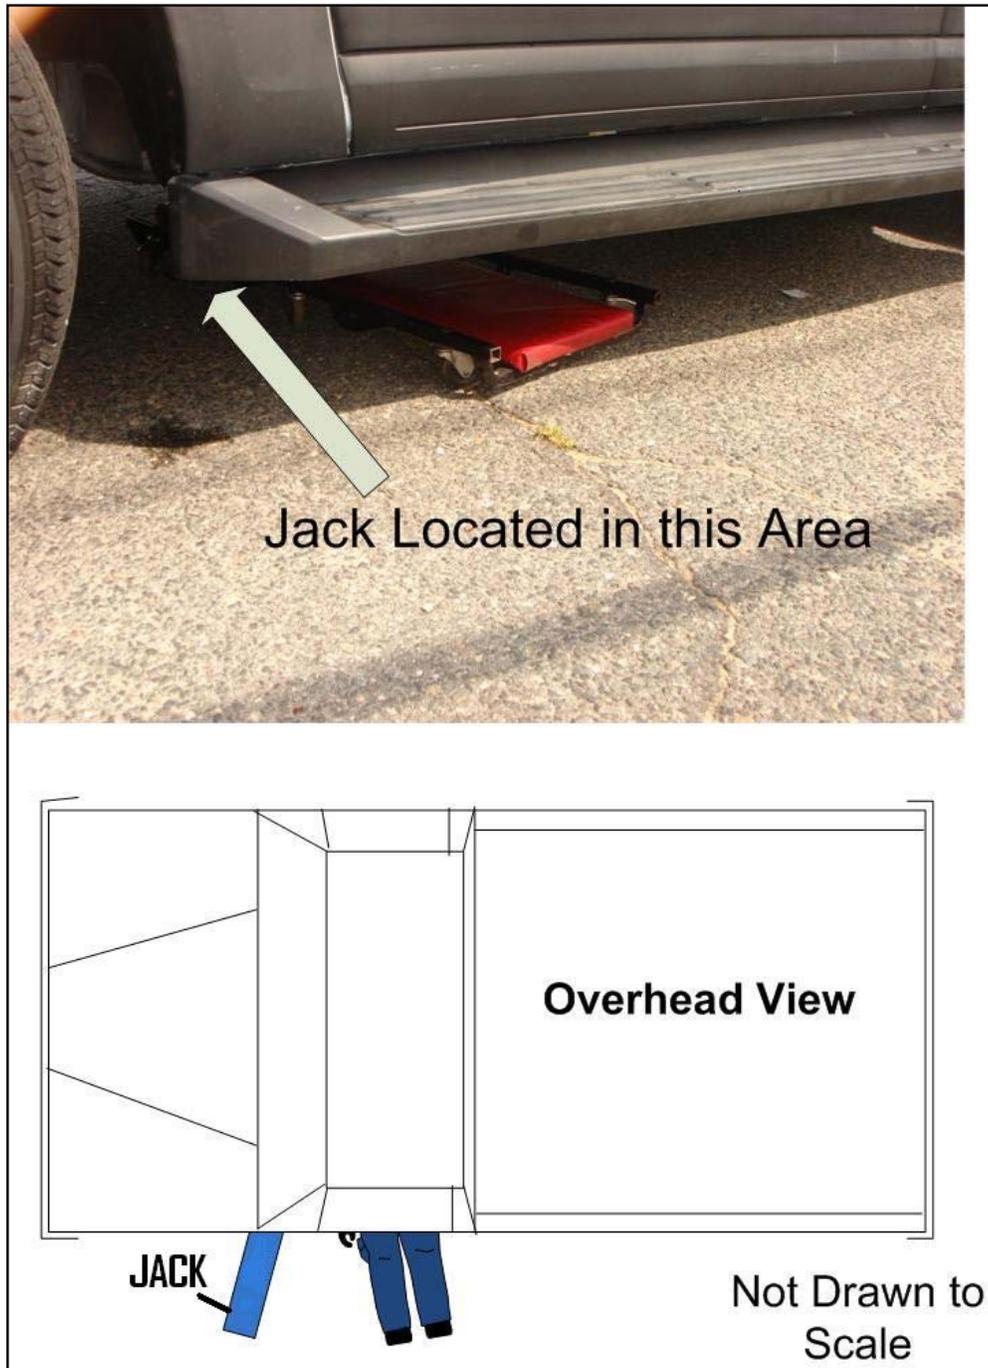
Diagram

when for an unknown reason, the jack lost pressure spraying hydraulic fluid over the pavement and lowering the jack to the ground (see Photo 6 and photo 7).
