## **Career Captain Injured in Aerial Ladder Collapse - Pennsylvania**

### **Executive Summary**

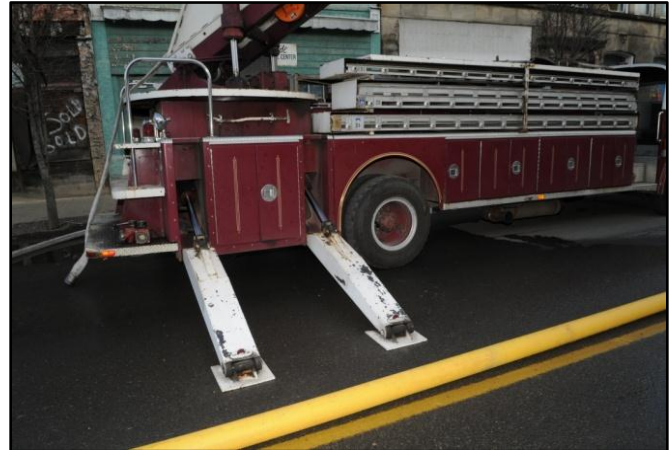
**Photo 2. Shows the two sets of hydraulic outriggers.**  
*(Courtesy of the Fire Department)*

The incident involved a 1975 custom fire apparatus with a 100-foot rear-mounted aerial ladder (see Photo 1). The aerial device was constructed of welded steel, assembled in four sections. The vehicle was stabilized by two sets of hydraulically controlled outriggers (see Photo 2). The aerial ladder movements of raise/lower, extend/retract and rotation were powered hydraulically and controlled from a pedestal located at the turntable (see Photo 3). The fire department did not have a manufacturer's operator manual for this apparatus for review during this investigation.

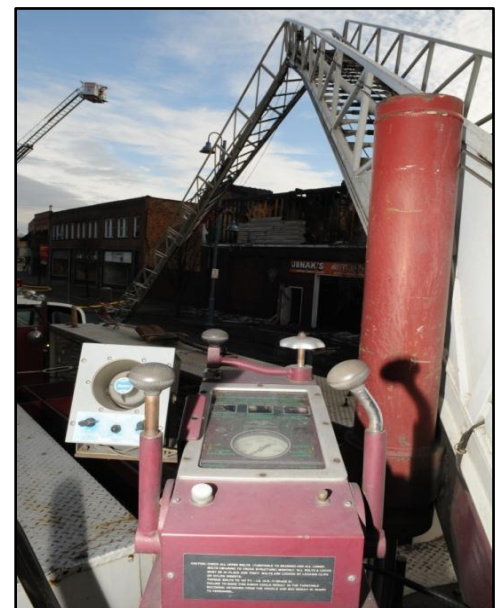
**Photo 3. Aerial ladder control pedestal**  
*(Courtesy of the Fire Department)*

The control pedestal has an indicating device consisting of three windows displaying a message relative to the safe operation of the aerial device (see Photo 4). From left to right, the displays indicated conditions for: Top End Supported, Water Tower Operation and Top End Unsupported.

In addition, there was a safety warning plate on the side of the turntable which states: "There is no hard and fast rule to cover fully the use of ladders. The common sense, experience and judgment of the men handling them must be depended upon."
