Two Career Lieutenants Killed and Two Career Fire Fighters Injured Following a Flashover at an Assembly Hall Fire—Texas

Executive Summary

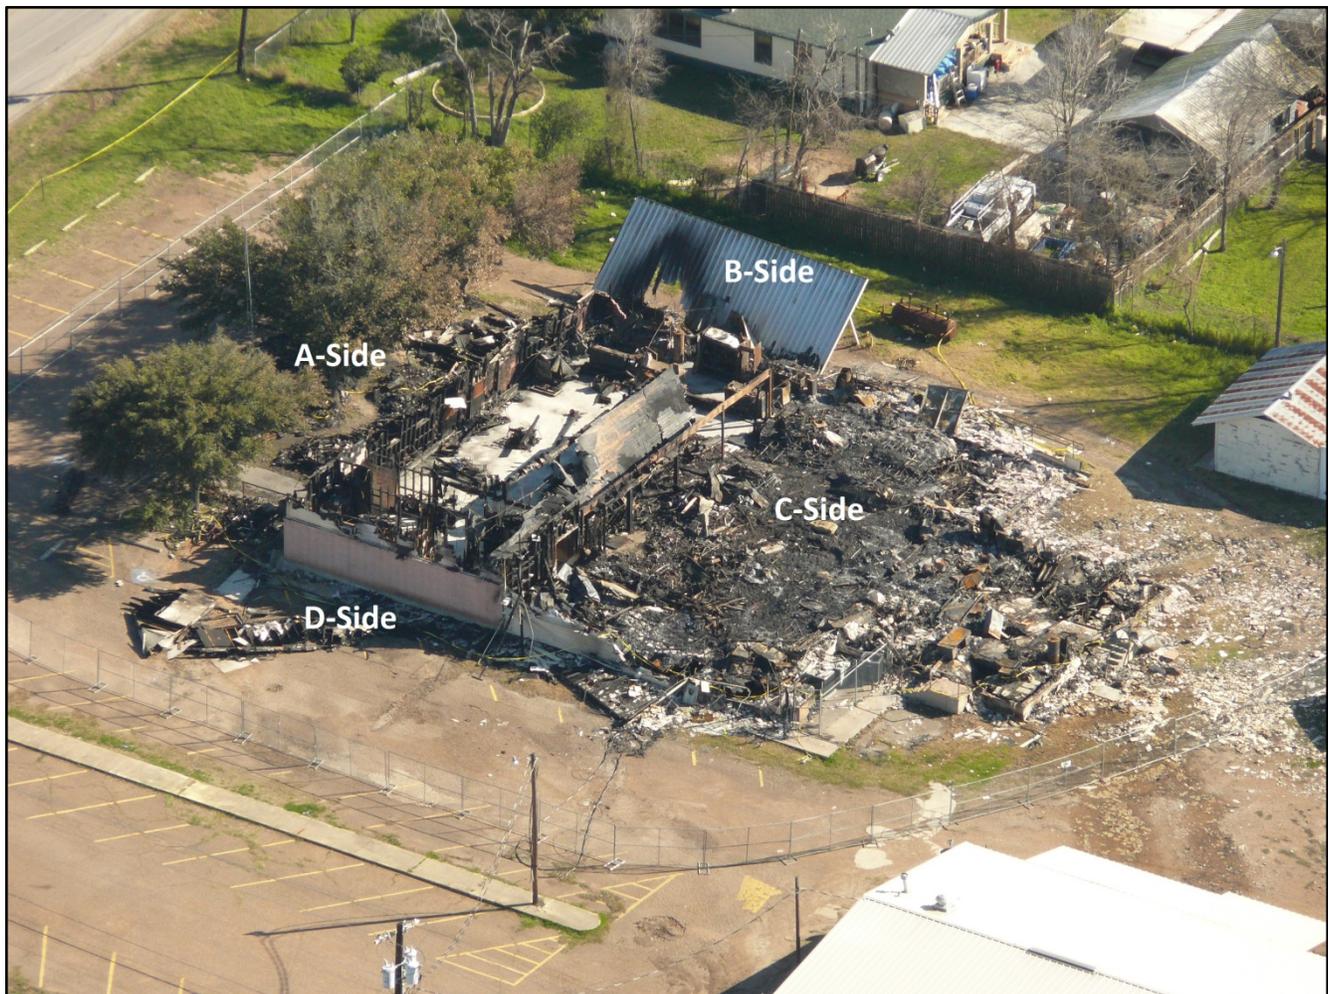
Photo 6. Looking toward the C/D corner, aerial photo of structure after being brought under control.

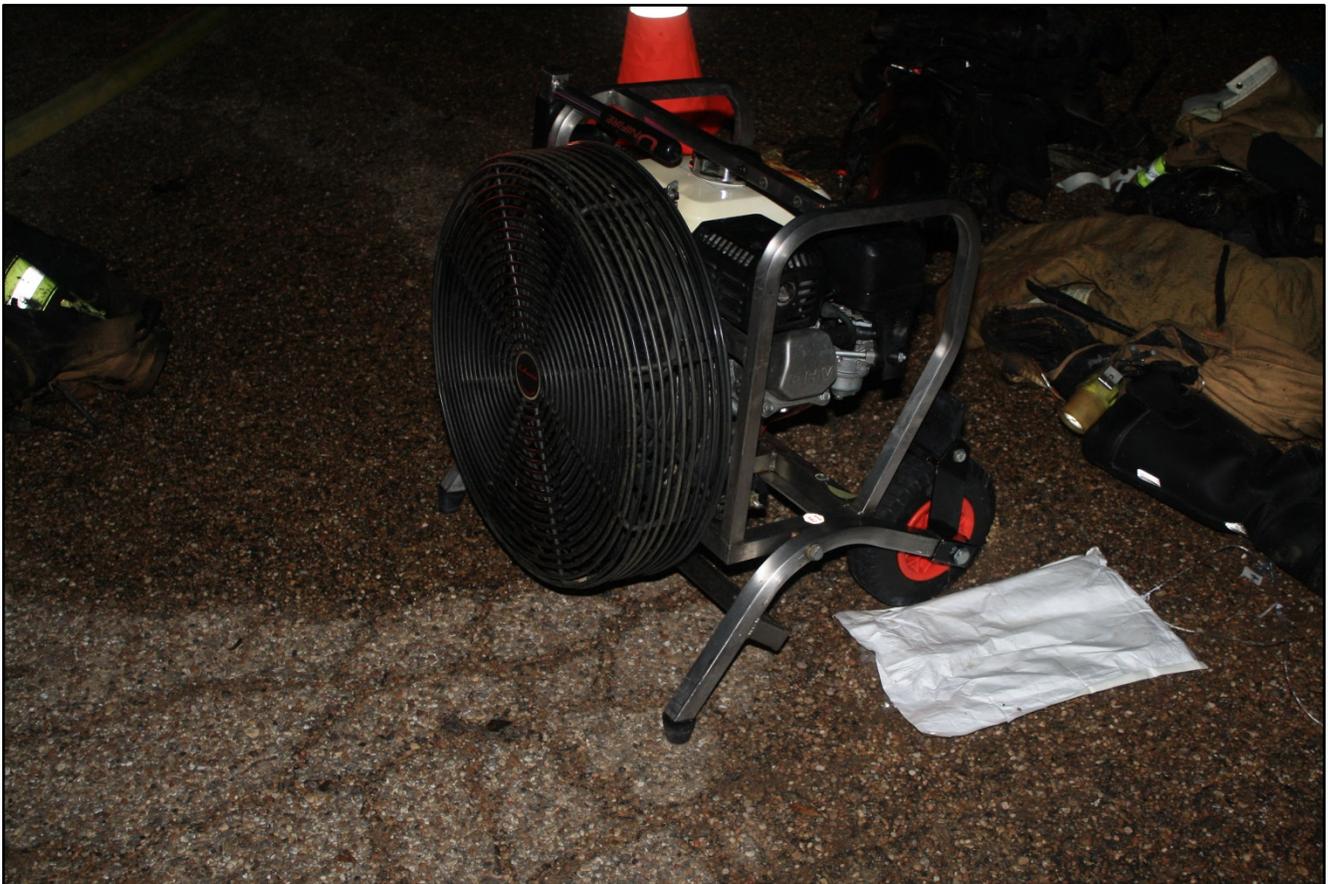
Photo 7. Photo of a PPV fan used during the incident.
(Photo courtesy of fire department.)

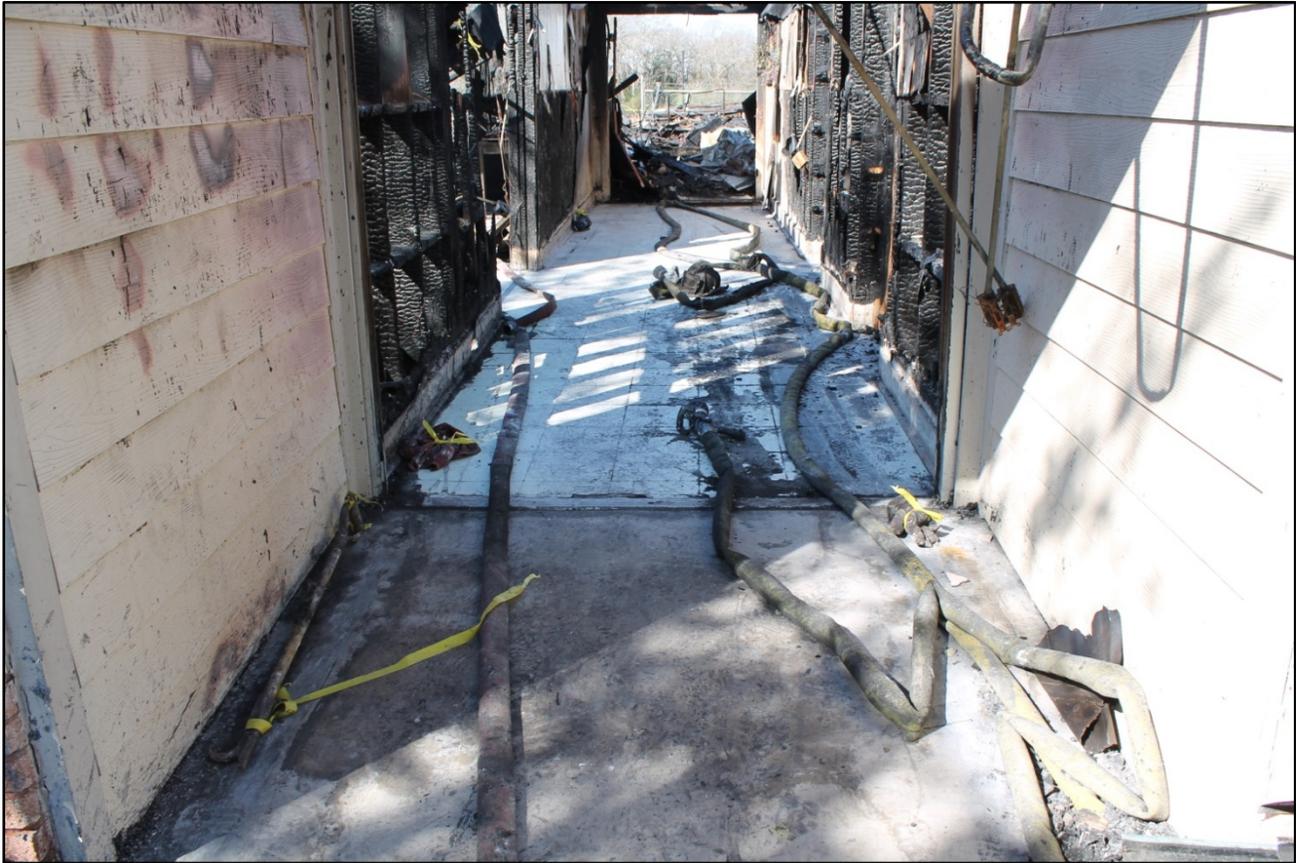
Photo 8. Shows vestibule and red hoseline on left leading into bingo hall. Yellow hoseline on right leads straight ahead into the dance hall. Photo taken after incident scene cleared of fire debris.

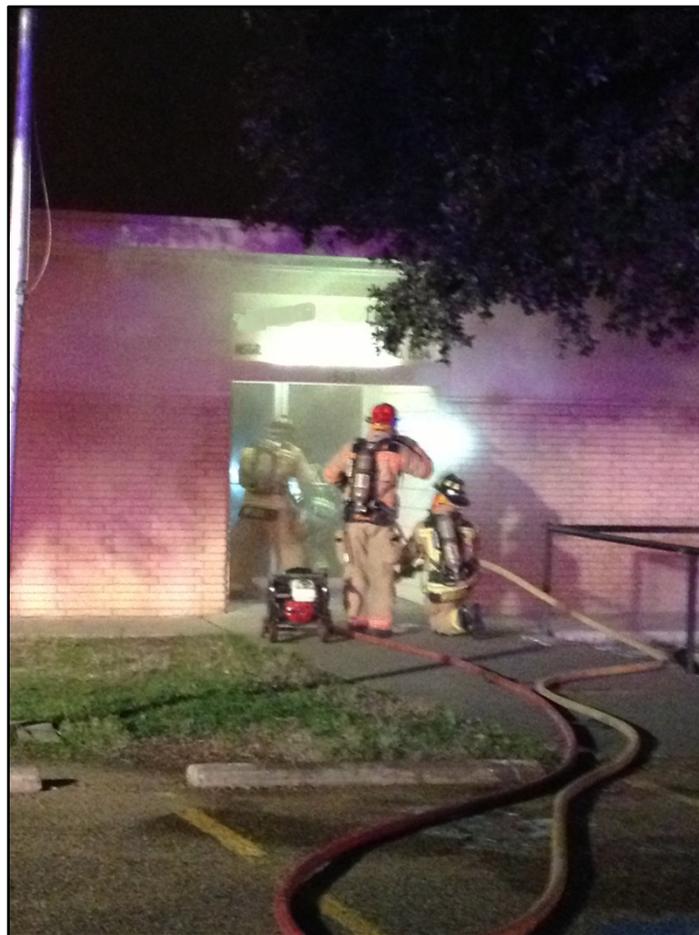
Photo 9. Looking toward the A-side entry door, red and yellow hoselines are stretched into the structure and a PPV fan is in position.
(Photo courtesy of law enforcement.)

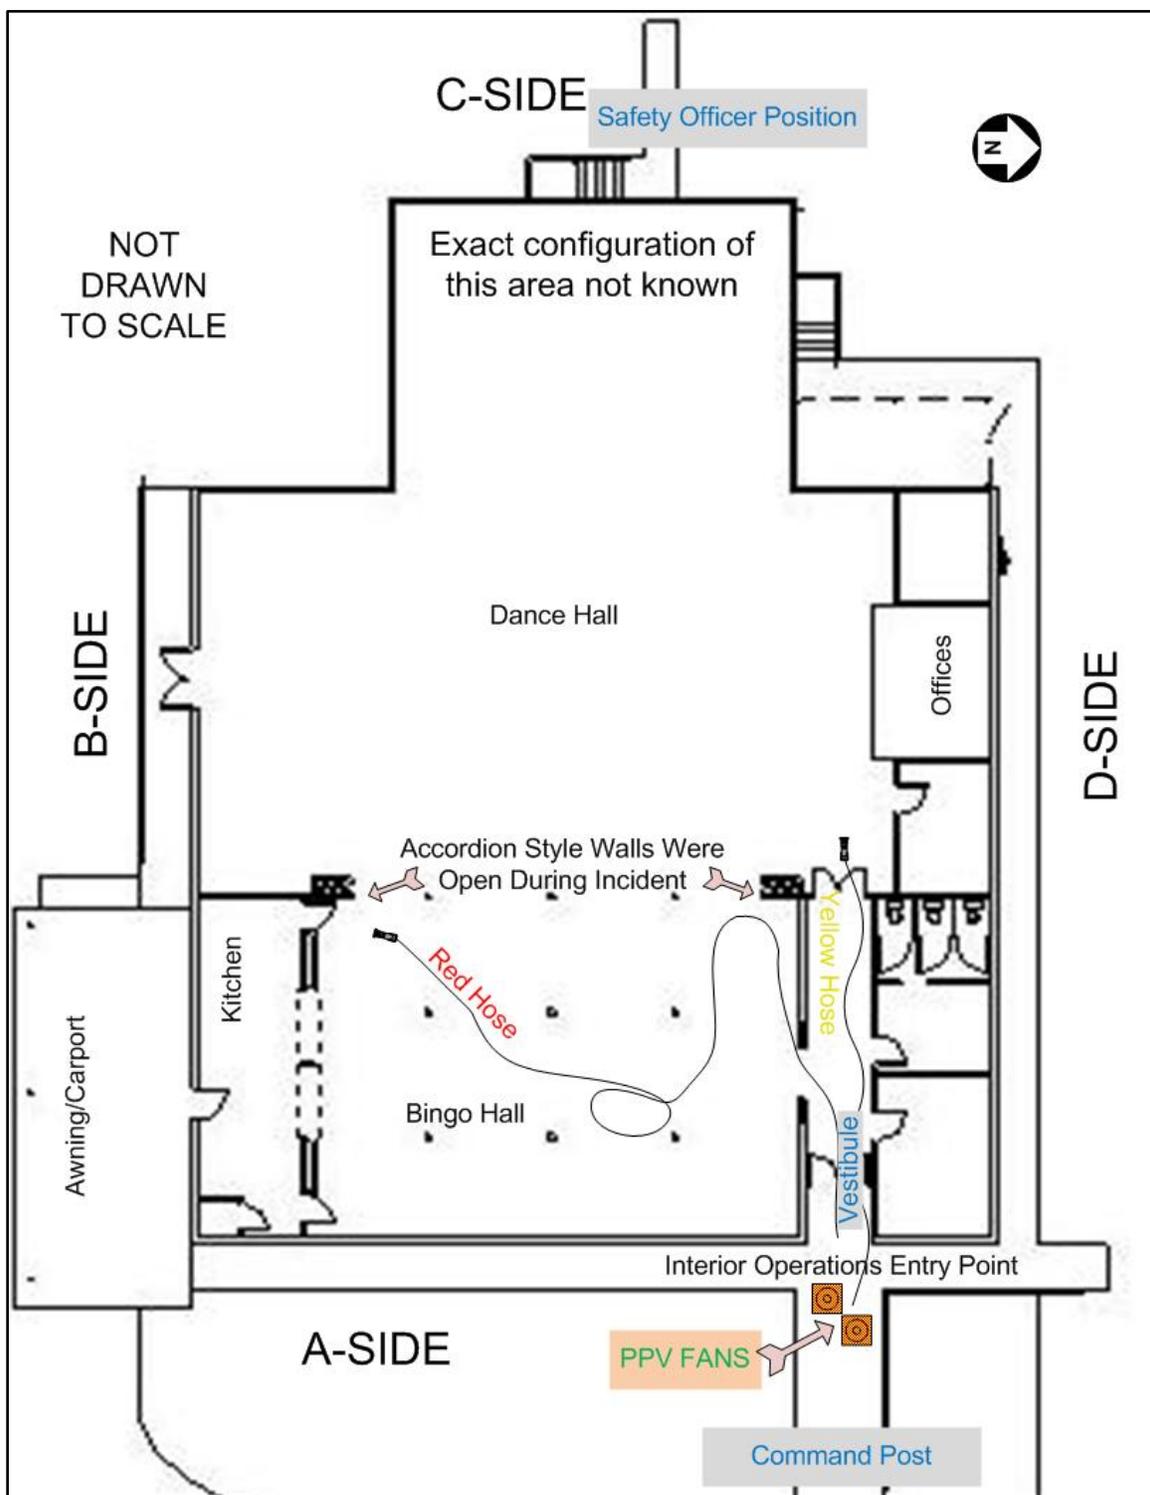
Diagram 2. Depicts layout of fireground when Victim #1 and his probationary fire fighter began to move toward the exit of the structure.

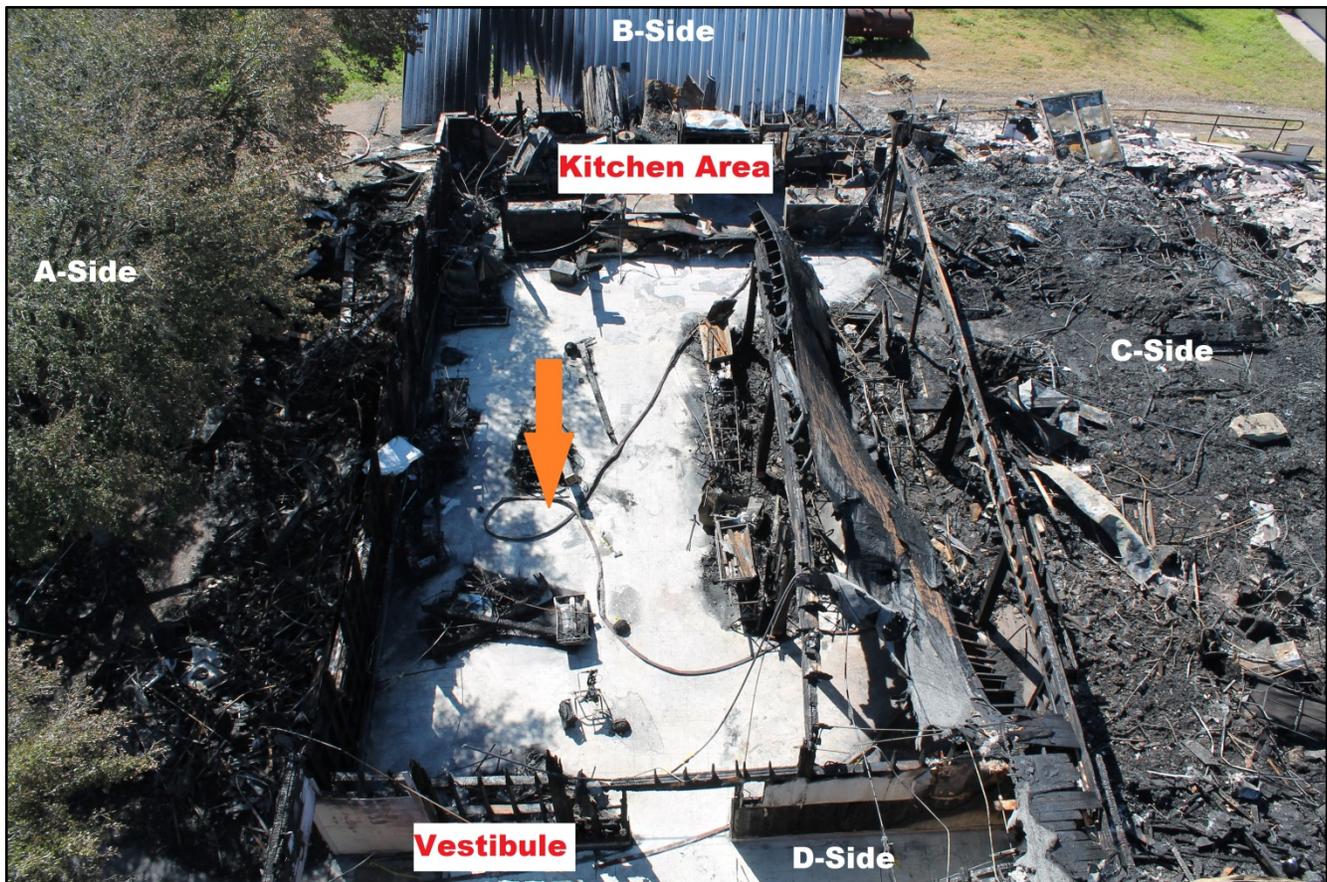
Photo 11. Aerial view of structure, after floor was cleared of fire debris, showing stretch of hoseline used by Victim #1 and his probationary fire fighter. Orange arrow shows location of loop in relationship to size of structure.
(Photo courtesy of state fire marshal.)
