Lieutenant and Fire Fighter Die and 13 Fire Fighters injured in a Wind-driven Fire in a Brownstone—Massachusetts

Executive Summary

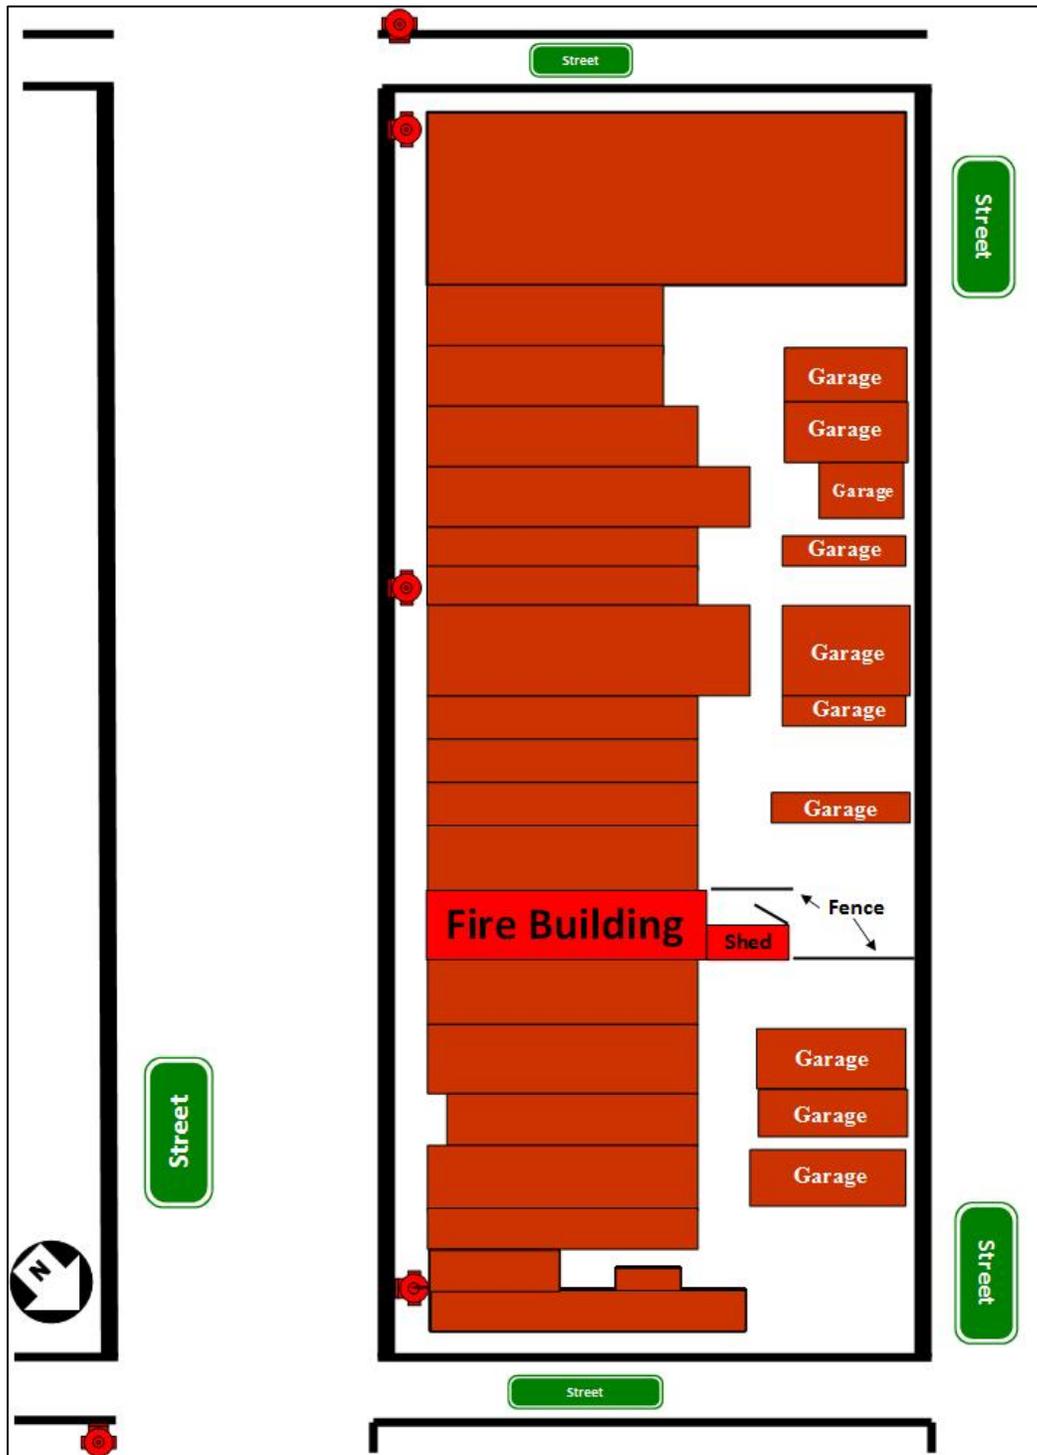
Diagram 3. The street diagram and location of the fire building.

The block where the fire occurred consisted of predominately brownstone buildings. In-fill structures abutted the buildings on either side of them, just as the original structures did. Parking was allowed on the street in front of the buildings. Parking was also allowed on a private, narrow street on the Charlie side of the building. As indicated in the diagram, several buildings had garages for tenant parking (See Diagram 3).
