Career Fire Apparatus Operator Dies after Falling Down an Unsecured Elevator Shaft at a 5-Story Residential Structure – Ohio

Executive Summary

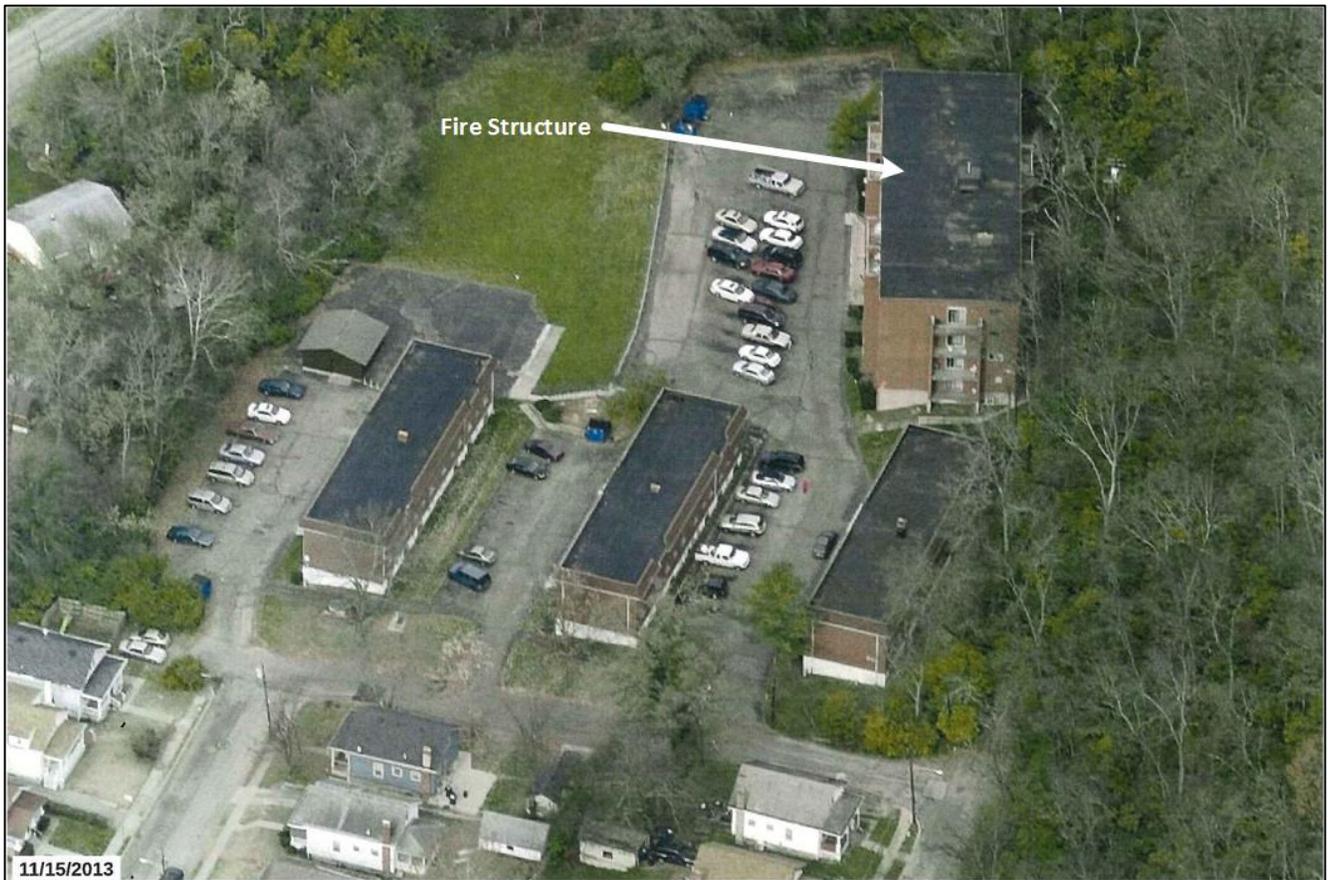
Photo 1. Overhead photo of incident scene.
(Photo courtesy of fire department.)

The structure involved in this incident was a five-story brick and concrete multi-family apartment building built in 1962. The 31,000 square-foot structure contained 38 separate apartments. The ground floor (Floor 1) contained offices, a mechanical room, storage space and six individual apartments. Floors 2 through 5 contained 8 apartments (both one and two bedroom) and a laundry room. Floors 2 through 5 had identical floor plans. A centrally-located hydraulic elevator provided access to floors 1 through 5. Two stairwells were located near the B/C and C/D corners. Both stairwells provided access to each floor and also ground-level exterior access (see Photo 1, Photo 2 and Diagram 1).

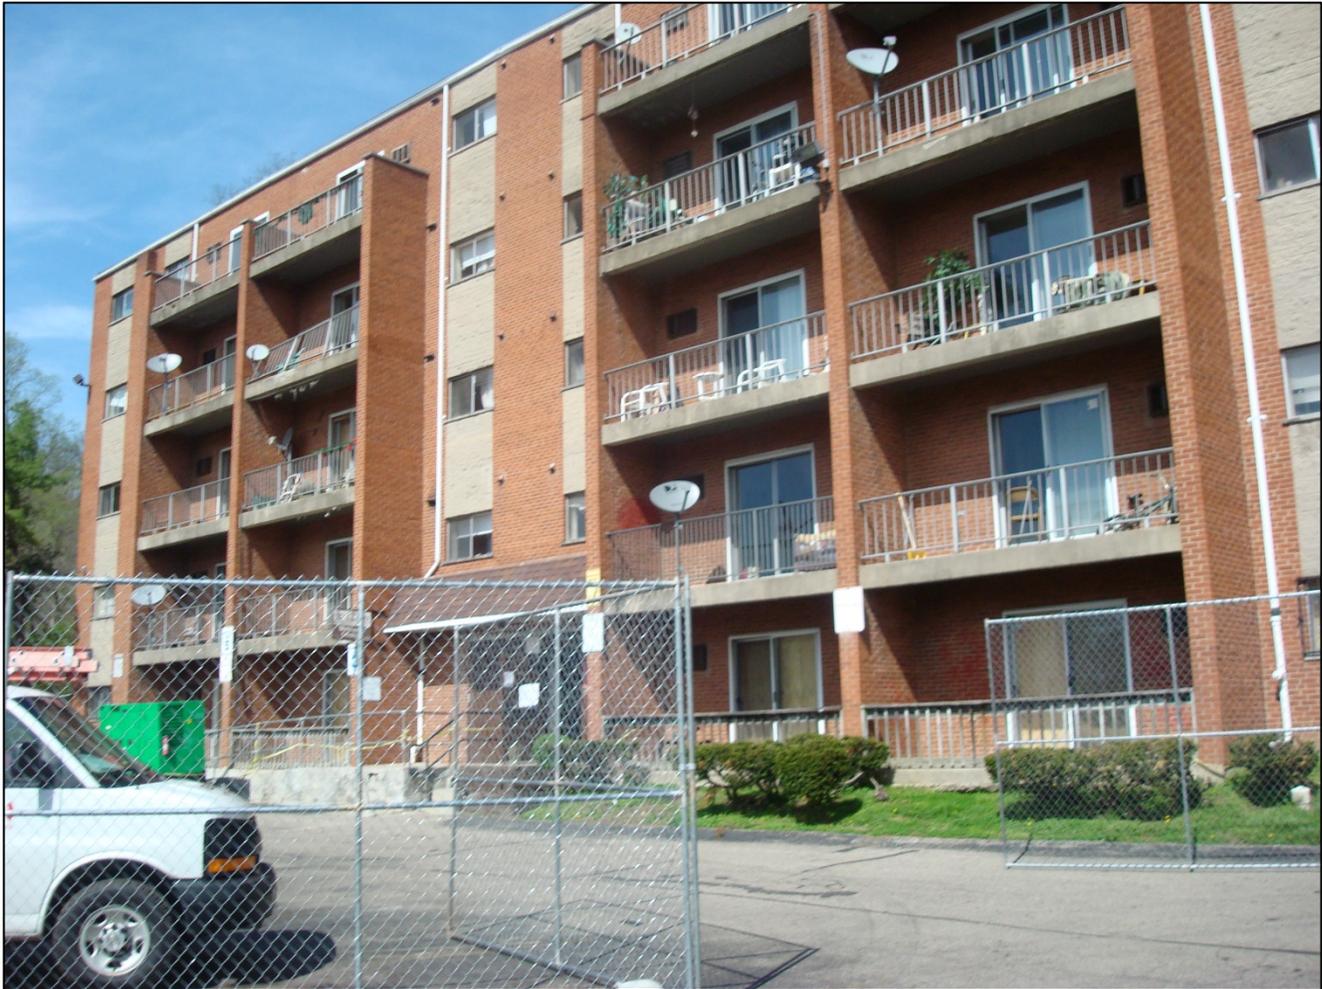
Photo 2. View of apartment Building D, Side A.
(Photo NIOSH.)

Due to the sloping hillside behind the building, the two apartments on Floor 2 on Side C had patios that were extended outward at ground level into the hillside (see Photo 2). The Side C rooms on Floor 1 were actually below grade.

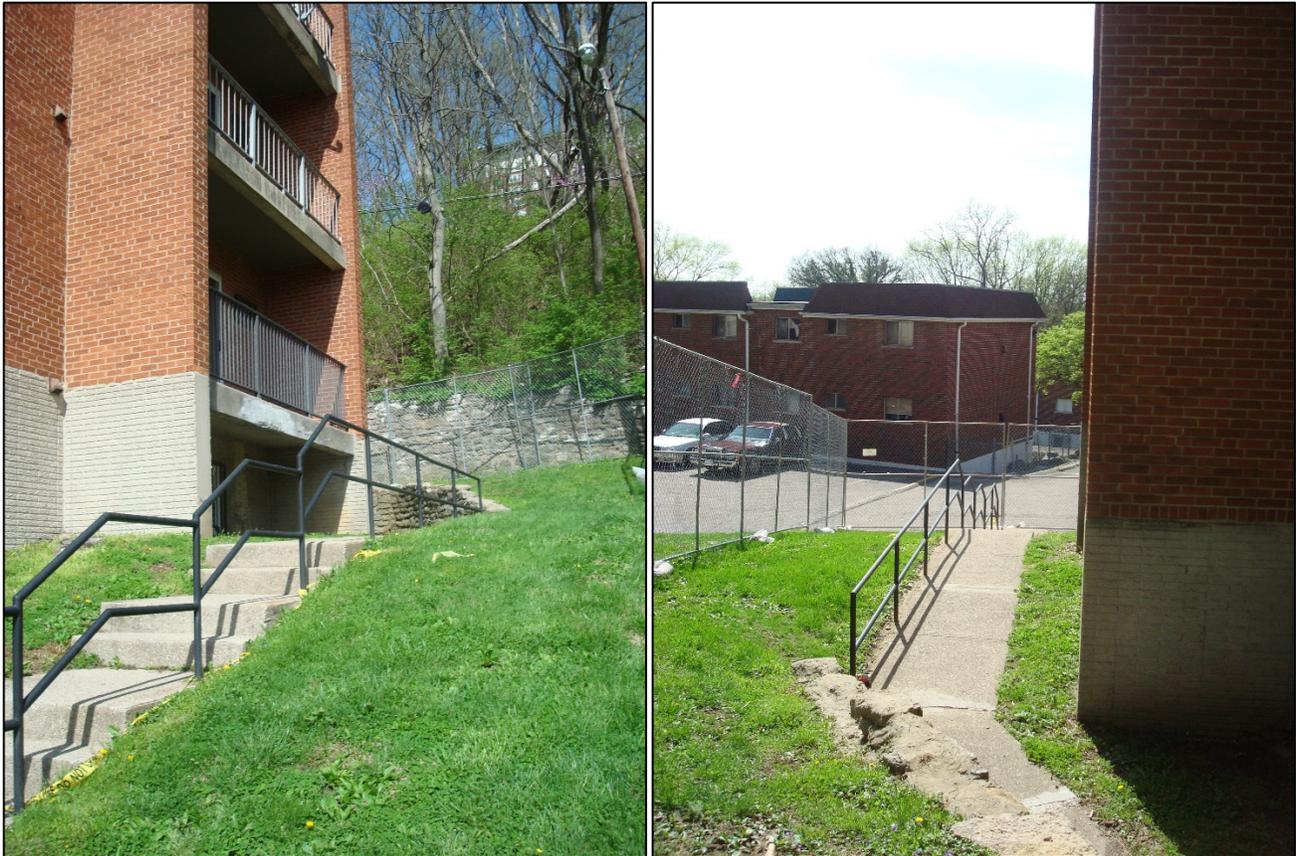
The incident commander (District Chief 4) assigned Engine 49 to pull a 1 ¾-inch preconnected crosslay to the second floor. The Engine 49 OIC pulled the crosslay off Engine 49 and pulled it around Side D to Side C (see Photo 3 and Photo 4) to reach the exterior stairwell exit door located on Side C near the C/D corner (see Photo 5 and Diagram 2). The Engine 49 FAO helped flake out the hose while the Engine 49 fire fighter 2 walked from the hydrant approximately 2 blocks away to catch up with the crew. The Engine 49 OIC pulled the uncharged hoseline up the C/D stairway and started to advance down the hallway. The Engine 49 OIC observed dense dark smoke and felt heat as he advanced but couldn't see any fire. He advanced the hose as far as he could but was short of the fire apartment because the hoseline had snagged on the stair treads between the ground level and second-floor landing (see Photo 6). He heard the Heavy Rescue 9 crew coming down the hallway from Side B toward him. The incident commander directed Engine 31 to take in a second hose line. At approximately 0551 hours, the Engine 49 OIC radioed for the hoseline to be charged as the Engine 49 fire fighter 2 was following the hoseline into the second floor hallway to meet him. When the hoseline was charged, the pressure in the hoseline knocked the Engine 49 fire fighter 2 off balance and dislodged her facepiece. As the Engine 49 OIC moved to assist the Engine 49 fire fighter 2, the conditions in the hallway rapidly deteriorated as the fire and heat intensified. The Engine 49 OIC felt his hands burning through his gloves and told the Engine 49 fire fighter 2 that they had to get out of the building. They followed the hoseline outside and returned to Engine 49 where medics treated the Engine 49 OIC for burns and prepared to transport him to a local hospital.

Photo 3 and Photo 4. Photos show the route the Engine 49 crew used to advance the initial attack hoseline along Side D to Side C to access the stairwell door on Side C.
(NIOSH Photos).

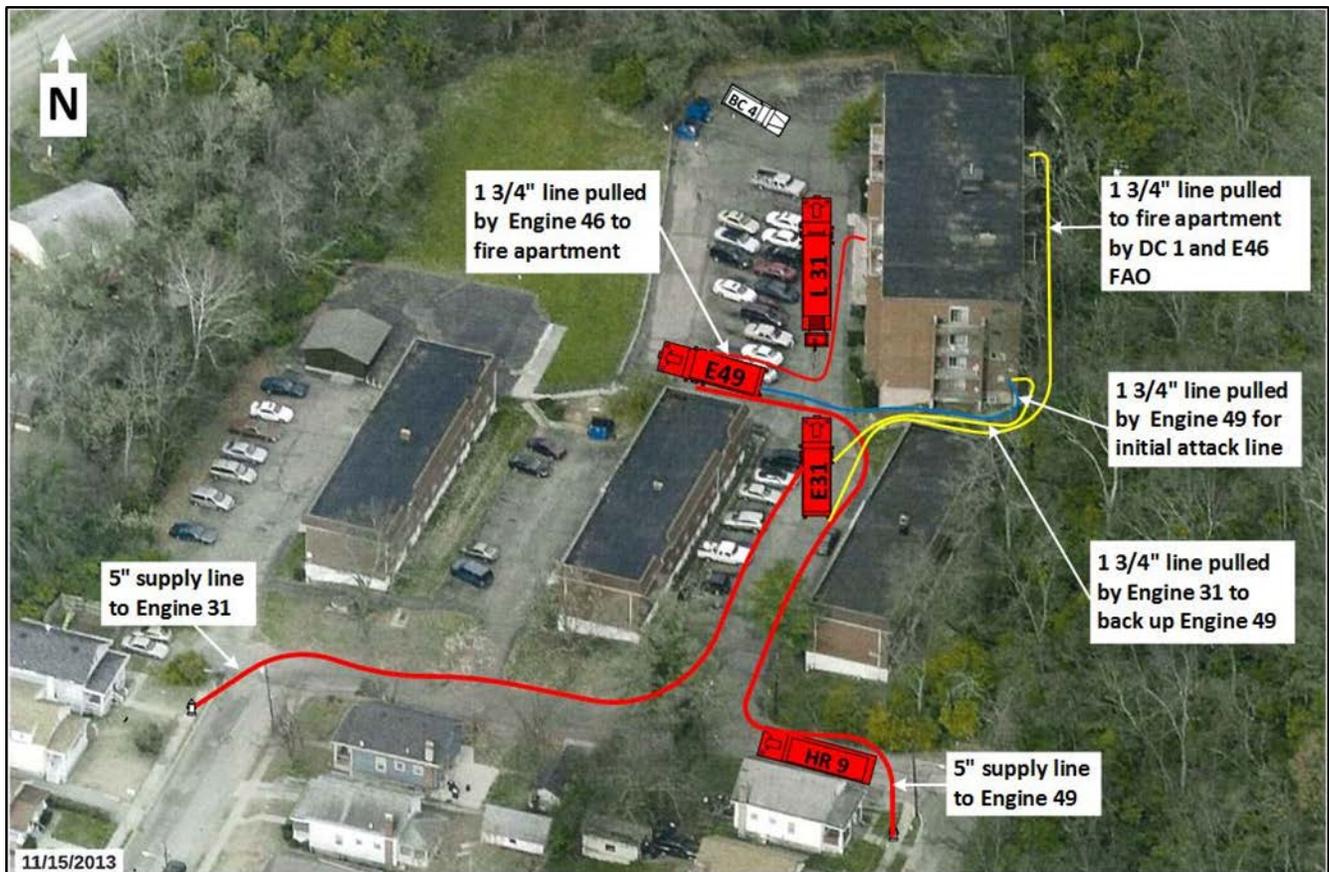
Diagram 2. Apparatus placement and hoseline deployment of the initial responding companies. Locations are approximate and not all responding companies are shown. (Adapted from photograph provided by fire department.)

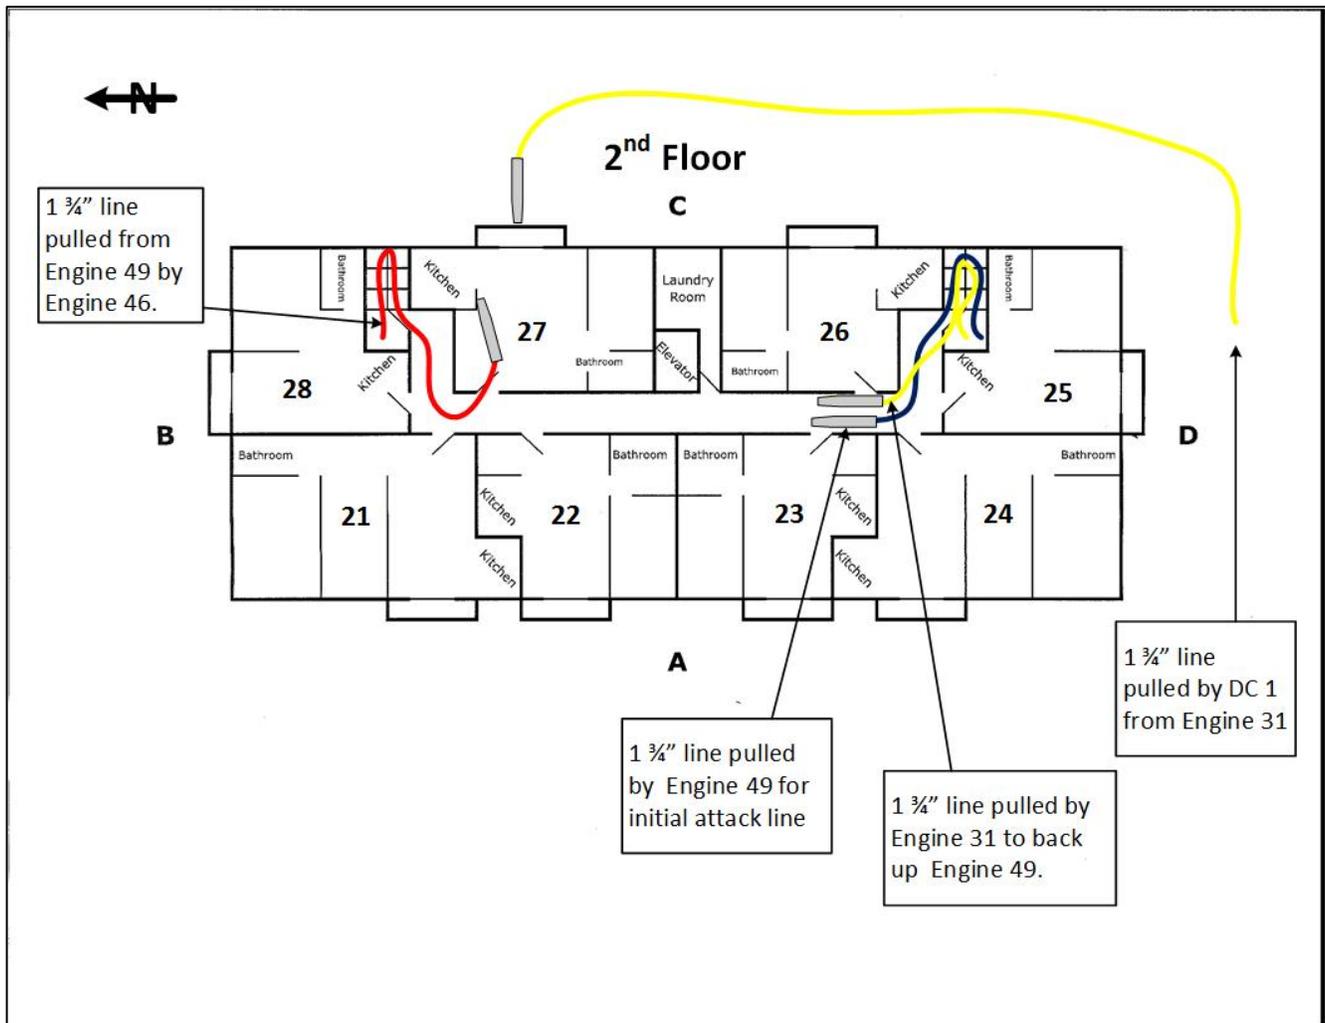
Diagram 3. Location and sizes of hoselines pulled to attack fire in Apartment 27.
(Source NIOSH: Adapted from floorplan provided by fire department.)

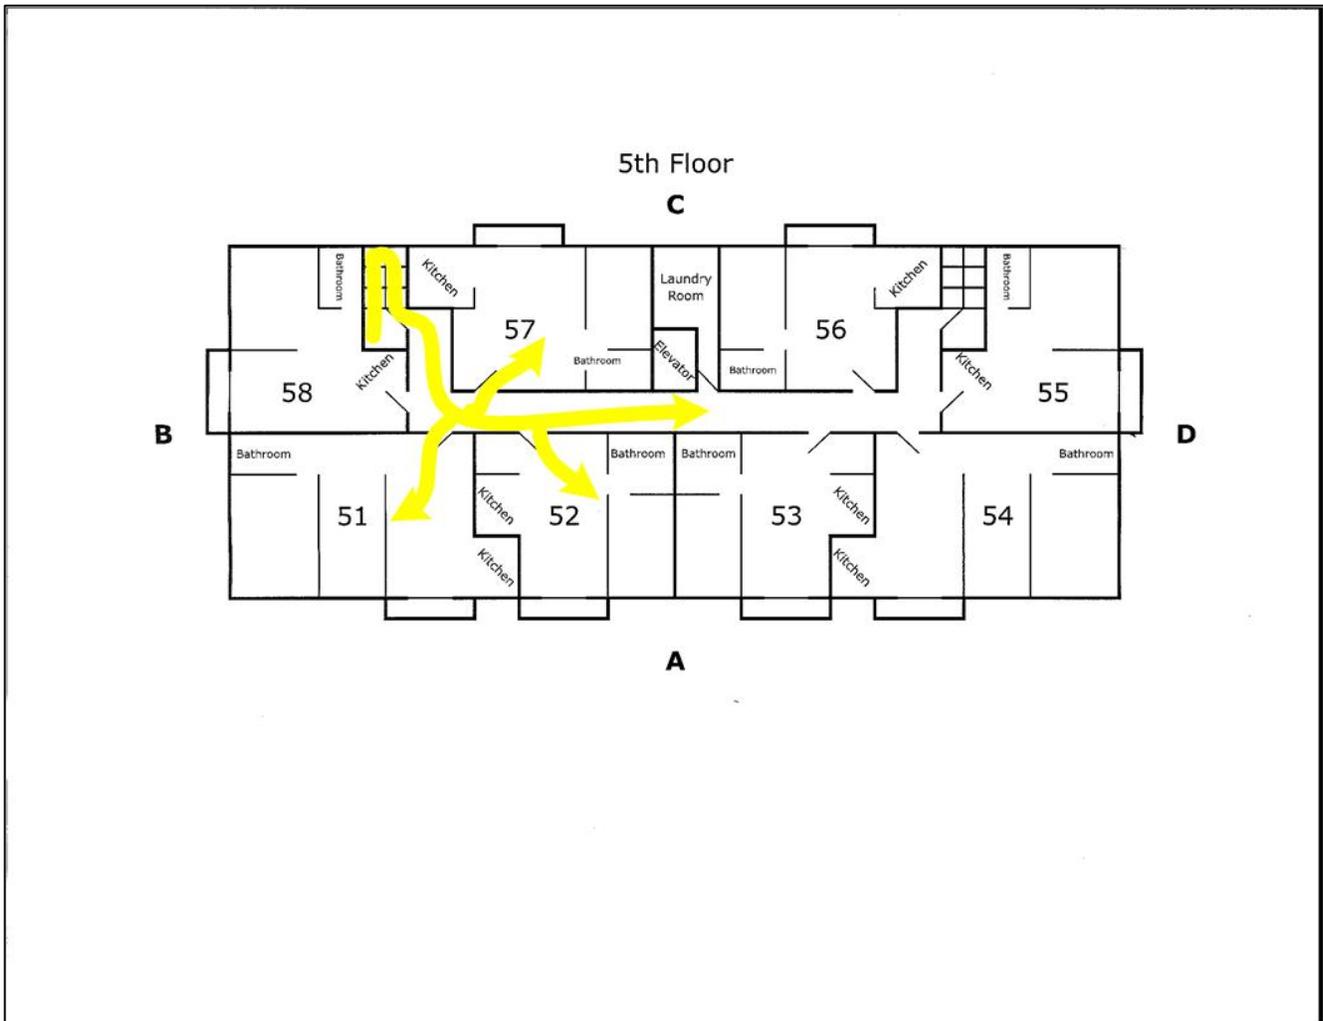
The Heavy Rescue 14 OIC, fire fighter 1 and fire fighter 2 met in the hallway after searching Apartments 51 and 57. The Heavy Rescue 14 OIC and fire fighter 1 entered Apartment 52 while Heavy Rescue 14 fire fighter 2 advanced down the hallway to the next door on the left (see Diagram 4). Heavy Rescue 14 fire fighter 2 observed that this door was different than the previous apartment doors he had entered. He pulled on the door handle and the door opened easily. Heavy Rescue 14 fire fighter 2 thought that something didn't seem right so he knelt down in the hallway and sounded the floor inside the door. He quickly realized that the door led to an open shaft. The Heavy Rescue 14 OIC and fire fighter 1 came out of Apartment 52 and met the Heavy Rescue 14 fire fighter 2. They discussed the open shaft. District Chief 3 (the Search and Rescue Operations Chief) met the Heavy Rescue 14 crew in front of the elevator door. The Heavy Rescue 14 fire fighter 2 used a permanent marker to write "**Do Not Enter. Open Shaft**" on the elevator door (see photo 8). The Heavy Rescue 14 FAO was not with the rest of the HR14 crew at this time.

Diagram 4. Route followed by the Heavy Rescue 14 crew as it advanced up the B/C stairwell to the fifth floor. The Heavy Rescue 14 officer-in-charge and fire fighter 2 searched Apartment 57 while Heavy Rescue 14 fire fighter 1 searched Apartment 51. They regrouped in the hallway and the Heavy Rescue 14 OIC and fire fighter 1 searched Apartment 52 while Heavy Rescue 14 fire fighter 2 proceeded down the hall and discovered the elevator hoistway door could be easily opened. The location of the Heavy Rescue 14 FAO was unknown during this time.
(Source NIOSH: Diagram adapted from floorplan provided by fire department.)
