A report from the NIOSH Fire Fighter Fatality Investigation and Prevention Program

January 23, 2017

Career Fire Fighter/Engineer Dies After Falling Through Translucent Corrugated Roof Panel While Searching for Fire Extension—Colorado

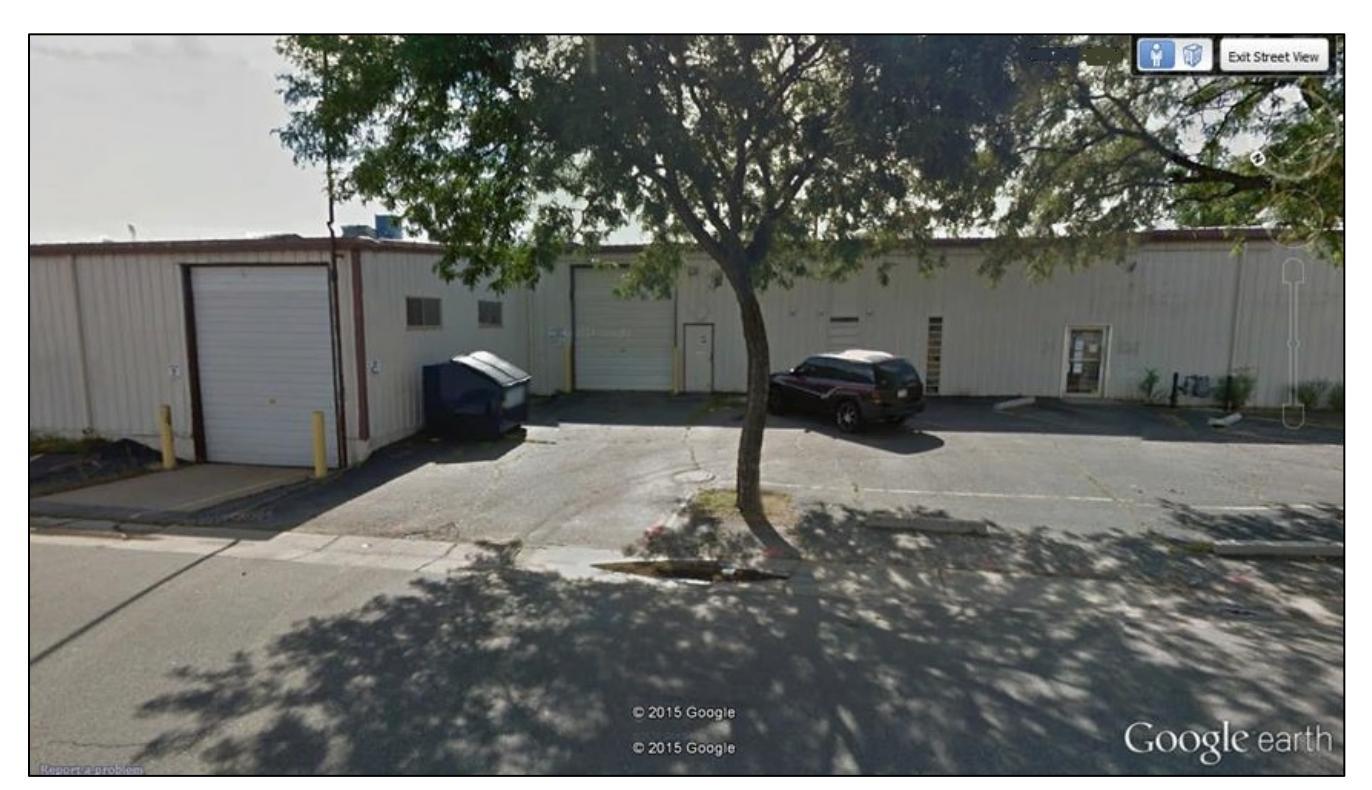
Photo 2. Street-level view of the structure facing Side Alpha. Google Earth photo taken prior to the incident date. (Source: Google Earth.)

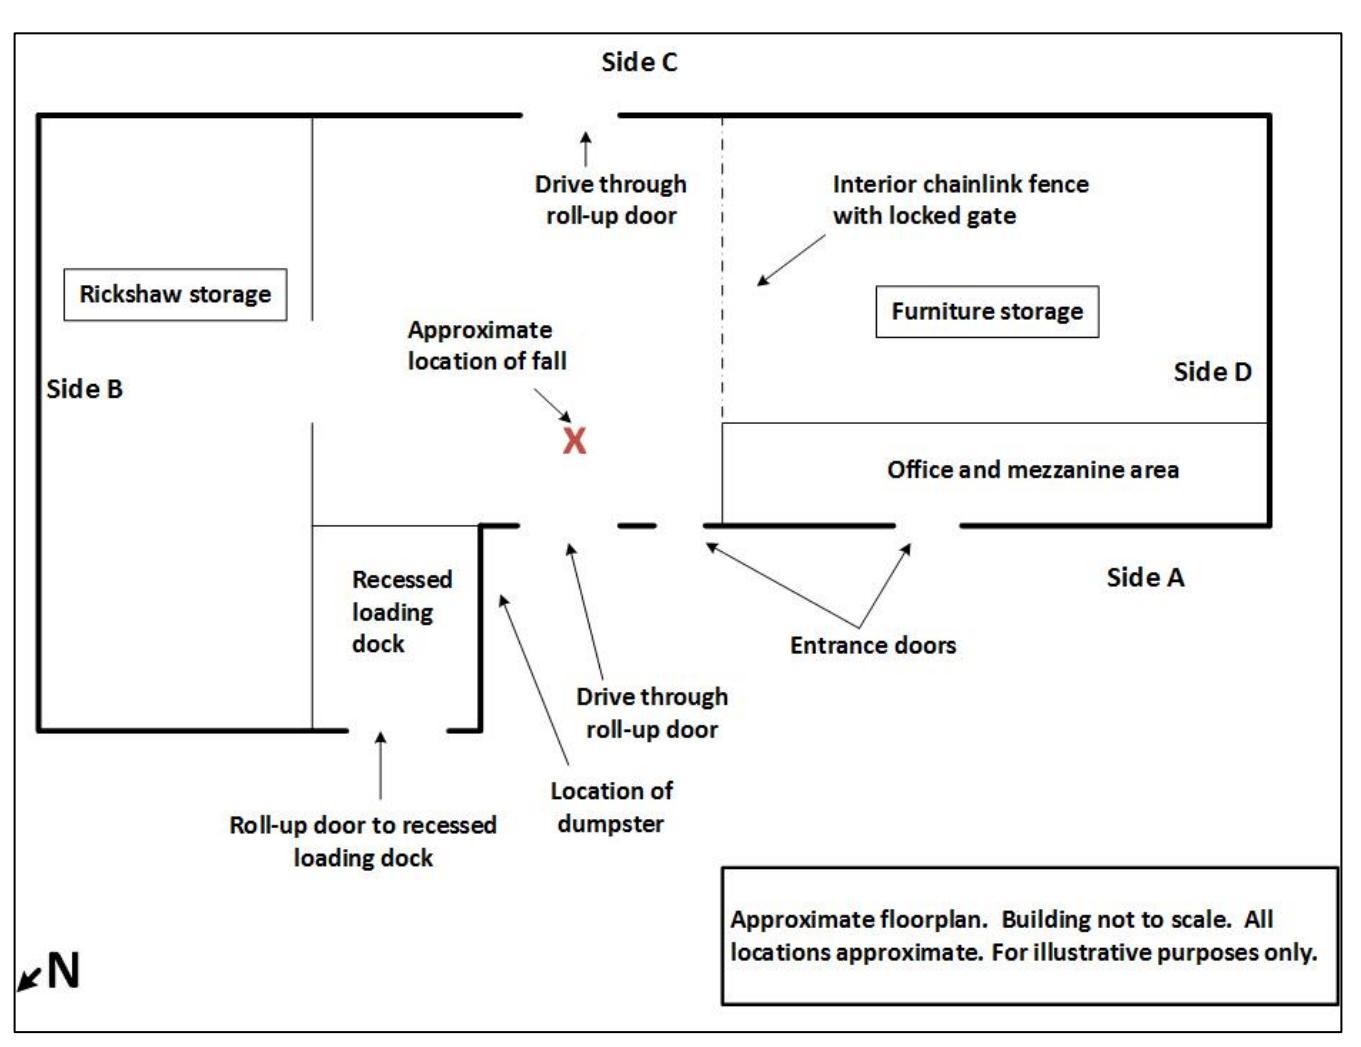
The building consisted of two sections that were joined perpendicular to one another to form an "L" shape (see Photo 1, Photo 2, and Diagram 1). The symmetrical, clear-span, rigid-frame building was constructed on a concrete slab foundation. The walls were constructed using corrugated steel sheets. The roof was a gable style with a 2:30 (6%) pitch (see Photo 3). The main portion of the building was estimated to be approximately 20 feet in height, 300 feet in length, and 60 feet in width. NIOSH investigators and fire department officials measured the point of the fall and determined that the Truck 8 engineer fell 17 feet 4 inches from the broken roof panel to the concrete floor inside the building.

Diagram 1. Approximate floorplan of building interior. (Diagram source: NIOSH.)

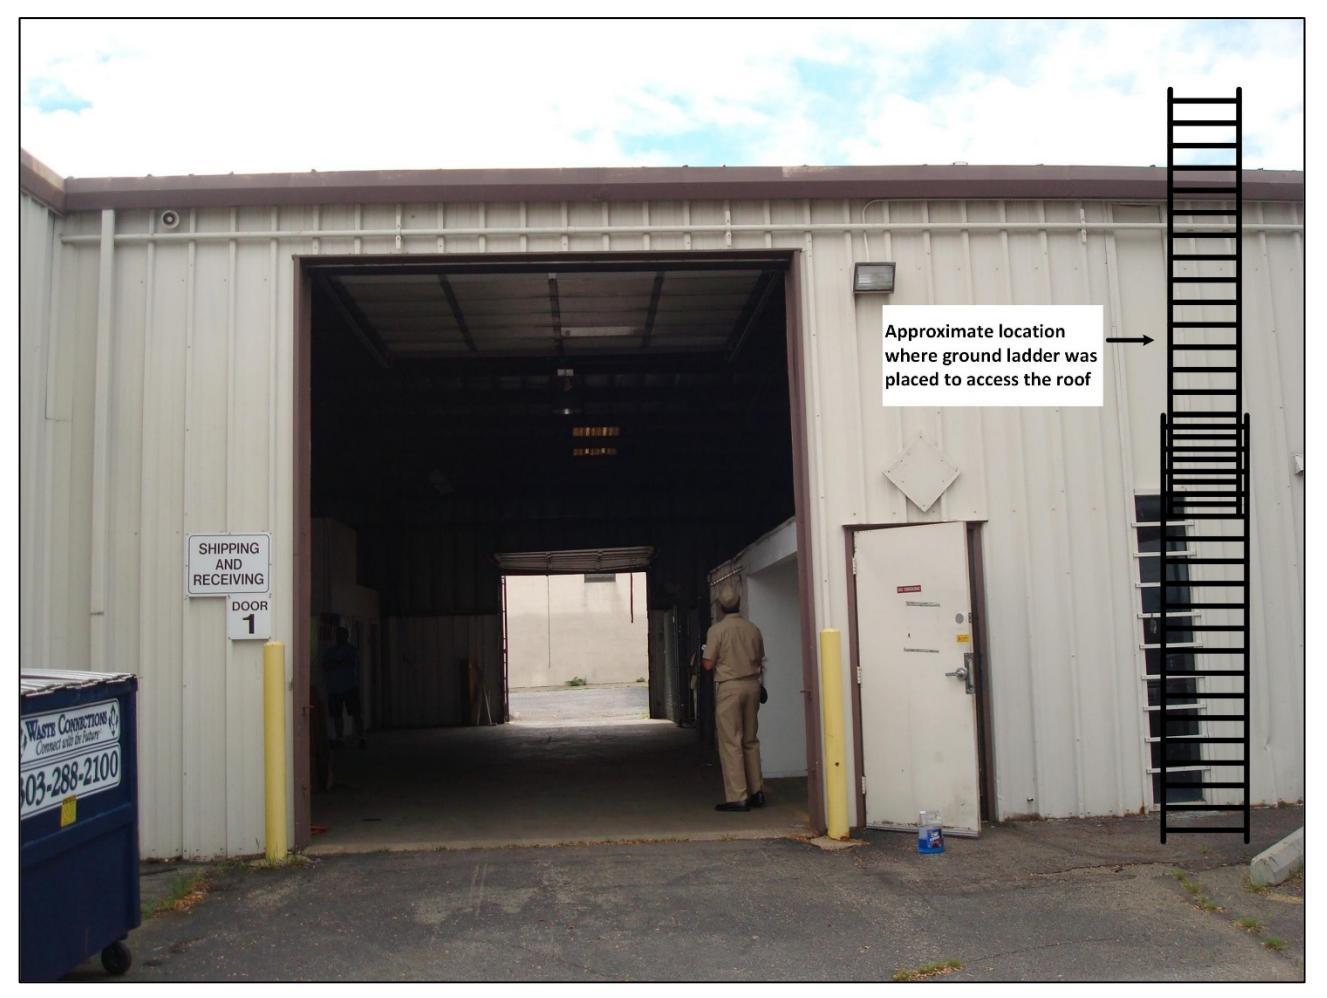
Photo 6. Approximate location where ground ladder was placed to access roof. (*Photo source: NIOSH.*)

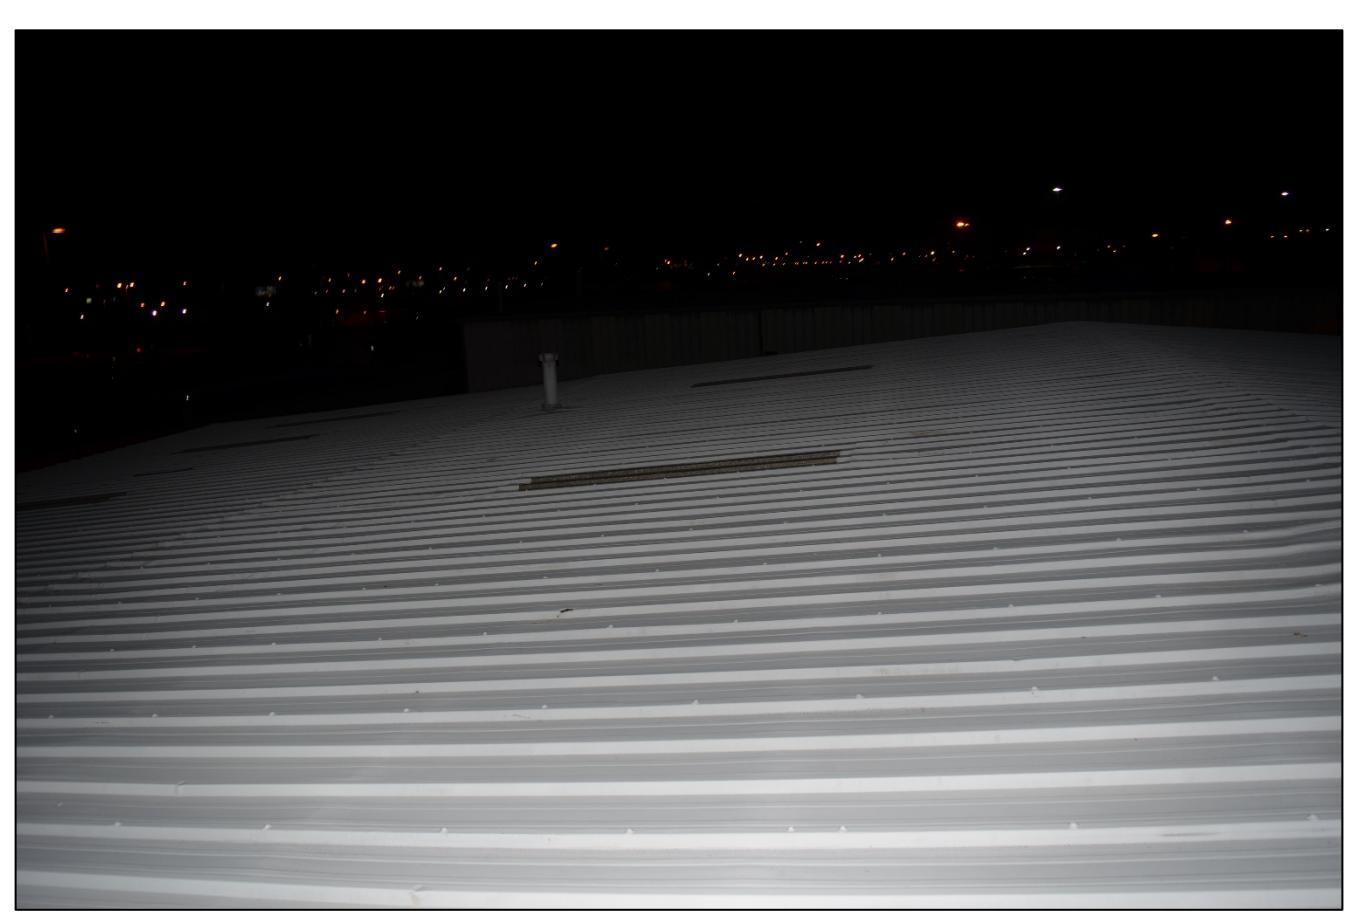
It was reported that when the engine companies arrived at the fire building, it was dark outside (time approximately 2134 hours). Upon arrival, Engine 9 turned on their spotlights, elevating them approximately 12 feet off the ground. Many fire fighters reported that the lighting was poor to adequate, indicating the primary sources of light outside of the building were from surrounding streetlights and lights from the emergency response personnel. Because it was after typical working hours, it was also reported that most of the lights inside the building were off as well. Fire fighters reported that at night while standing on the roof, it was very difficult to differentiate the translucent roof panels from the corrugated sheet metal roof. NIOSH investigators examined the roof and confirmed this finding during their site visit (see Photo 9 and Photo 10). The translucent roof panels were flush with the roof and lacked any identifiers, aside from a slight color difference visible only during daylight hours. The fire department reported that a few days after this incident, images taken using a thermal imager at approximately 2200 hours showed a distinct heat difference between the roof material and the panels. However, whether a heat difference between the panel and the roof material could have been seen in the evening/early morning hours, or in winter months, is unclear.

Photo 9. Photo of roof taken during NIOSH investigation at approximately the same time that the incident occurred. In this photo, the roof is illuminated by lights on the fire department's tower ladder. (Photo source: NIOSH.)

Recommendation #1: Fire departments should ensure that all fire fighters, company officers, and chief officers are aware of and trained to recognize translucent corrugated roof panels and the fall hazard these panels present.
