## Two Fire Fighters Die and Two Fire Fighters are Injured at Multi-occupancy Fire with Structural Collapse—Missouri

### Executive Summary

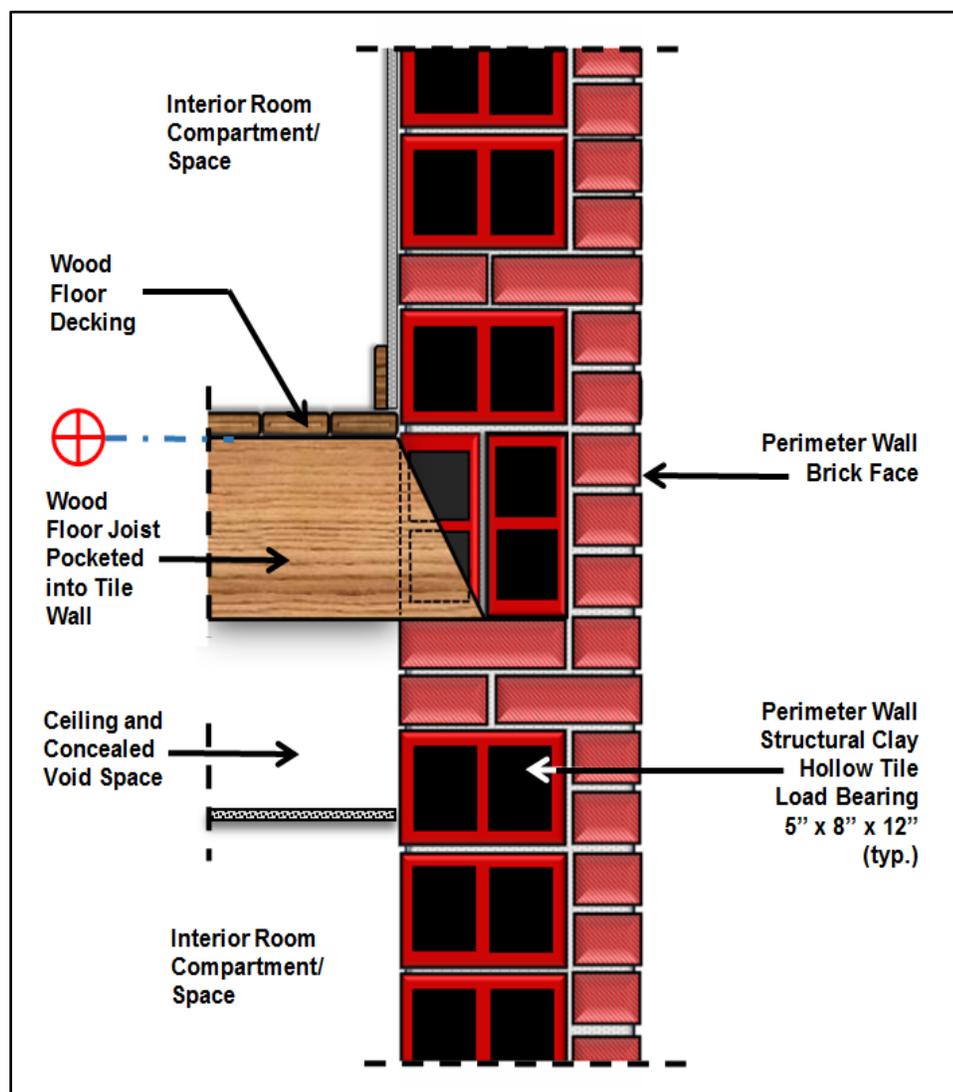
- **Side Bravo.** The Side Bravo wall was shared on the 1<sup>st</sup> floor with an additional building (financial loans). This building was not part of this report. The Side Bravo wall was masonry bearing, hollow clay block with unreinforced construction with full-face brick veneer construction (See **Diagram 4**).

**Diagram 4.** Typical masonry perimeter wall with clay hollow tile and floor joist.  
(Graphic courtesy of *Buildingsonfire.com* / C.J. Naum.)

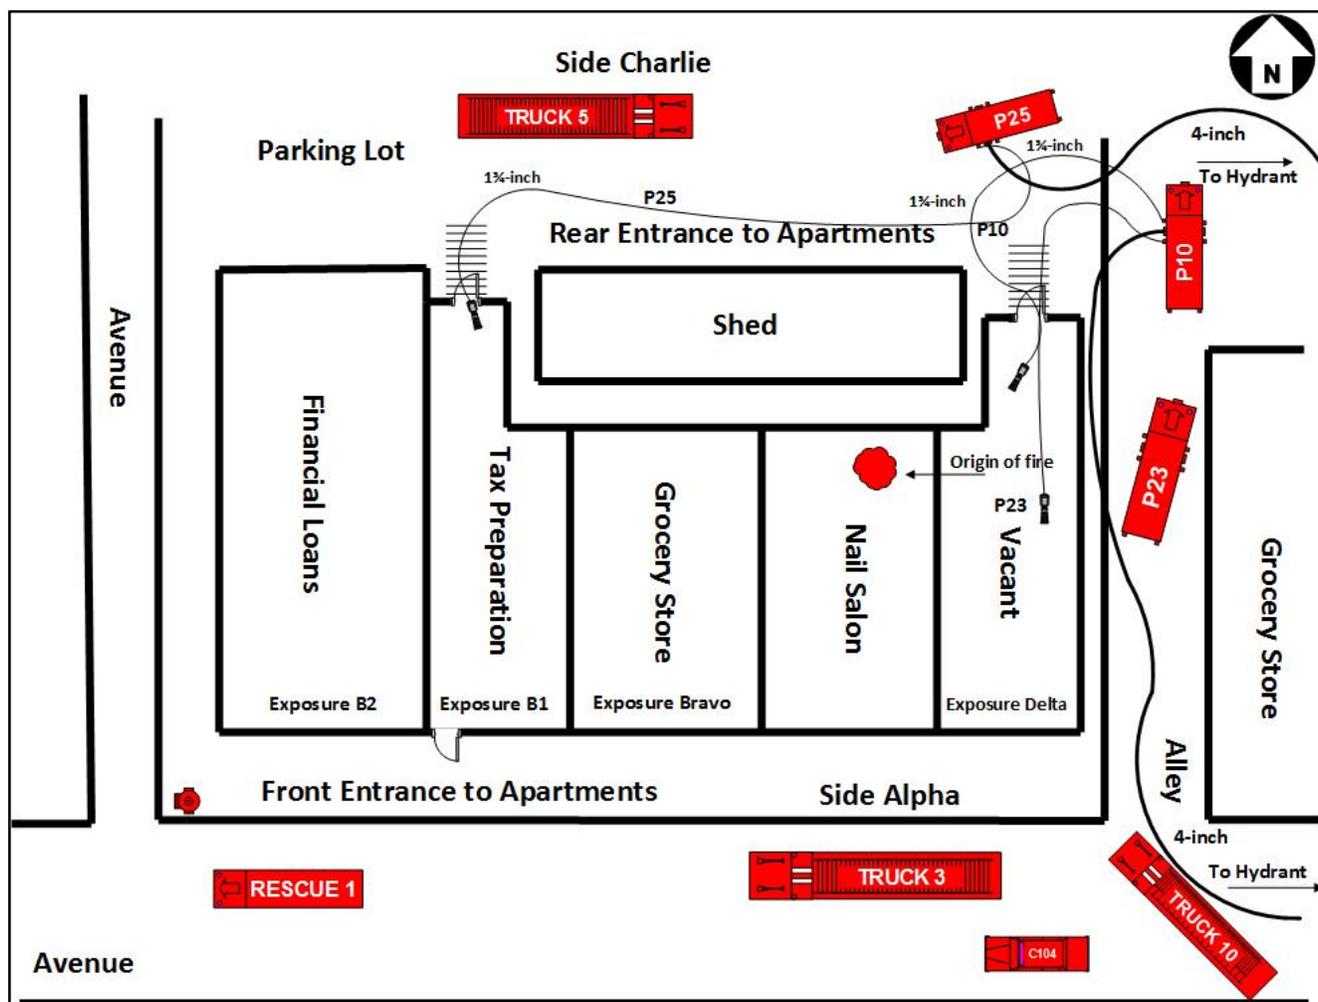
imager indicated that the fire was next to them in the nail salon. *Note: The rear entrance (Side Charlie - North side) to the nail salon was bricked over. Companies had no access to the rear of the nail salon, which required companies only use the Side Alpha access.*

**Diagram 6.** The apparatus placement of the “Regular” Alarm assignment initiated on Side Charlie with Pumper 10, Pumper 23, Pumper 25, Truck 10, and Truck 5. The time was approximately 1935 hours.
