## Career Lieutenant Killed in Building Collapse While Fighting Row House Fire—Pennsylvania

### Executive Summary

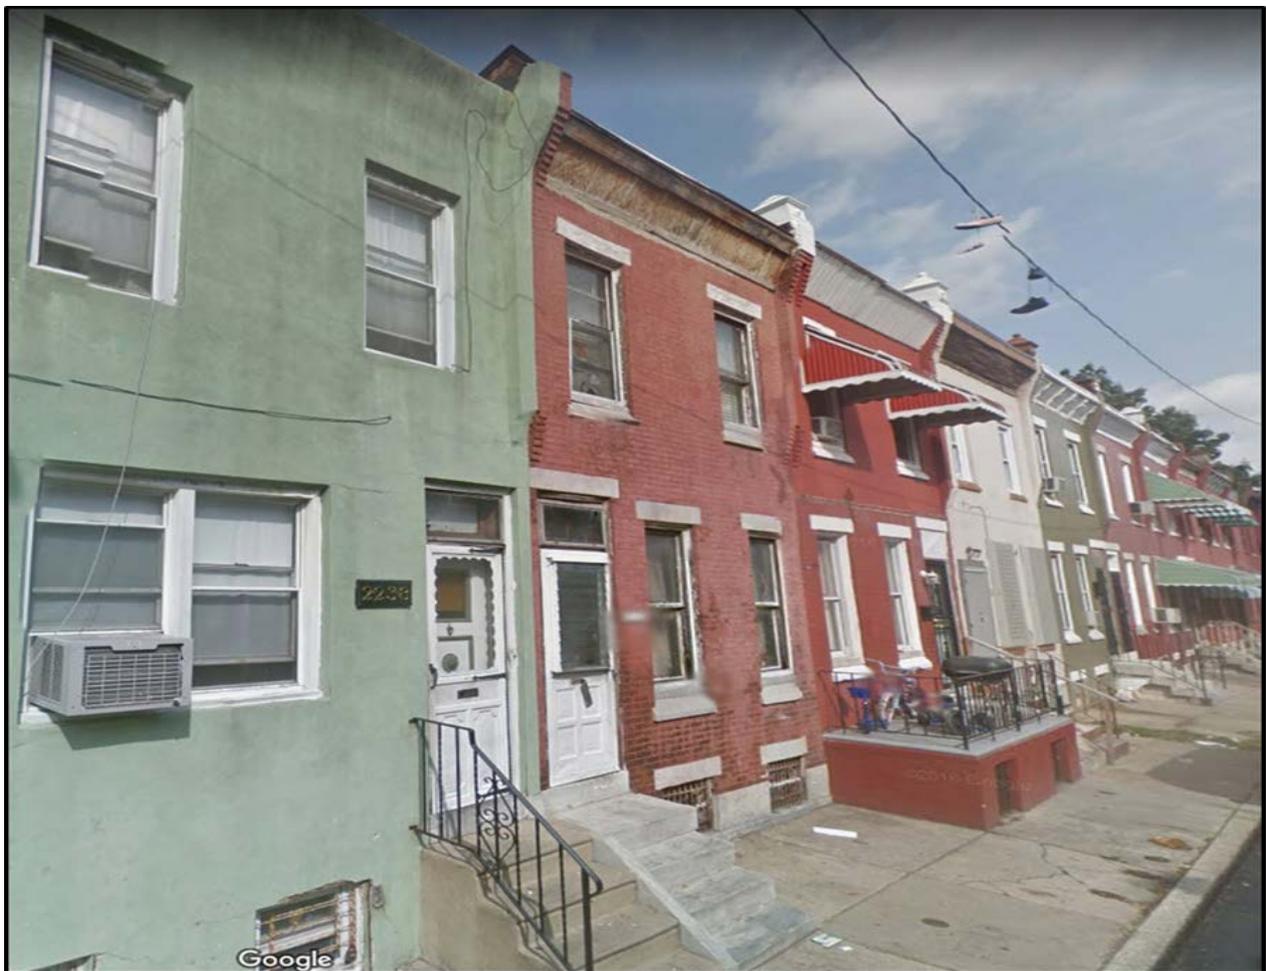
The fire structure was a 2-story, approximately 1,038 square feet, single family, occupied residential row house of ordinary construction (Type III) masonry, brick and wood joist built between 1880 and 1888 (see Photo 1 and floor layout in Diagrams 1 through 5). It was located on a narrow street comprised of thirty-four attached row house buildings that spanned the city block. Similar row houses made up the exposures on all four sides. Side Charlie had a slight buffer area for utilities, but not enough room for access by fire department vehicles or equipment.

*Photo 1. Side Alpha of incident dwelling, including view of exposures Bravo and Delta.  
(Photo Courtesy of Google Earth)*

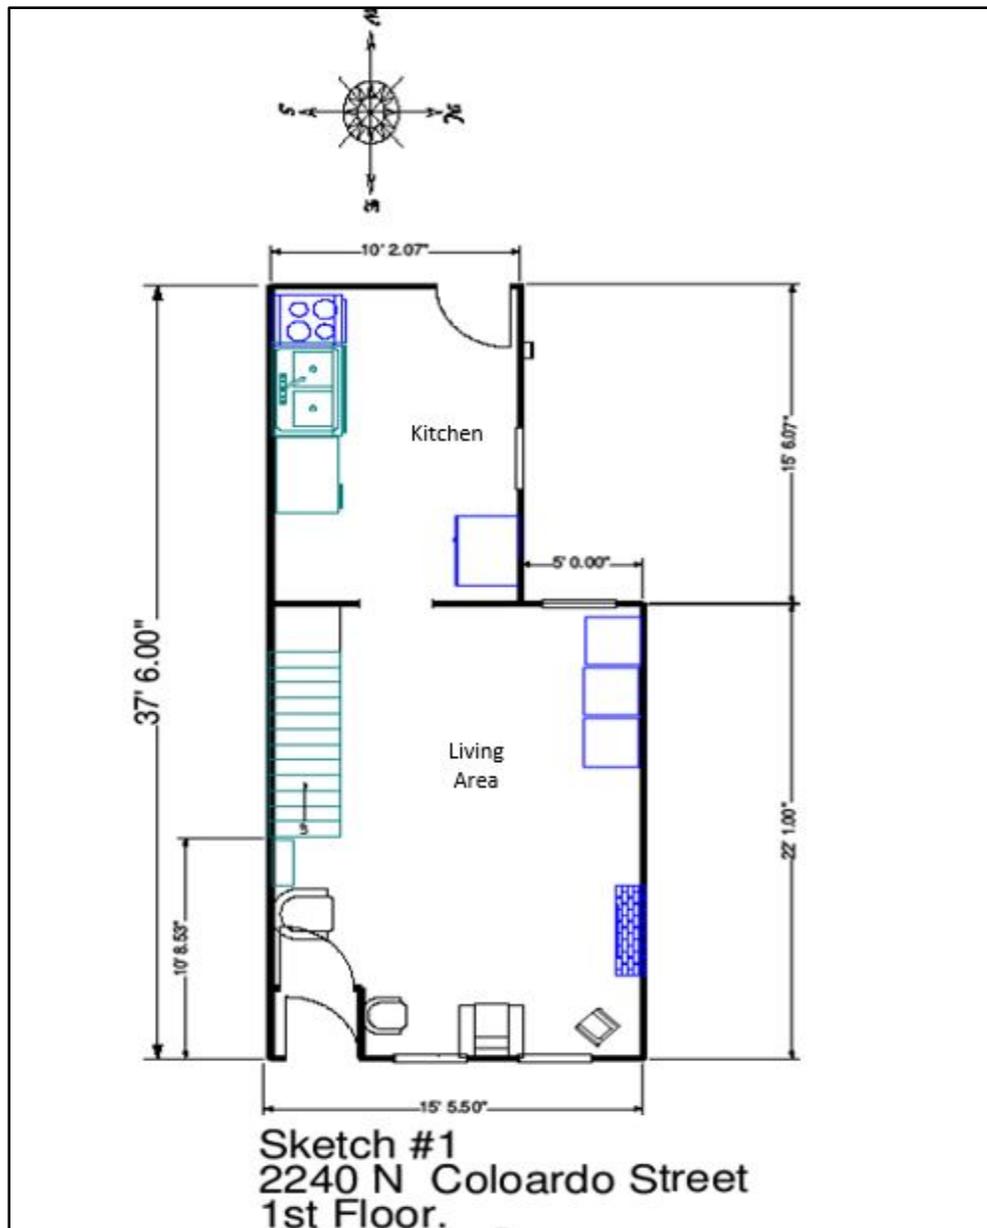
*Diagram 1. Sketch of first floor layout.*

*Note: there was severe clutter conditions not depicted in this sketch.  
(Diagram courtesy of fire department Health and Safety Office)*

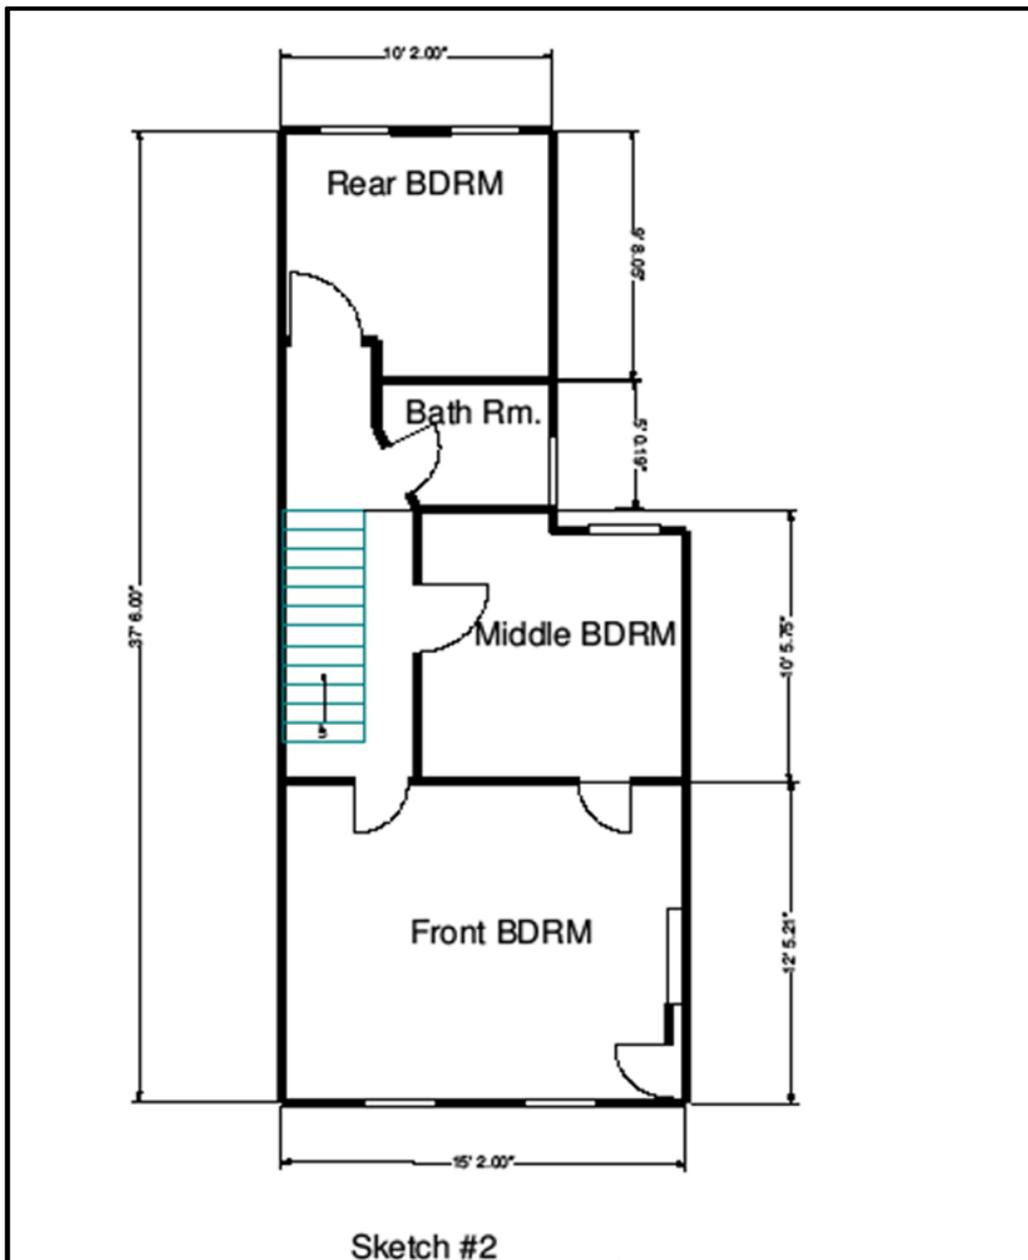
*Diagram 2. Sketch of second floor layout.*

*Note: there was also severe clutter conditions not depicted in this sketch.  
(Diagram courtesy of fire department Health and Safety Office)*

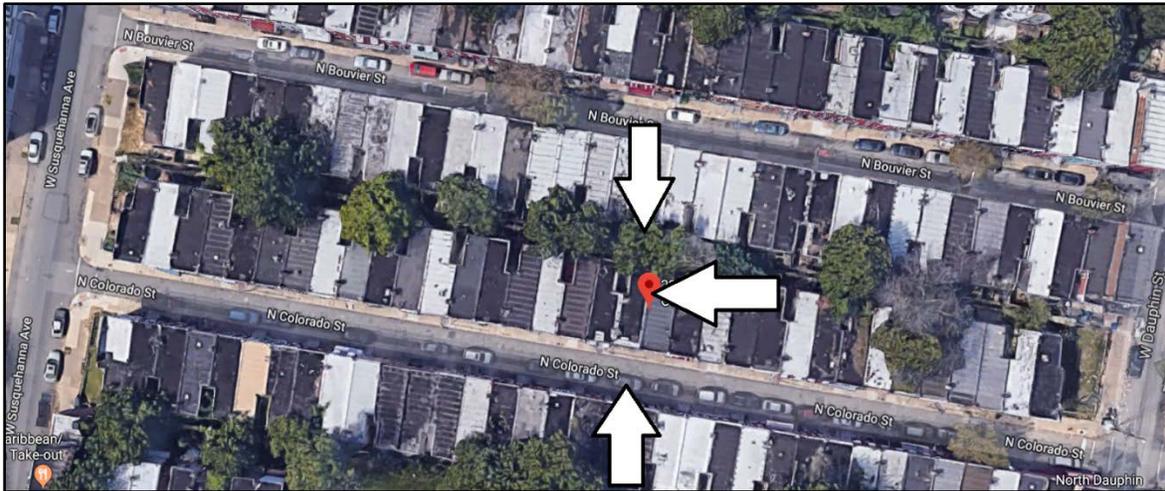
The weather was a primary contributing factor in this incident. Firefighters experienced significant interruptions in water supply with as many as 6 inoperable (possibly frozen) fire hydrants as well as a frozen nozzle tip and difficulties with personal protective equipment including SCBA (frozen head straps and a head net in a SCBA facepiece). They also faced extreme cold, snow and ice in the response roadways and a narrow street that had cars parked on one side of the street, making it impossible for heavy fire apparatus to access the front of the fire building. Crews had to hand stretch handlines 260 feet past 15 row houses from intersecting larger streets that could accommodate engines and ladders (see Photos 3 and 4).

*Photo 3. Red pin and horizontal arrow point to incident structure, vertical white arrows indicate the narrow access to side A due to narrow roadway and on street parking and very limited access to the utility alley on side C.*

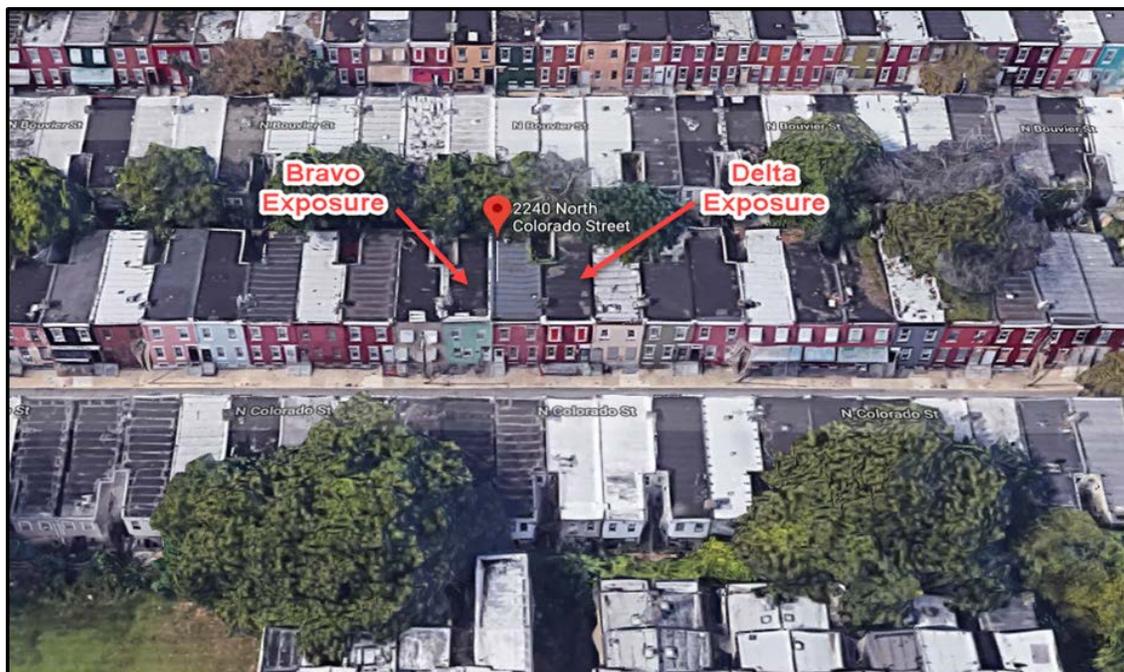
*Photo 4. 1800's era row homes with dense construction and narrow streets. Incident location noted with red pin and exposures noted.*

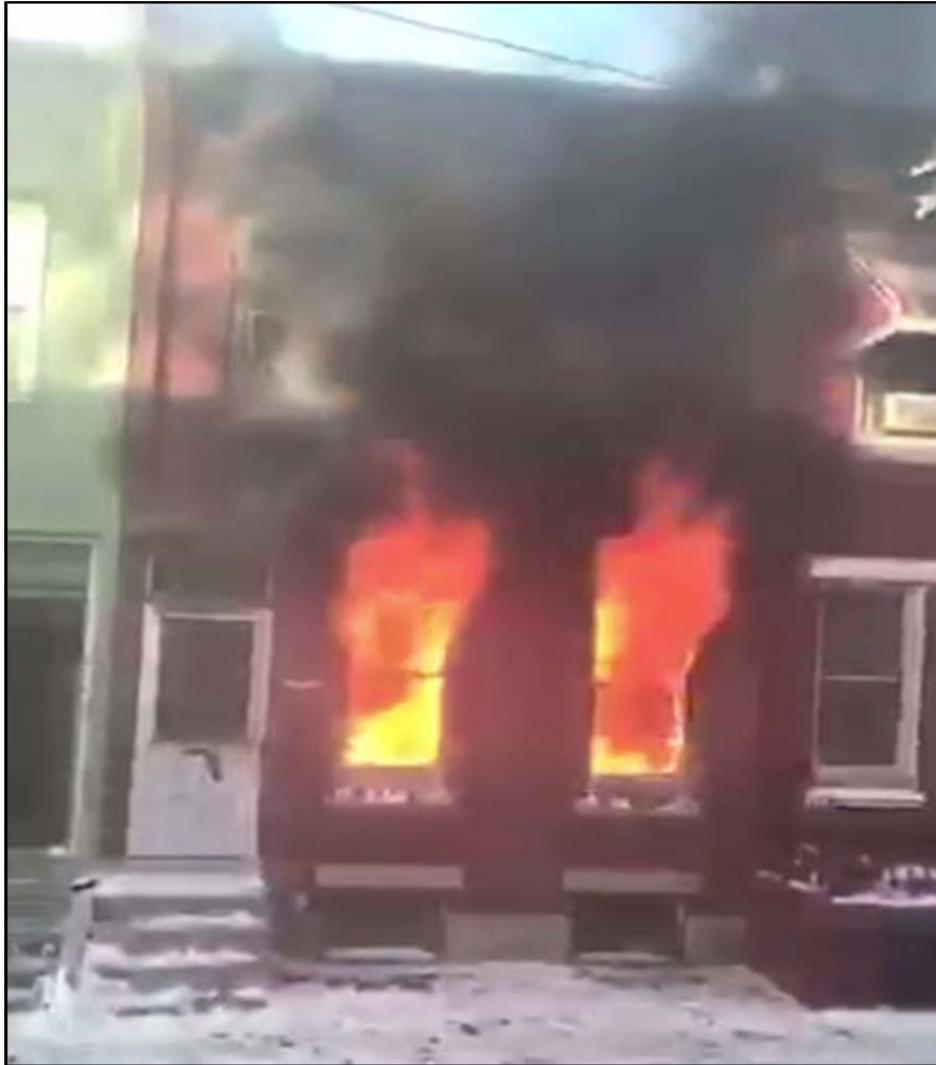
En-route to the fire, firefighters had a report of possible victims trapped in the structure. Engine-45 was the first engine to arrive and parked on the main street. Engine-45's officer instructed his crew to stretch a 3-inch line connected with a gated wye to a 1 ¾ inch handline and for Engine-45 to find a hydrant to secure a water supply. The Engine-45 officer sized up the incident and gave his initial arrival report of a two story, 15 feet by 35 feet middle of the row dwelling with fire showing on the first floor (see Photos 5 and 6).

*Photo 5. Fire conditions pre-arrival of fire department time: 08:55:20.  
(Photo courtesy of fire department from resident video)*

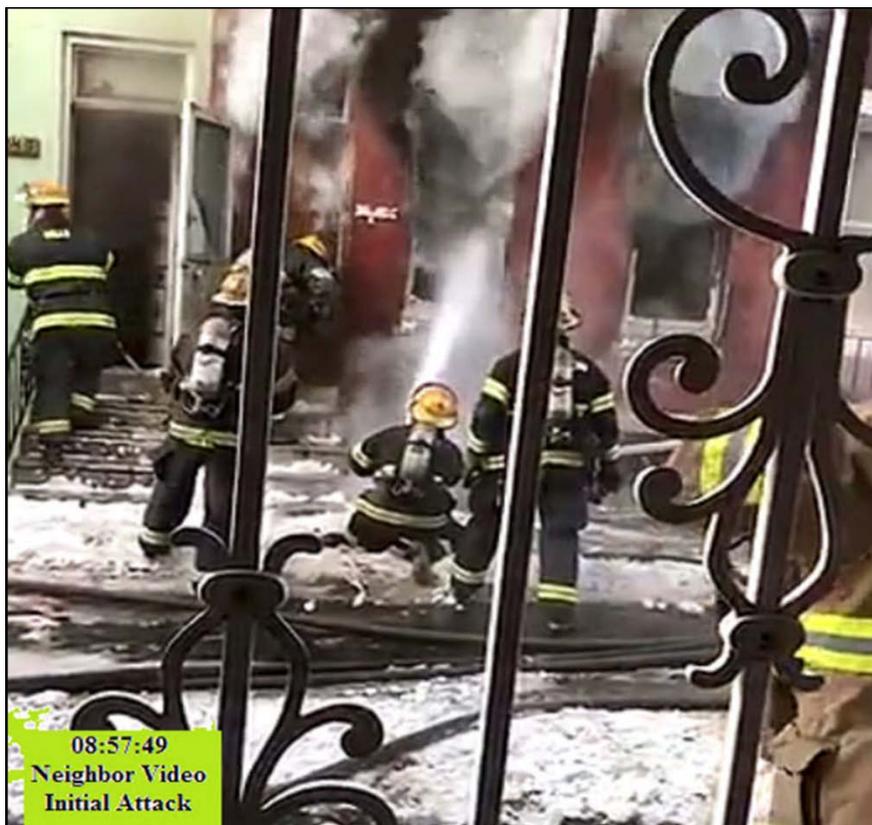
*Photo 6. Initial fire department operations.  
(Photo courtesy of fire department from video taken by area resident across the street)*

frozen. Engine-45's officer instructed the Engine-45 Tip to remove the stream straightener off the nozzle and this allowed water to flow. This did knock the fire down on the first floor (see Photo 6).

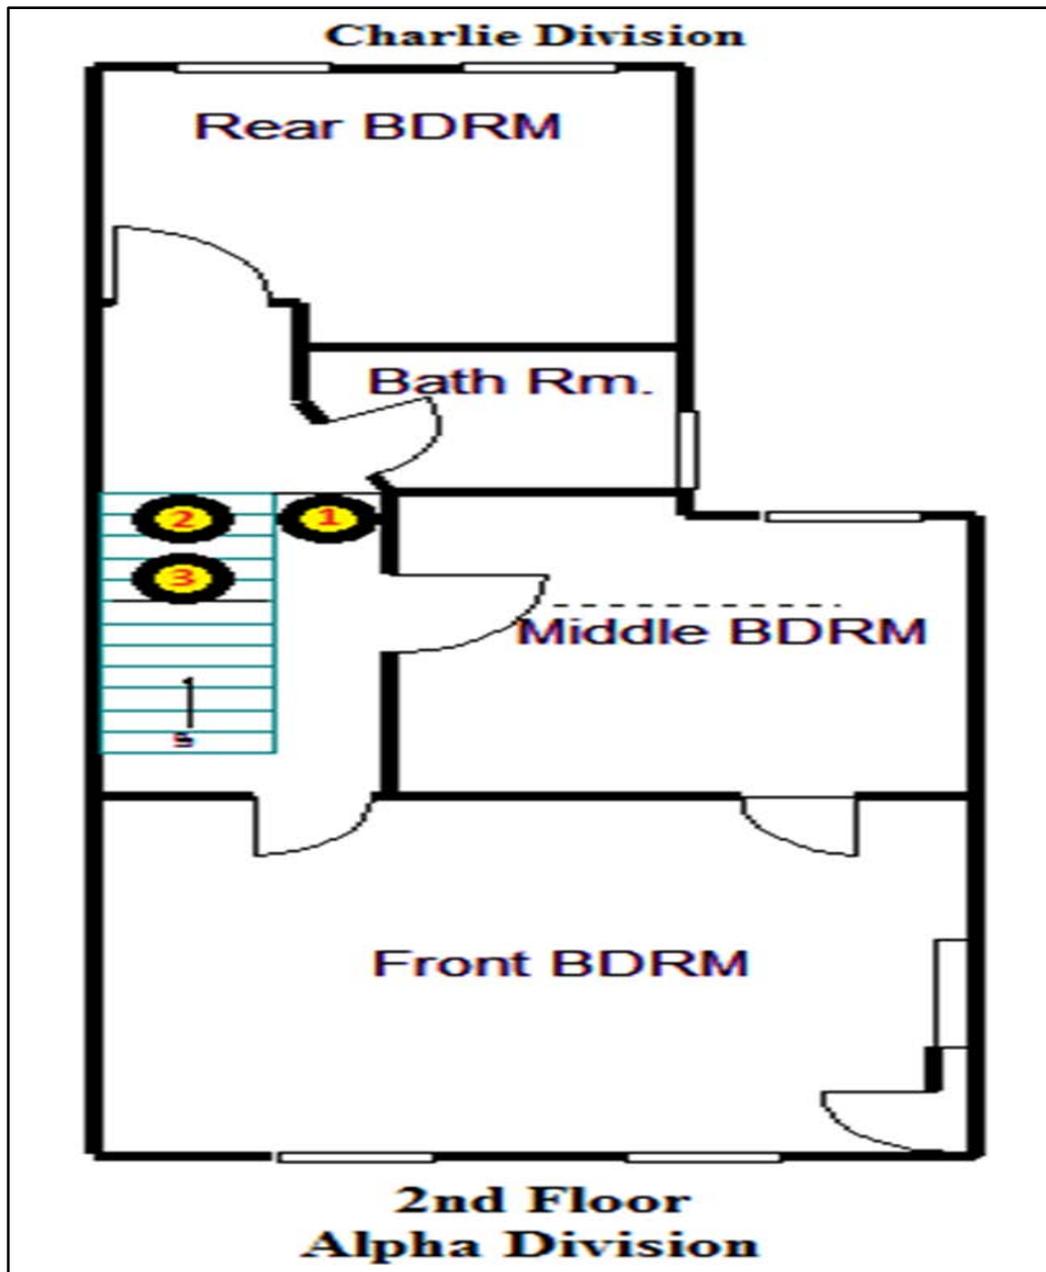
The crew on the second floor reported that they experienced a shift in the floor and the Ladder-12 Pak yelled to the crew on the stairs that he felt the floor sag. During interviews, he reported the floor sagged approximately 2 inches. The Engine-50 officer ordered the Ladder-12 Pak man off the 2<sup>nd</sup> floor; however prior to getting back to the stairs, the 2<sup>nd</sup> floor collapsed into the first floor.

Diagram 6. Location of members on floor 2 at time of collapse. 1 = Ladder-12 Pak, 2 = Engine-45 Pak, 3 = Engine-50 Officer.

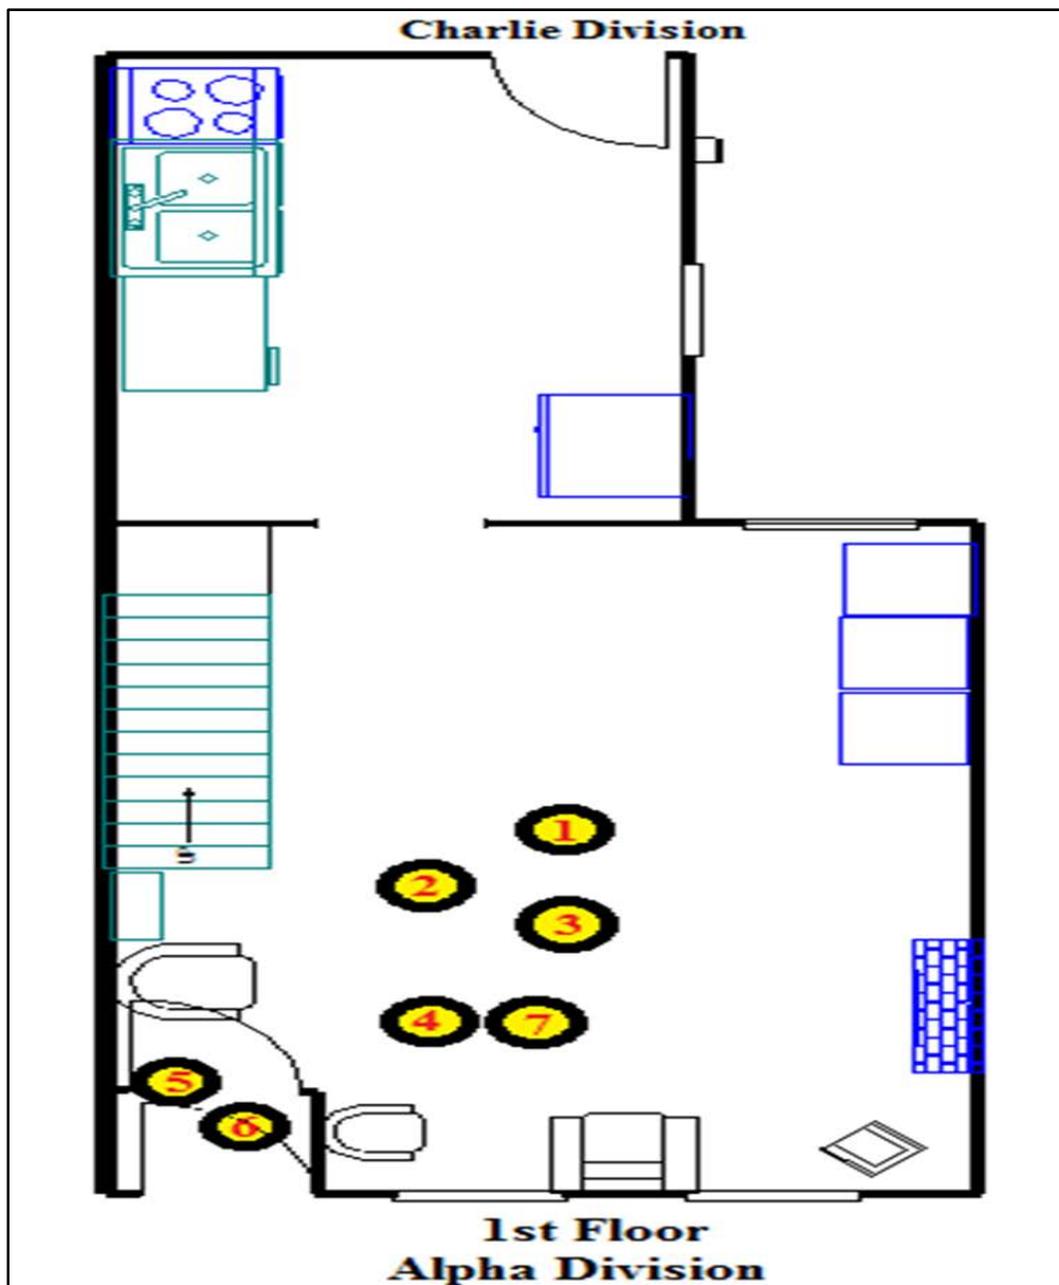
*Diagram 7. Location of members on floor 1 at time of collapse. 1 = Engine-45 Officer (victim), 2 = Rescue-1 Search, 3 = Engine-45 Tip, 4 = Squad-72 Officer, 5 = Squad-72 Search, 6 = Squad-72 Pak, 7 = Engine-50 Pak.*

Squad-72's officer reported hearing a loud crack and went to the front door (side Alpha) and told Command to get everyone out. At approximately 0933 a V-shaped collapse occurred trapping several firefighters. Command ordered an evacuation of the building and a PAR and notified everyone that they were going defensive.

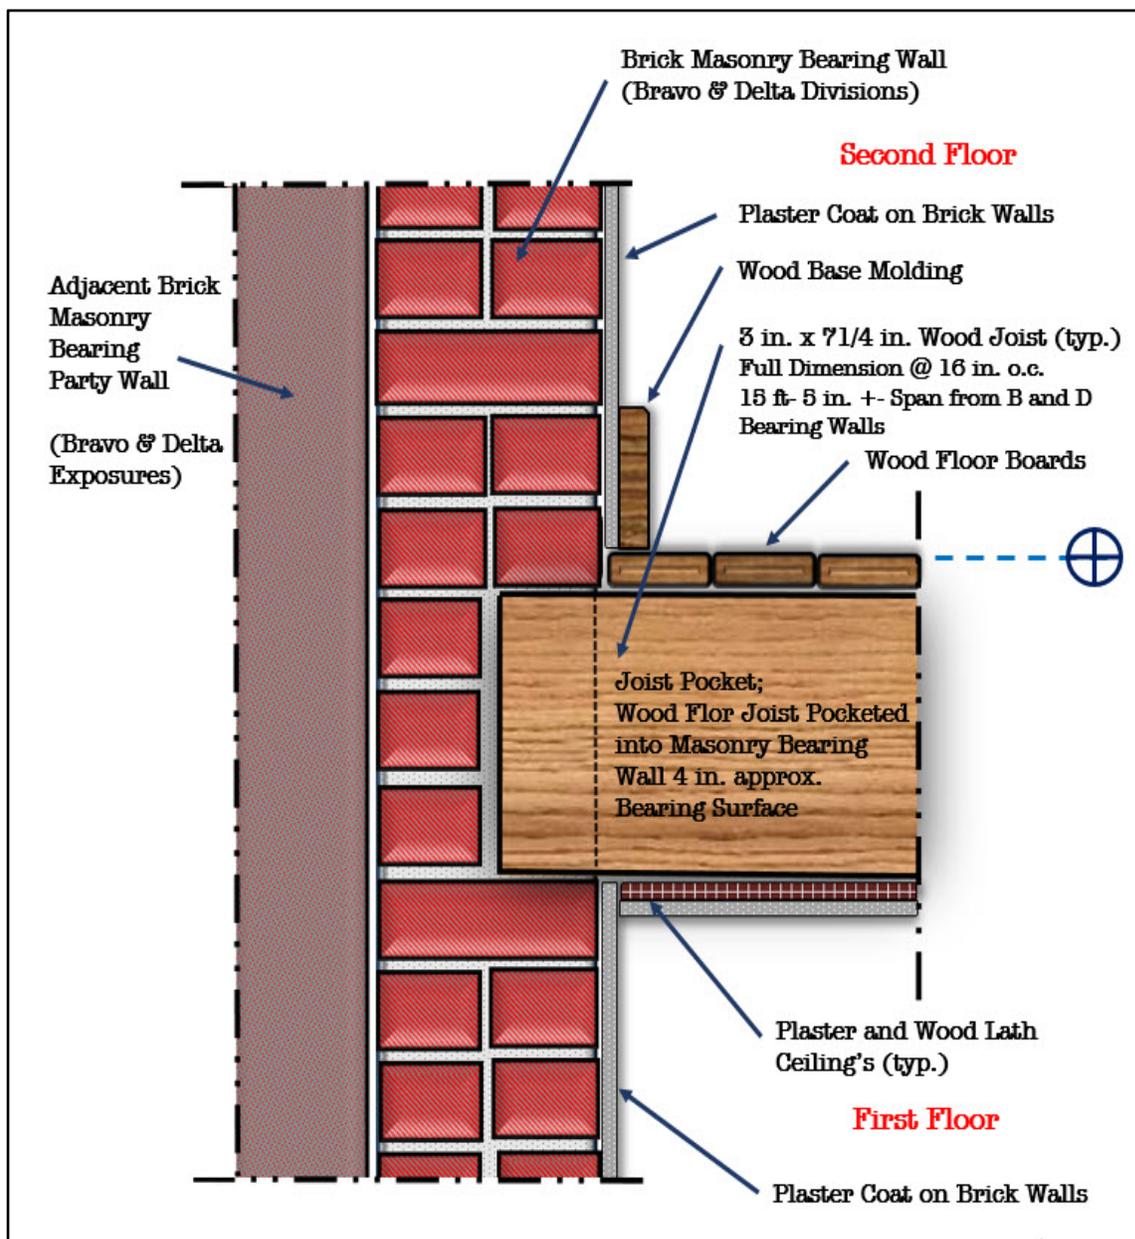
- A unique feature of this row house (as well as the exposure structures and likely in other surrounding row houses) was a 1-inch by 1-inch notch cut in the upper top portion of the wood joists to allow for a gas pipe when gas service was provided in the late 1800's. These notches are in every joist in a line from Side A inward approximately 20 feet (see exemplar from exposure in Photo 2).

Appendix 2 Diagram 4. Detail-B Masonry Party Wall and Floor Joist Section & Detail-A Gas-line & Notch

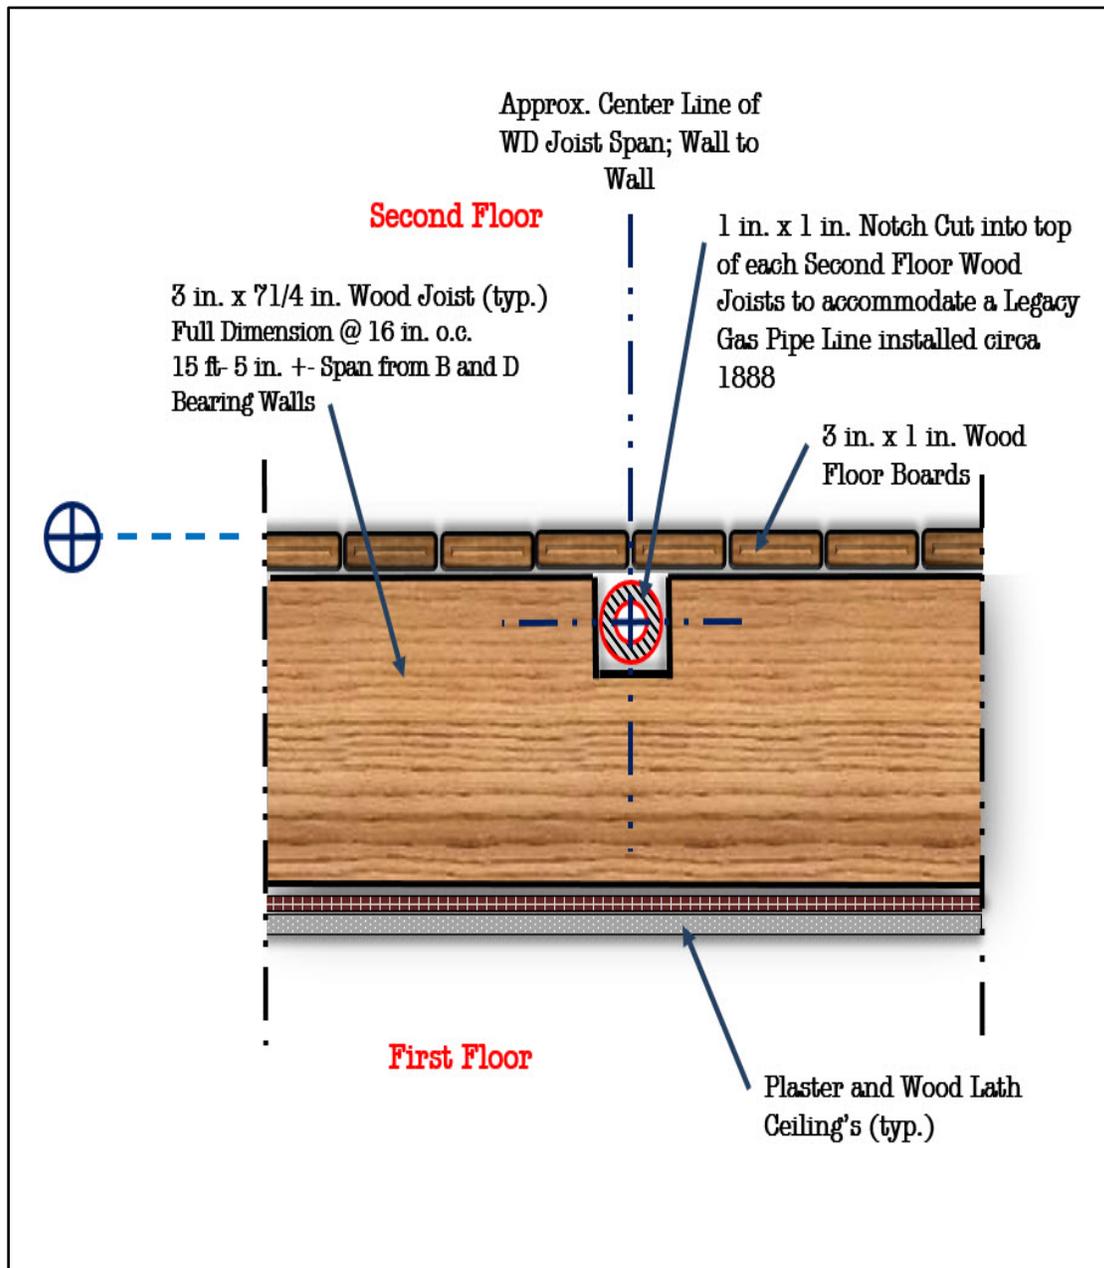
Appendix 2 Diagram 4a. Detail-B Detail-A Gas-line & Notch. Graphic Courtesy of Buildingsonfire.com | C.J. Naum

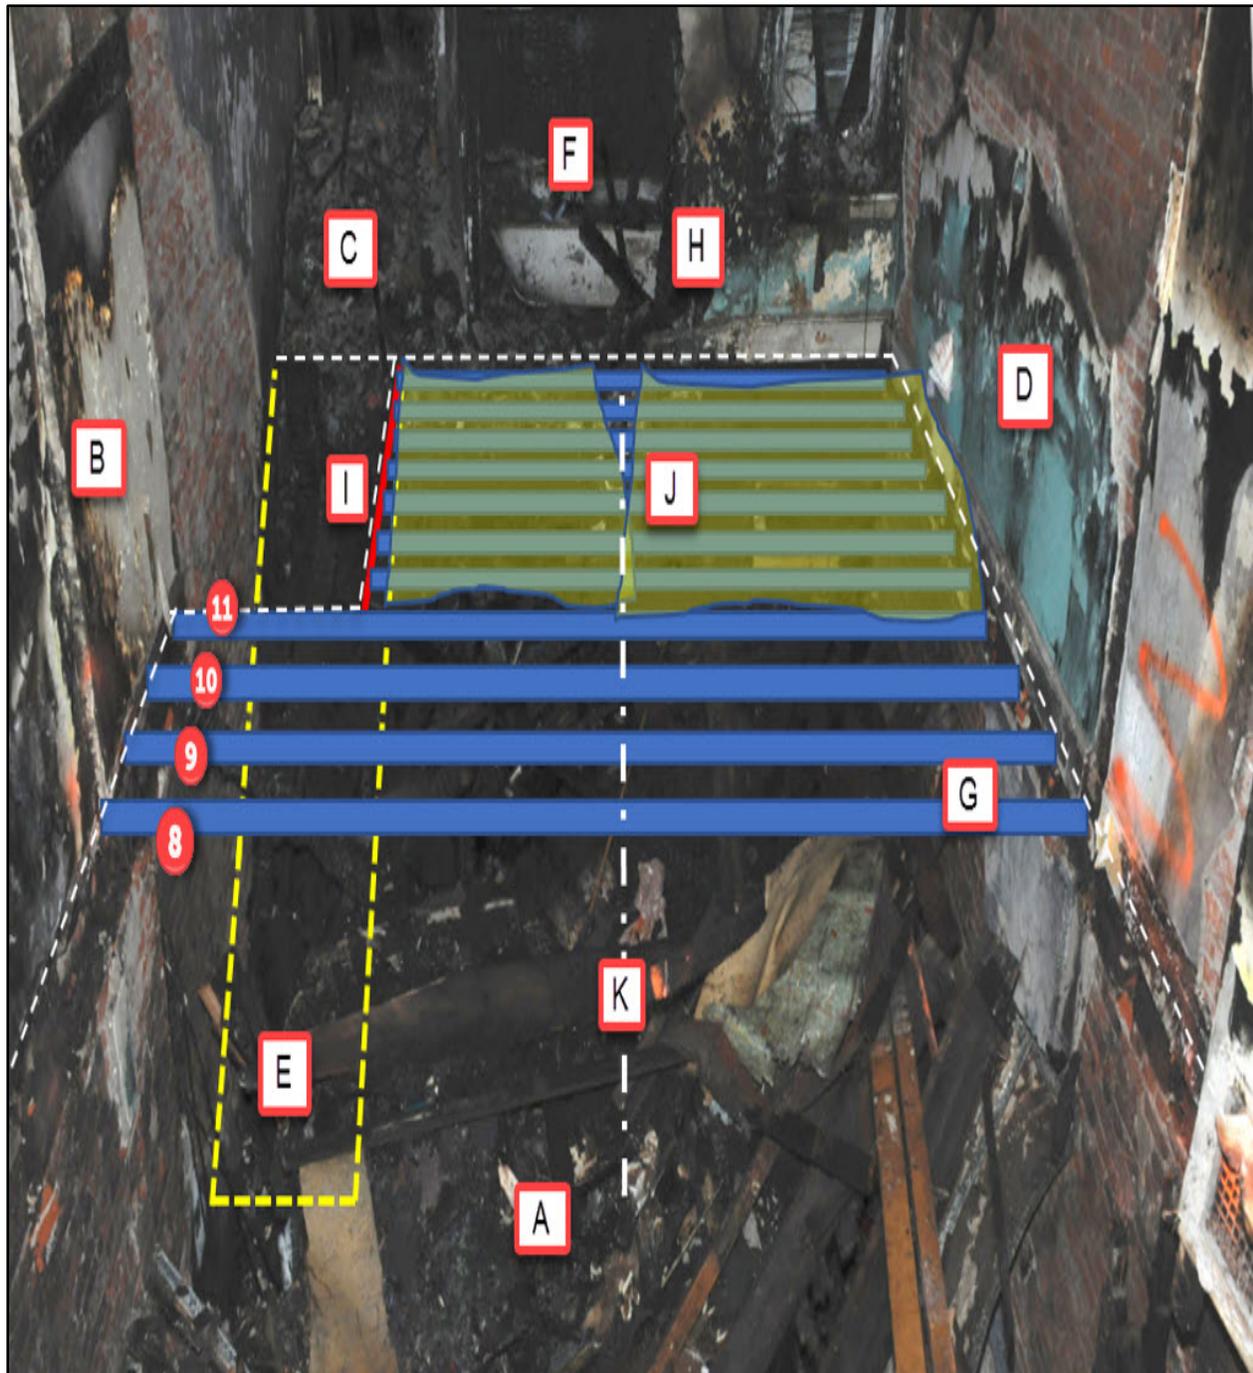
**Appendix 2 Diagram 8. Second Floor Joist Reconstruction and Collapse Area, looking inward from the Alpha Division.** Photo Courtesy of Fire Department, Photo Analysis Diagram Courtesy of Buildingsonfire.com | C.J. Naum

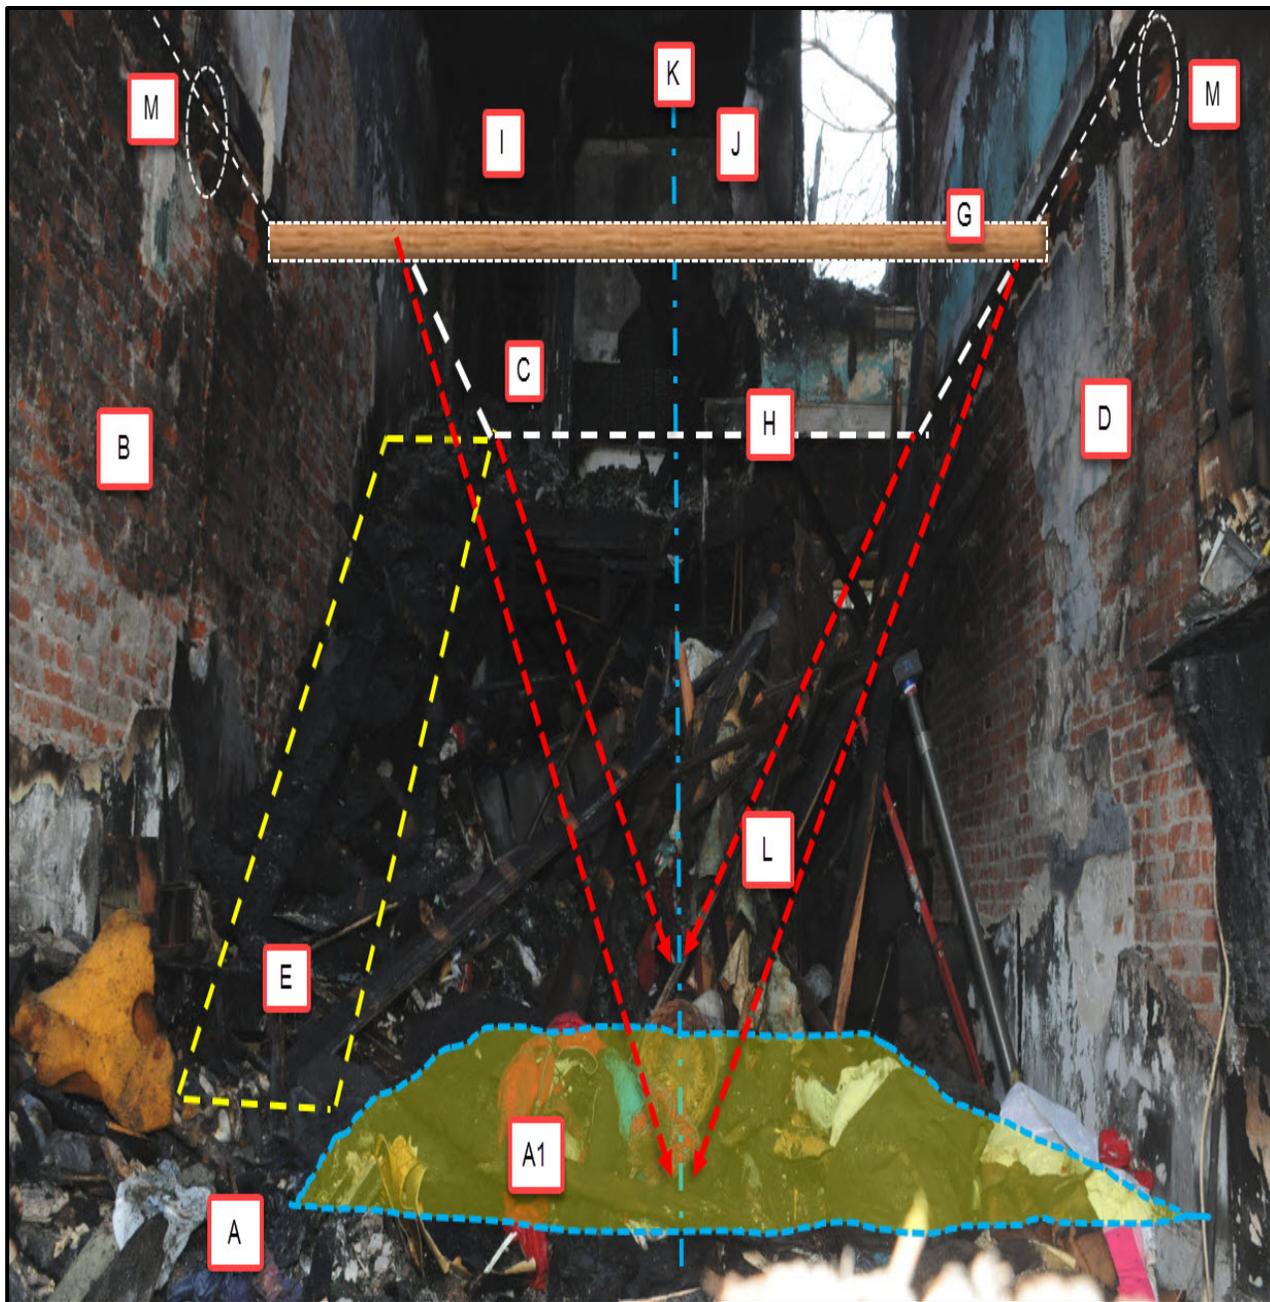
**Appendix 2 Diagram 9. First Floor Collapse Zone Reconstruction and Orientation, looking inward from the Alpha Division.** Photo Courtesy of Fire Department. Analysis Diagram Courtesy of Buildingsonfire.com | C.J. Naum Post Collapse and after debris removal from both First and Second areas.

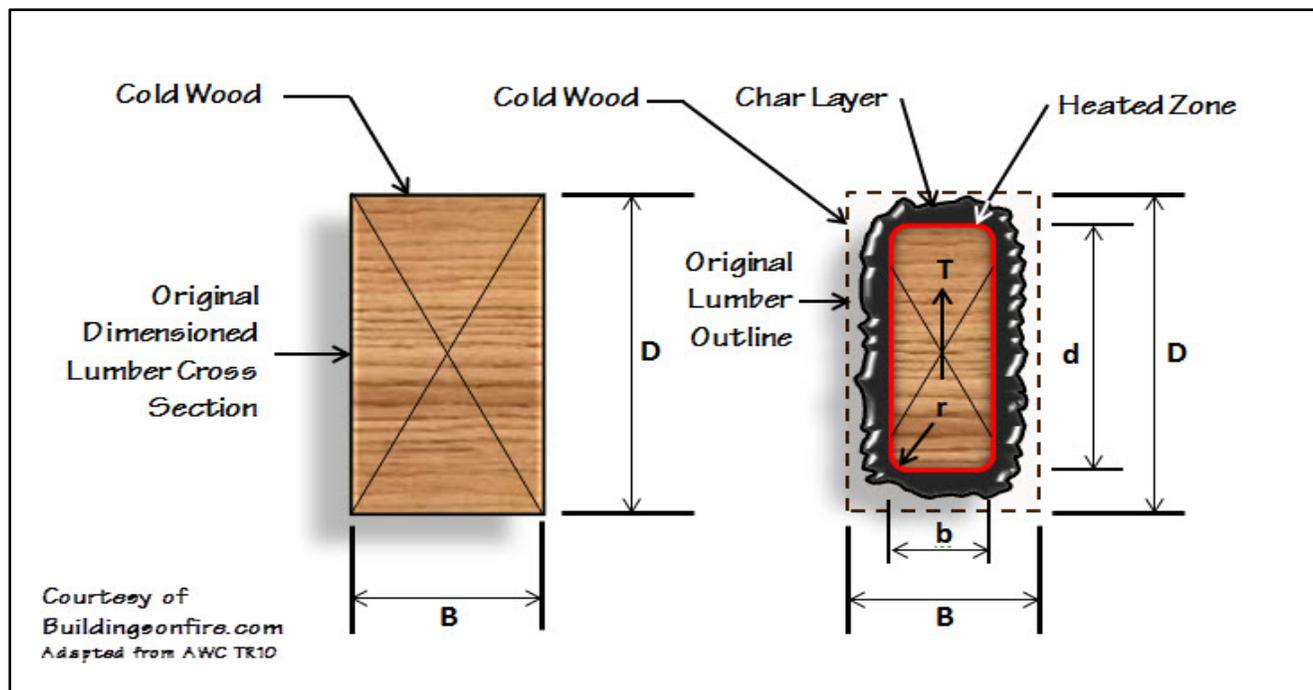
**Appendix 2 Diagram 11. Reduction in Wood Floor Joist Component Breadth and Depth over time.** Graphic Courtesy of Buildingsonfire.com | C.J. Naum. Adapted from AWC Technical Report #10 (2012)

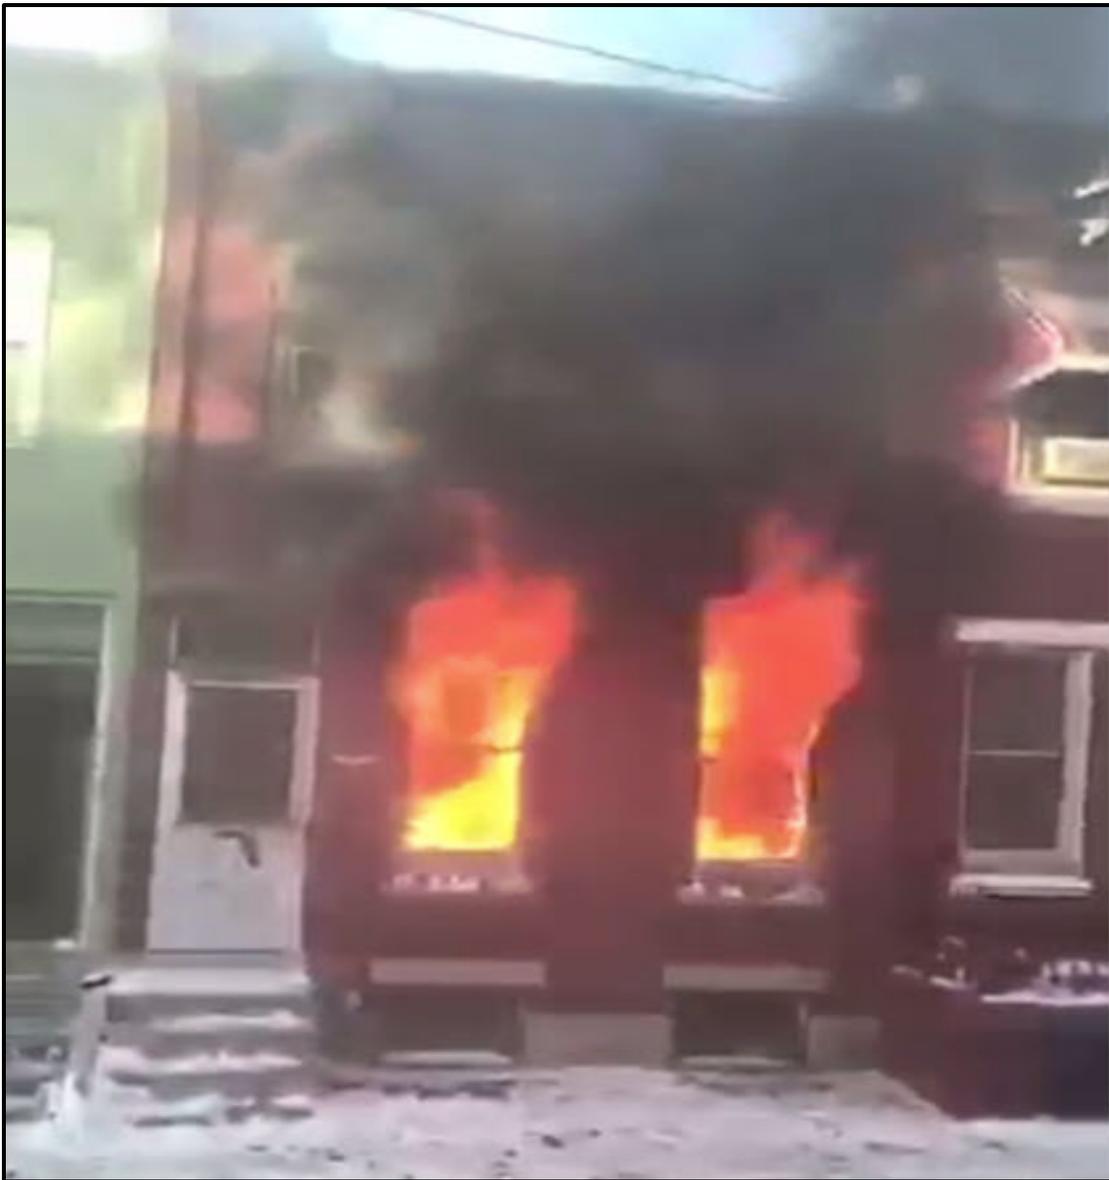
**Appendix 2 Photo 11. Fire Conditions Pre-Arrival of FD Time: 08:55:20.** Photo: Courtesy of Fire Department (from resident video).

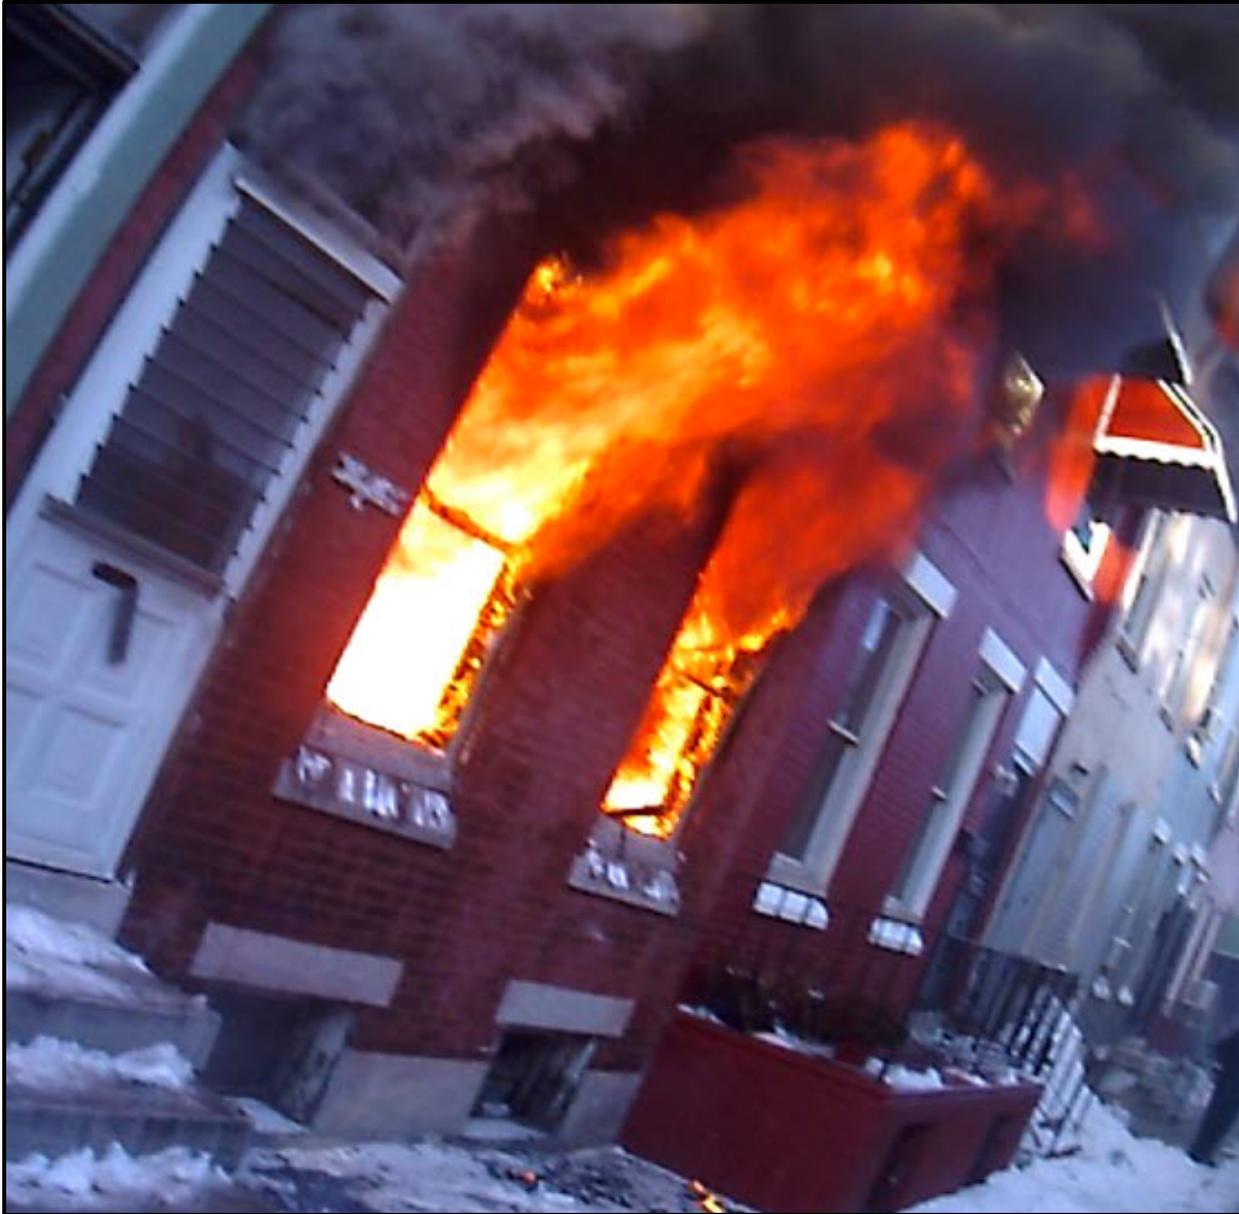
**Appendix 2 Photo 12. Fire Conditions upon FD Arrival.** Photo: Courtesy of Fire Department

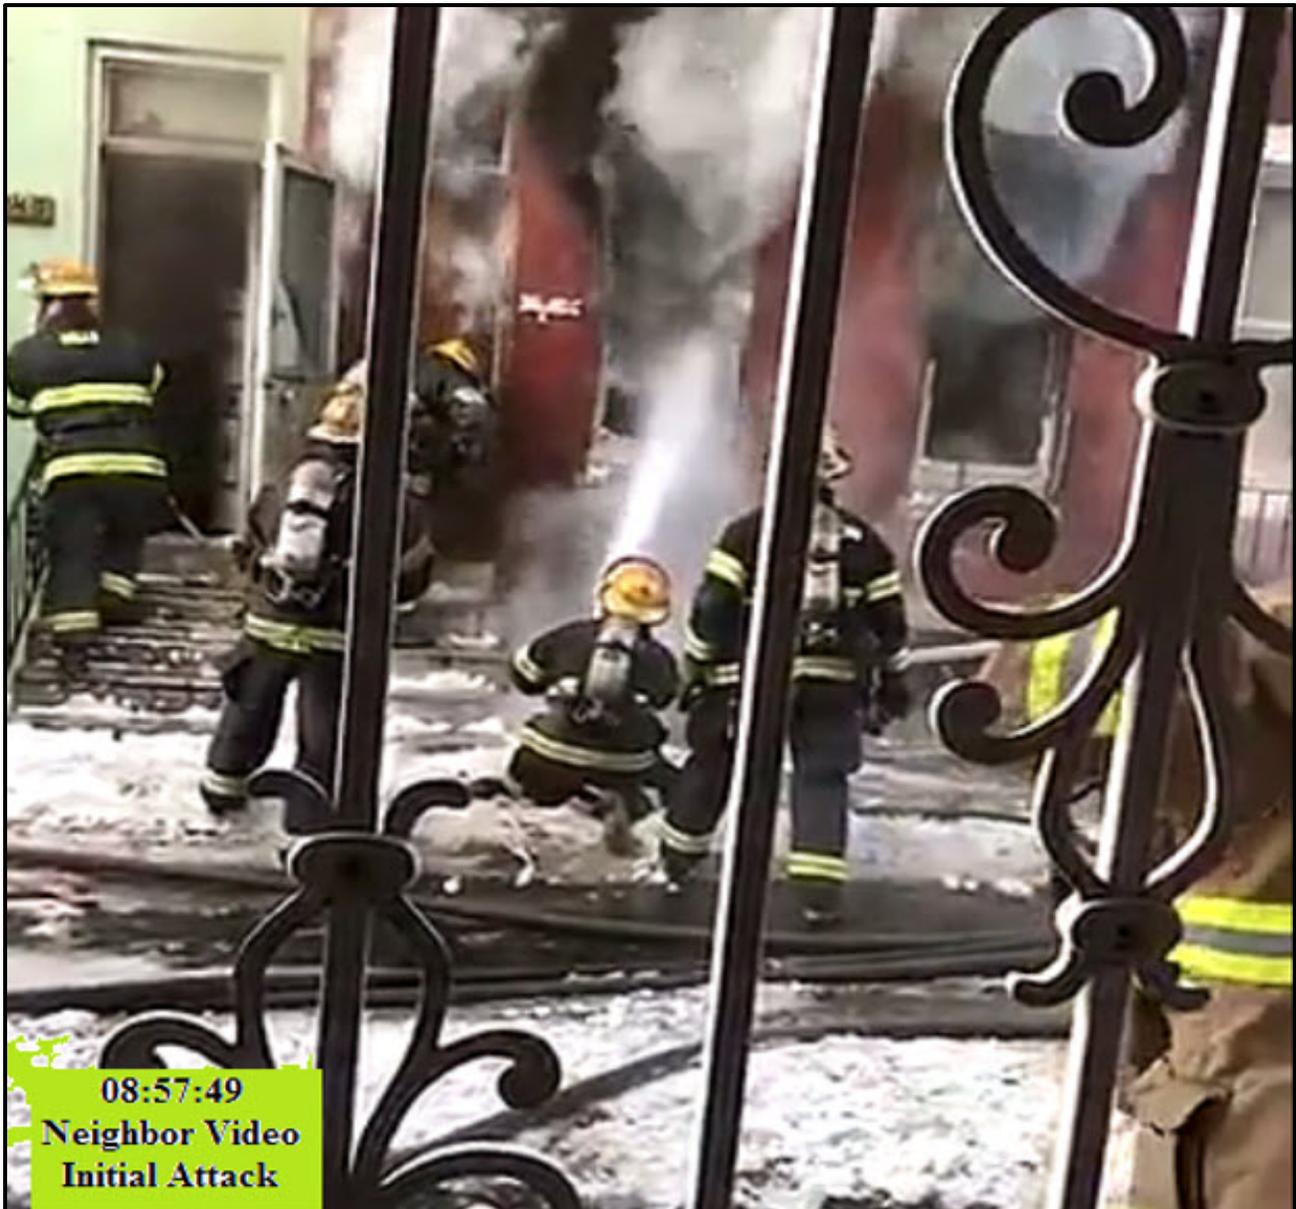
**Appendix 2 Photo 13. Initial FD Operations; Transitional Attack Time: 08:57:49.** Photo: Courtesy of Fire Department (video taken by area resident across the street).
