## Career Lieutenant Killed in Building Collapse While Fighting Row House Fire—Pennsylvania

### Executive Summary

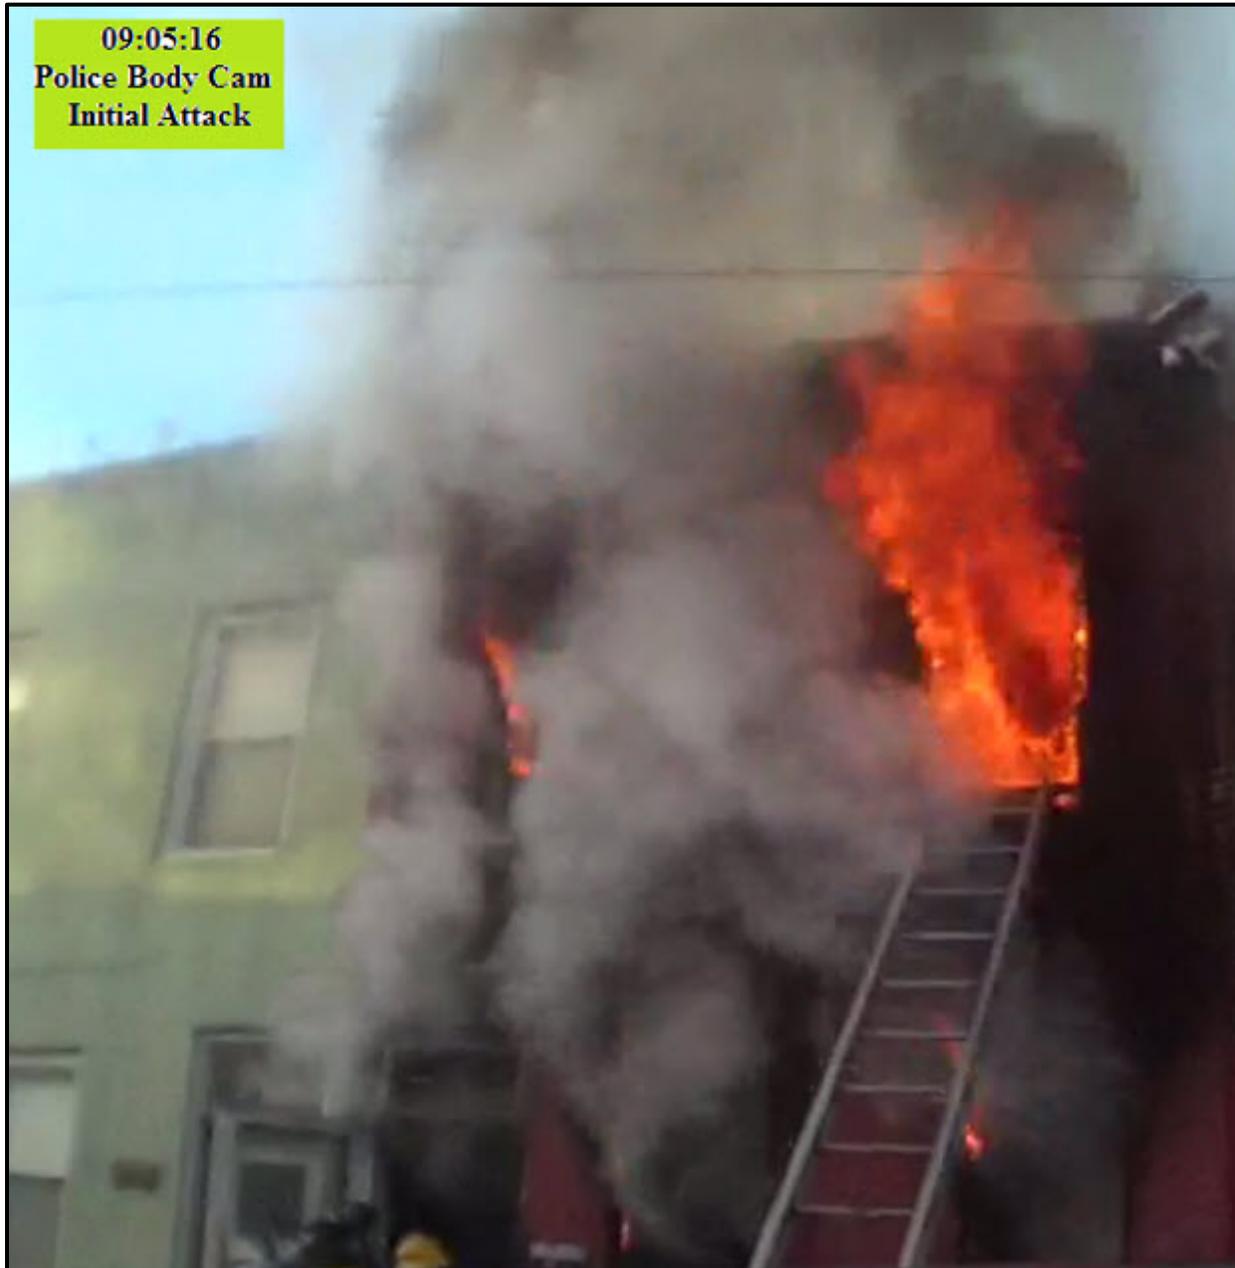
**Appendix 2 Photo 14. Initial Fire Attack View from Police Body Cam Time: 09:05:16.** Photo Courtesy of fire department obtained from Police Body camera

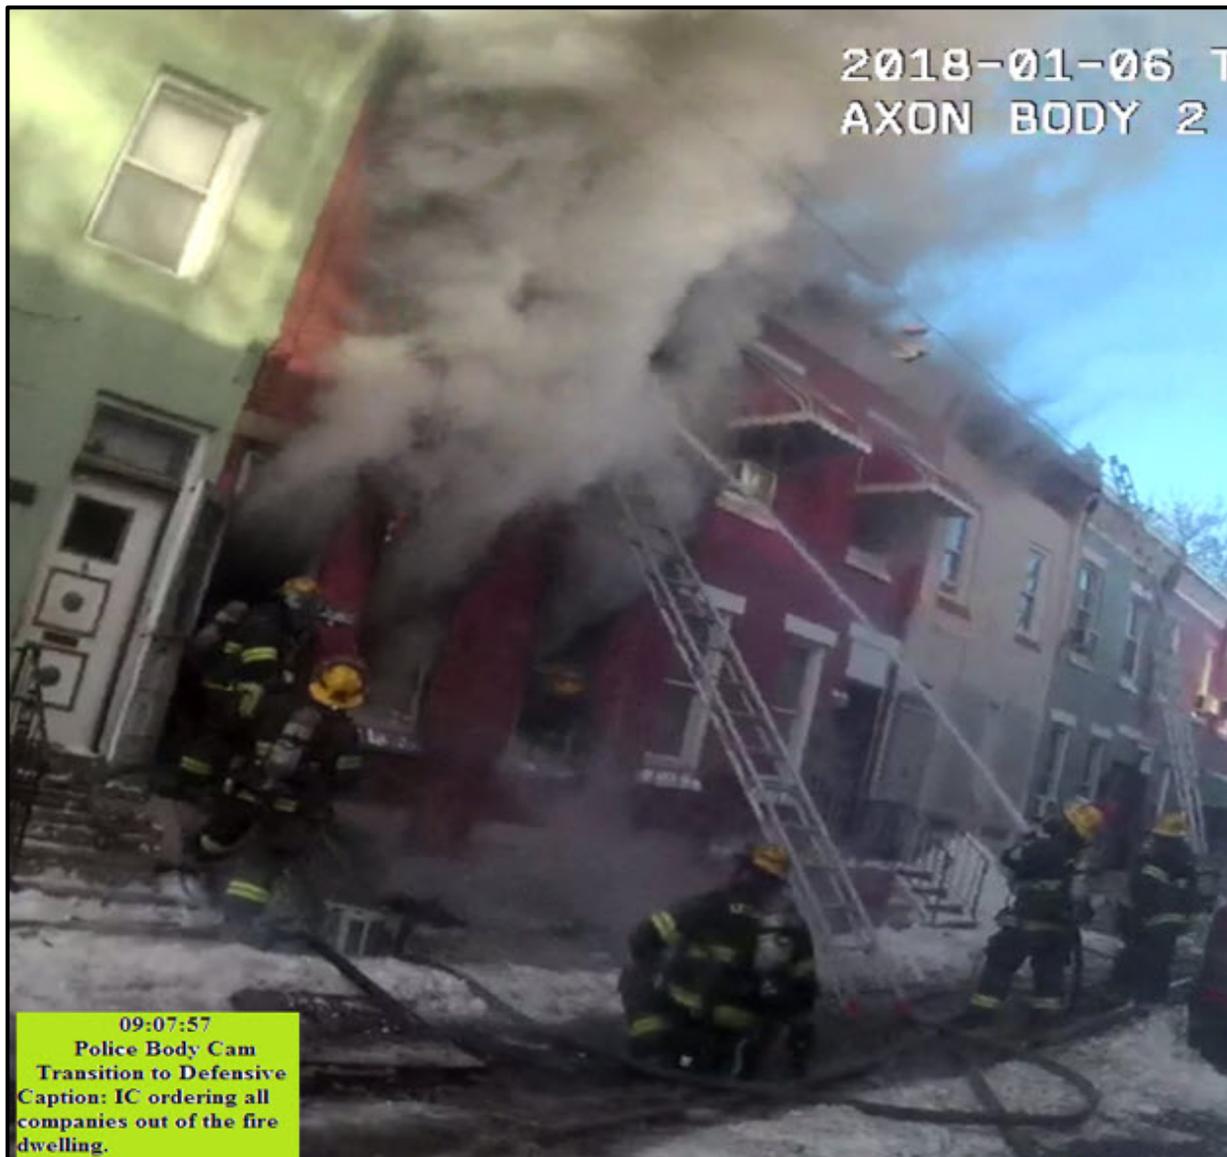
**Appendix 2 Photo 15. Transitional Fire Attack from Offensive to Defensive Operations View from Police Body Cam Time: 09:07:57.** Photo Courtesy of fire department obtained from Police Body camera

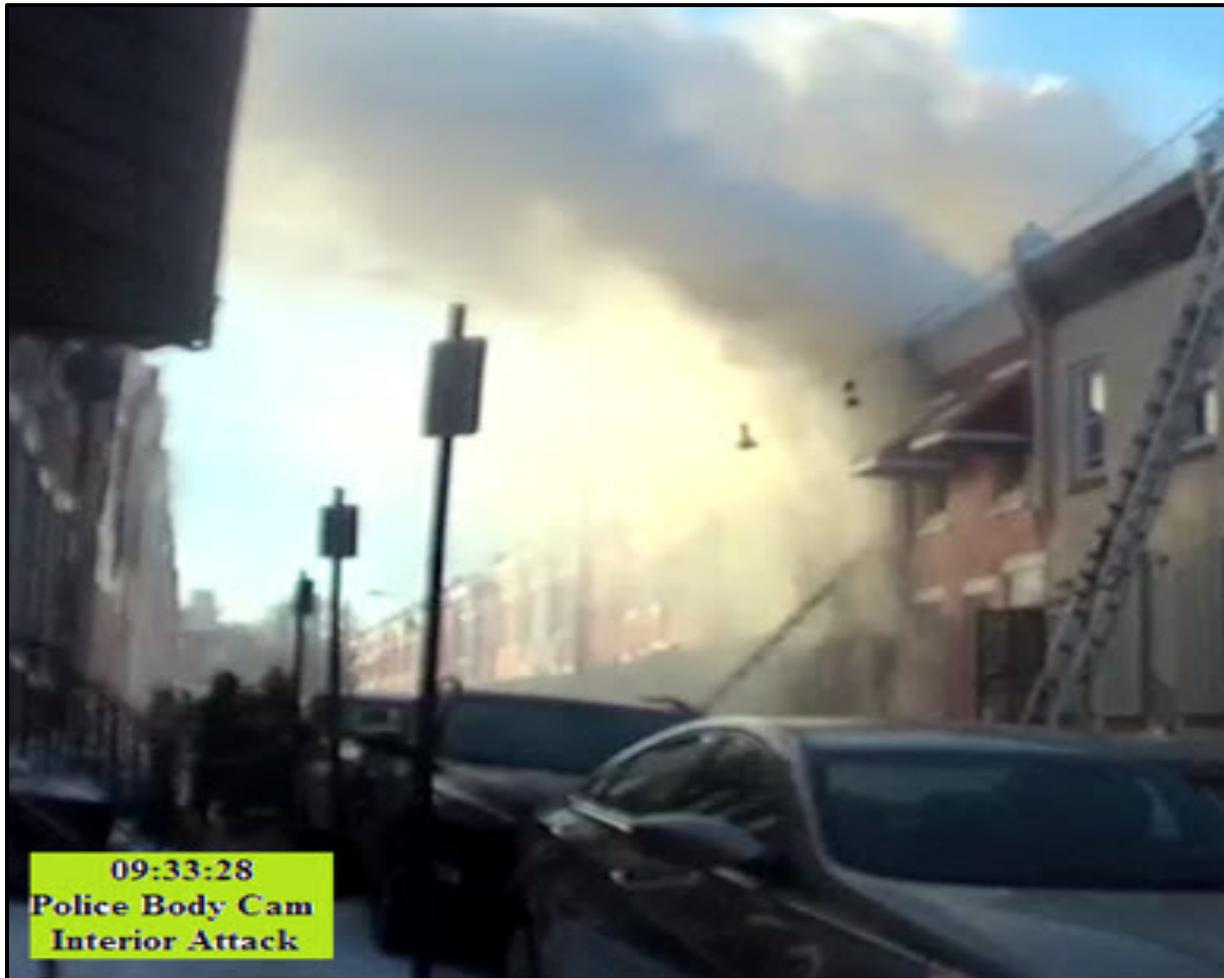
**Appendix 2 Photo 16. Transition back to Offensive Fire Operations and Initial Structural Collapse View from Police Body Cam Time: 09:33:28.** Photo Courtesy of fire department obtained from Police Body camera.

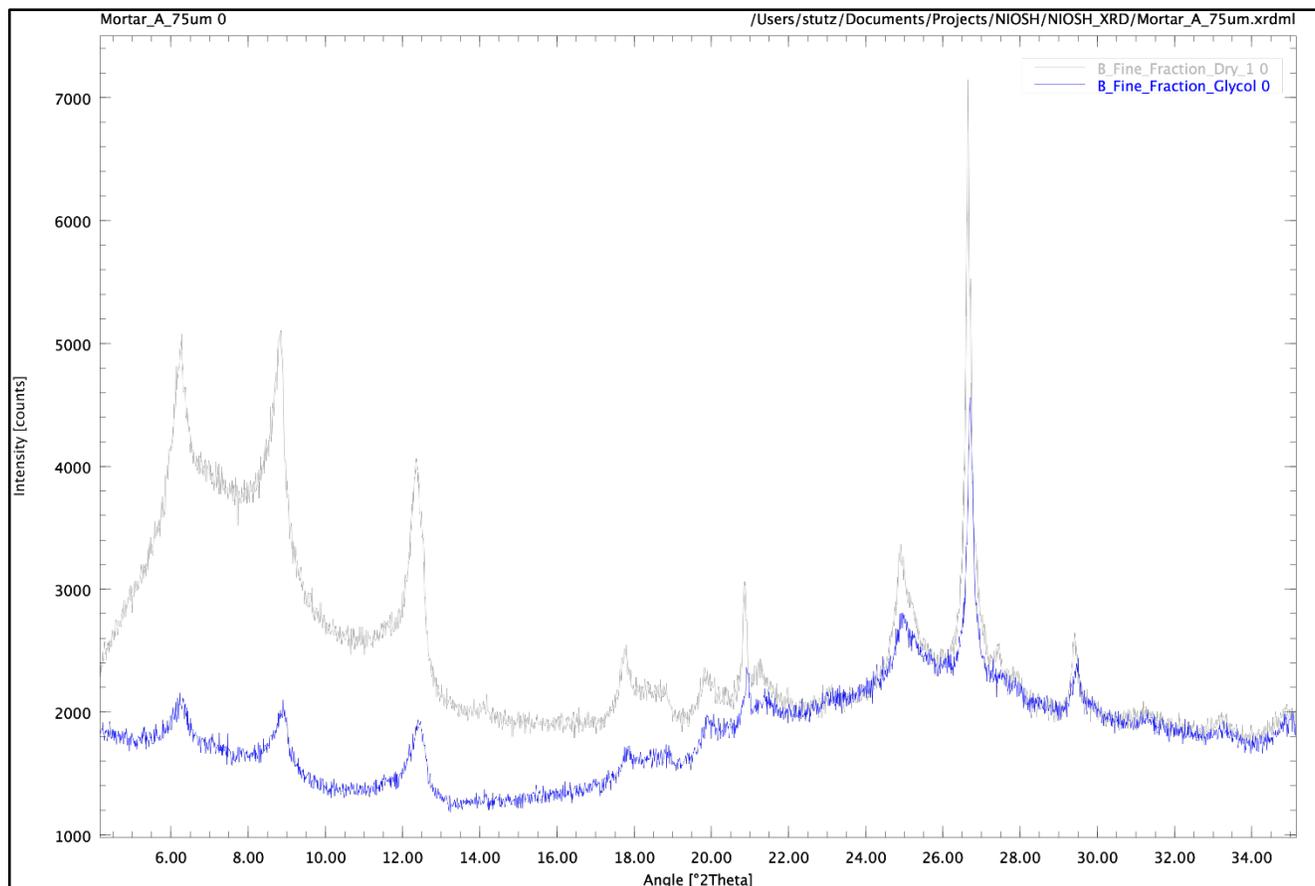
The darker material of B appears to be a soil based upon the clay minerals (chlorite and possibly kaolinite, illite/mica) in the binder (the glue binding the sand grains) based upon X-ray powder diffraction, but also contains minor black fragments and what appear to be slag or ash grains. The dark material on B is very friable relative to the mortar on specimen A and does not contain any portland cement. The XRD patterns of a clay fraction (size separation to remove the sand-size particles, file=B\_Binder\_clay\_Fraction.png) shows peaks at the low angle region typical of common clays found in soils as mentioned earlier (the first three peaks from the left side are characteristic of these clays).

Appendix 3 Diagram 2. Graft of mortar composition, NIST Report to NIOSH. B Binder clay fraction.
