Brick Gable End Collapses at a Residential Fire Killing a Fire Captain and Seriously Injuring Three Other Firefighters – Illinois

Executive Summary

Brick Gable End Collapses at Residential Structure Fire Killing a Fire Captain and Injuring Three Fire Fighters – Illinois

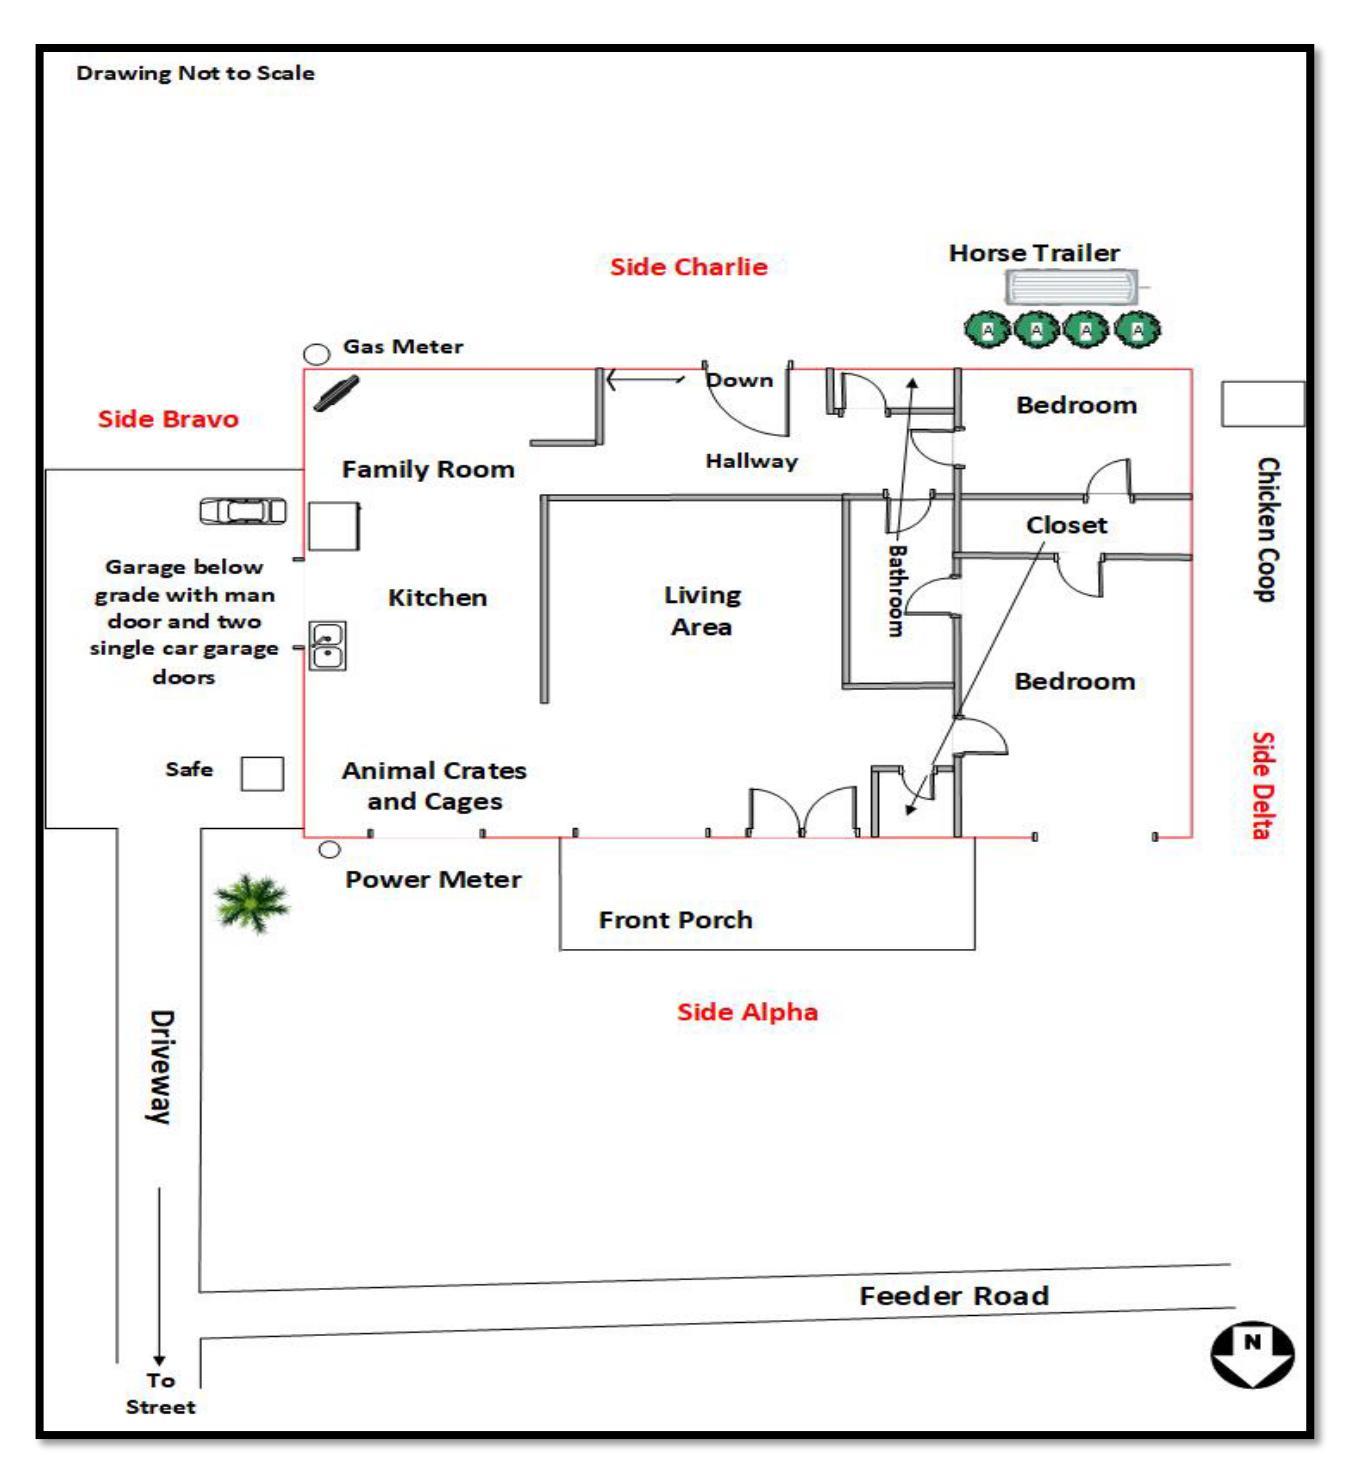
Side Alpha (north) consisted of a large front yard that ran about 180 feet from a frontage (feeder) road to the front door. A covered porch sheltered the front door and the middle two-thirds of the home. Side Charlie (south) included a back door with a few small steps leading down to the backyard where a horse trailer was parked. The brick siding and gable on Side Delta (east) did not have any doors or windows. The Side Delta yard contained a large chicken coop (**Diagram 1**). The nearest fire hydrant was located approximately 250 feet to the north-east.

Diagram 1. A diagram of the fire building's first floor and its position on the property. Dimensions are approximate. The home's square footage was 1,526 feet.
