Oxygen Regulator Flash Severely Burns One Fire Fighter - Florida

SUMMARY

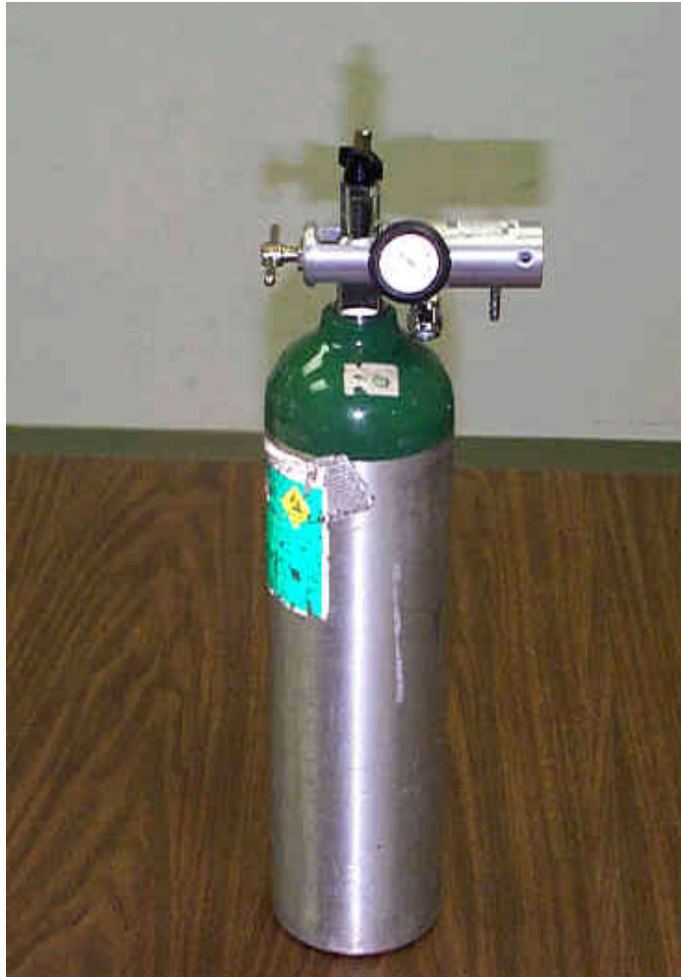
The fire fighters involved in the process of filling cylinders with oxygen are trained in the proper procedures. The oxygen cylinders commonly filled by the fire department and used as medical equipment by the paramedics and EMTs are D- and E-size cylinders (Photo 3). These cylinders are filled from a cascade system of 12 M-size (300-cubic-ft.) cylinders connected in series (Photo 4). The cascade systems used at Station 34 and 28 are capable of refilling 14 D- or E-size oxygen cylinders at a time. Two banks of 7 cylinders each are arranged in a storage rack for filling (Photo 5). As cylinders are refilled, 1 out of every 14 is sampled to ensure the cylinder is filled with 99.7% pure oxygen. If a sample is found to fall below 99.7%, the entire lot of 14 is isolated until the problem is identified and corrected. After filling, each cylinder is capped with a plastic plug over the post valve opening to keep the valve clean and to identify cylinders that are ready for use.

Photo 3: This photo depicts a D-size cylinder similar to the one that was involved in the incident.

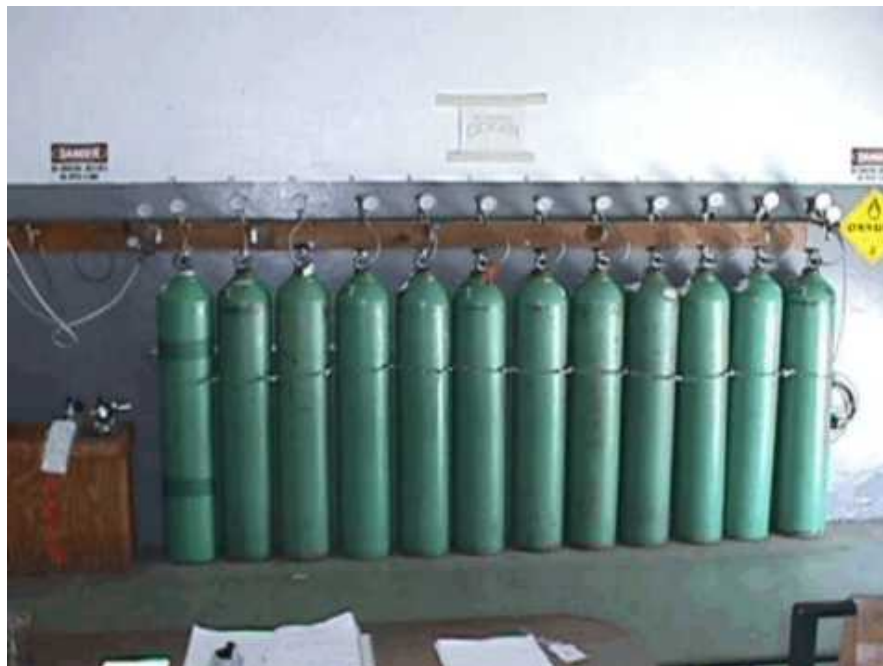
Photo 4: This photo depicts the cascade system used by the fire department to refill the oxygen cylinders. The cascade system is composed of 12 M-size (300 cubic

foot) cylinders connected in series.

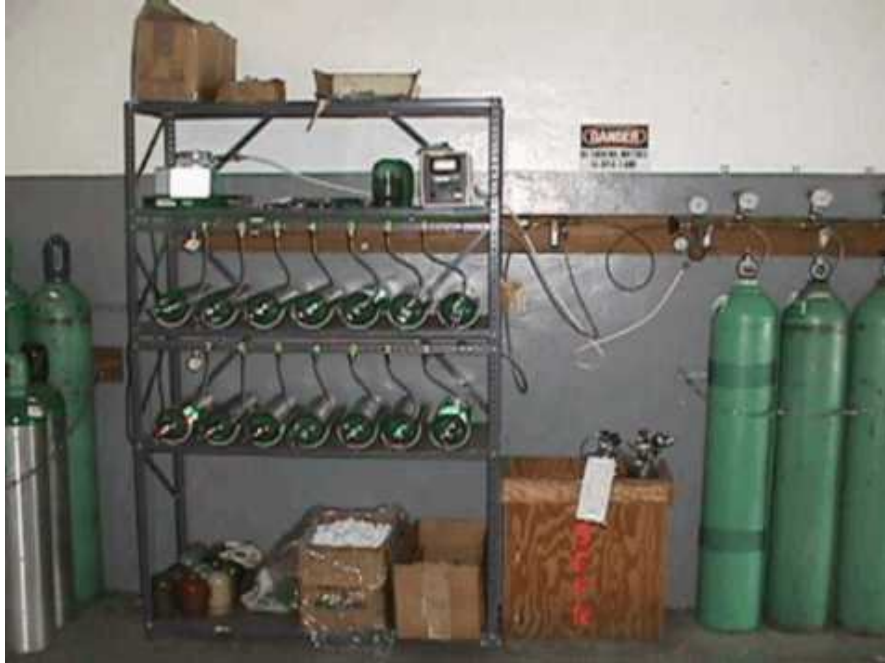
Photo 5: This photo depicts the cascade system at station 34 which is capable of refilling 14 D-size oxygen cylinders at a time. Two banks of 14 cylinders (27 total) are arranged in a storage rack for filling.
