A Summary of a NIOSH fire fighter fatality investigation

Volunteer Fire Fighter Died After Being Struck by an Eighteen-Wheel Tractor Trailer Truck - South Carolina

Fatality Assessment and Control Evaluation Investigative Report #99F-38

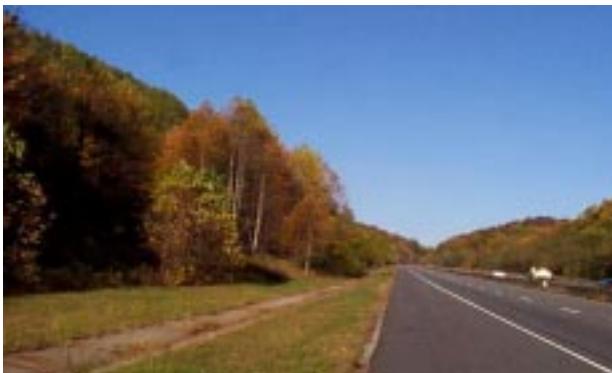
Incident Scene

On September 27, 1999, one male volunteer fire fighter died after being struck by a tractor trailer truck. He was part of a volunteer fire department (Volunteer Fire Department #2) that had been called out to provide assistance for another local volunteer fire department (Volunteer Fire Department #1). Volunteer Fire Department #1 was dispatched to a reported wreck involving a tractor trailer truck on a four-lane highway approximately 1 mile south of the North Carolina state line. The victim arrived on scene to provide assistance with traffic control for the fire fighters attending to the tractor trailer wreck. After arriving on scene, the victim was told to set up for traffic control in the southbound lanes. The victim then drove Rescue Unit 205 (R-205) northbound on the outer emergency lane of the southbound lanes, facing oncoming traffic, to an area that provided the most visibility and warning to oncoming traffic (Figure 1). Rescue Unit 205 was positioned $\frac{1}{2}$ mile north, around a curve, and in the lanes opposite the tractor trailer wreck. After being on scene for approximately 40 minutes, the fire fighters from both departments and one highway patrol officer heard a truck applying brakes and then saw the tractor trailer, in the southbound lane, fish tailing

and then coming to a complete stop. They recalled seeing the driver of that truck getting out of his vehicle and walking around the truck as if he were inspecting his truck for any damages or malfunctioning parts. The driver then got back into his truck and drove away. Approximately 2 minutes later, another truck driver heading southbound stopped and informed the fire fighters that he had just passed a fire fighter who was lying on the ground in front of a fire truck. The fire fighters from both departments then drove up the road and found that the victim and R-205 had both been struck by a motor vehicle. The victim was treated at the scene and then transported by ambulance to the local hospital. Medical treatment was continued at the hospital where he was later pronounced dead. NIOSH investigators concluded that, to minimize the risk of similar incidents, fire departments should

- *establish, implement, and enforce standard operating procedures (SOPs) regarding emergency operations for highway incidents*
- *ensure that fire fighters responding to a scene involving a highway incident or fire*
