NIOSH
Fire Fighter Fatality Investigation
and Prevention Program

A Summary of a NIOSH fire fighter fatality investigation

Six Career Fire Fighters Killed in Cold-Storage and Warehouse Building Fire - Massachusetts

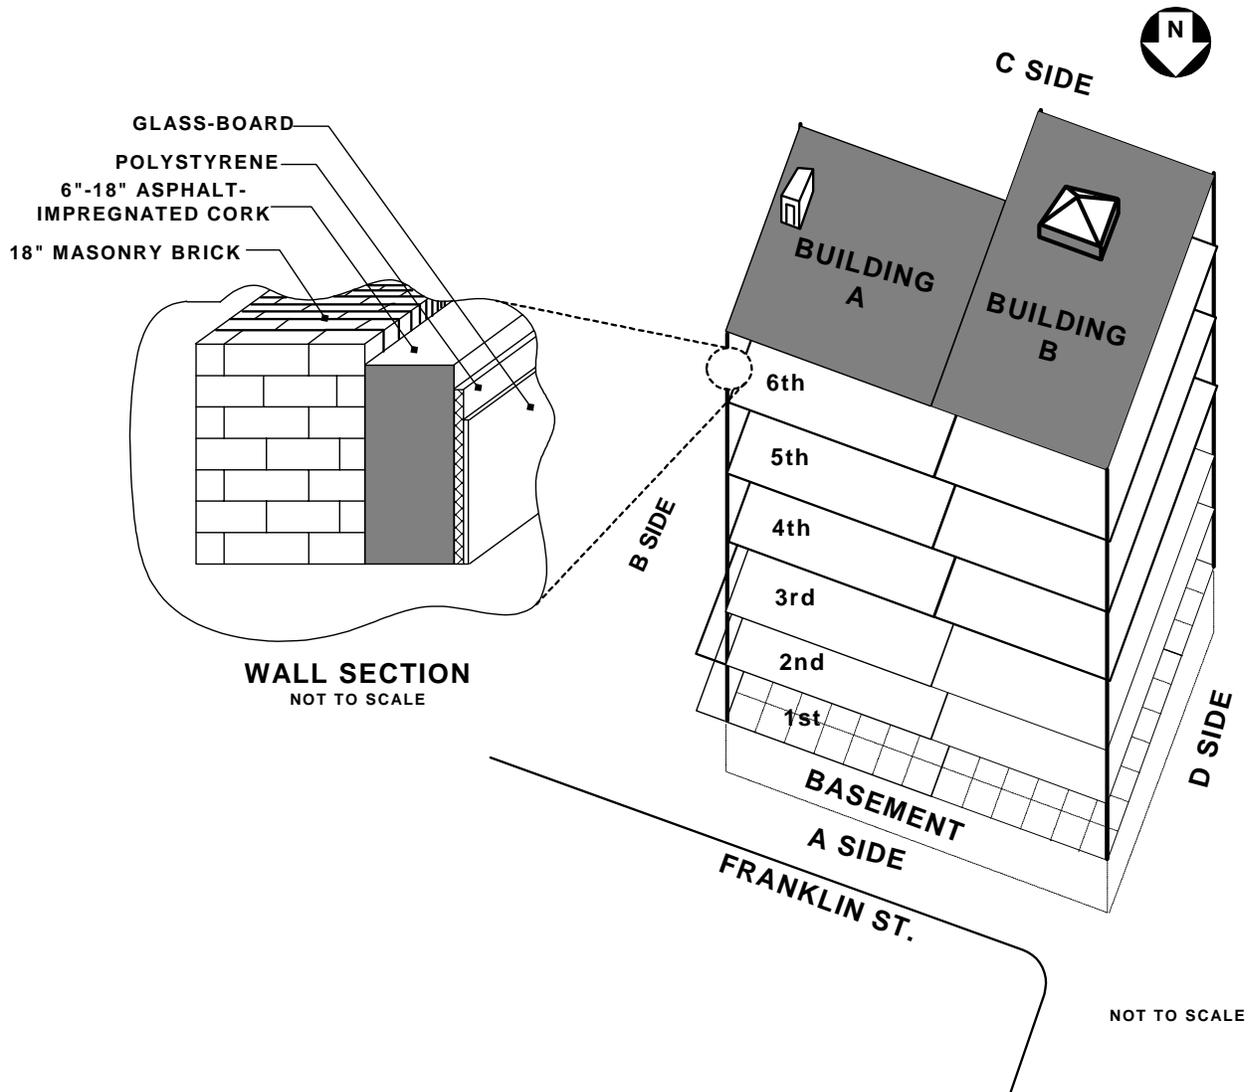
Figure 1. Cold Storage and Warehouse Building Layout, Plain View

in 1912 was referred to as Building B. The entire building contained six floors above ground, for a total of 94,176 square feet, and a full basement (see Figure 1). The exterior walls, constructed of brick, measured 18 inches thick. The interior walls were covered with 6 to 18 inches of asphalt-impregnated cork (depending on the floor level), 4 inches of polystyrene and/or foam glass, and a thin layer of glassboard (see Photo 1). The flooring was wooden except for the flooring in the basement and first and second floors, which were concrete. The joists consisted of heavy timbers. Two stairwells were present; one was located on the B side and extended from the basement to the flat roof, and the other was located on the C side and extended to the third floor only (see Figure 2). Two sets of freight elevators were present, one on the B side and the other on the C side, and both were adjacent to stairwells. Two loading dock areas existed; one was located on the B side while the other was located on the C side (see Photo 2). Six windows were present on the second-floor level, three on the A side and three on the D side of Building B, but they had been covered with plywood. Window openings which were present in the stairwell on the B side were also covered with plywood. Although the building entrances and exits had been secured by plywood since 1991, homeless people had gained access to the building and established living quarters.

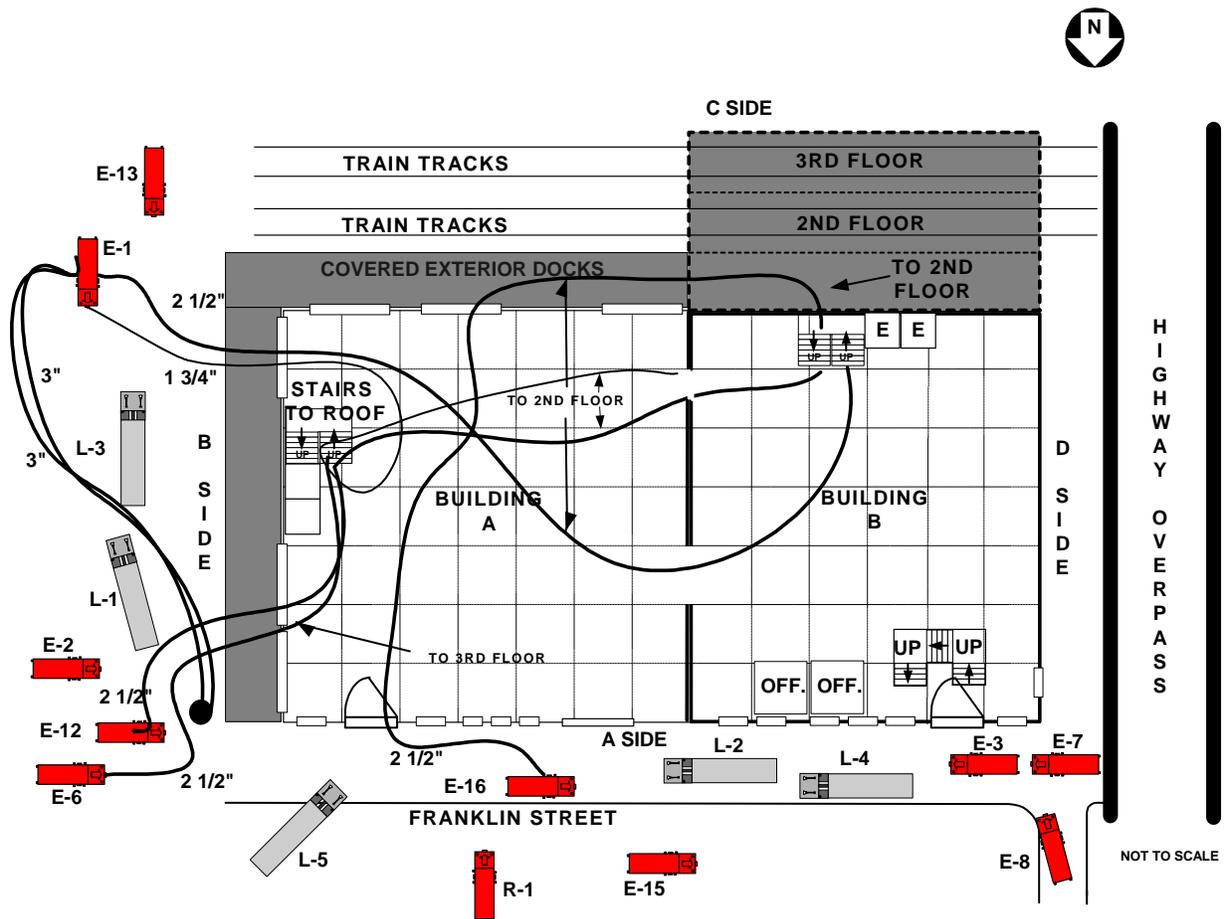
Figure 3. Cold Storage and Warehouse Building, Hoseline/Apparatus Layout, First Floor View

a 2 ½-inch line from Engine 16 be laid to the elevator shaft on the second floor at the C/D corner. A 1 ¾-inch line from Engine 1, a 2 ½-inch line from Engine 12, and a 2 ½-inch line from Engine 6 had been laid to the second and third floors through the stairwell on the B side (see Figure 3). All the lines were charged except the 2 ½-inch line from Engine 6, and active fire fighting began. (The line from Engine 6 had been laid to the third floor in Building A, but since no fire was found there, the line was not charged.) At 1826 hours, IC#1 was advised that two homeless people might be in the building. Car 2 (the second Incident Commander [IC#2] and his Aide) arrived on the scene at 1831 hours. IC#2 assumed command and was positioned on the outside of the A/B corner of the building. He requested a status report from IC#1, who was now the Interior Commander conducting interior operations, and he was told that heavy fire was burning on the second and third floors in Building B and that two homeless people might be in the building.
