SERIOUS INJURY REPORT

REPORT F2026-01 • April 2026

Four Career Firefighters Injured from a Floor Collapse in an Abandoned Residential Structure Fire – Kansas

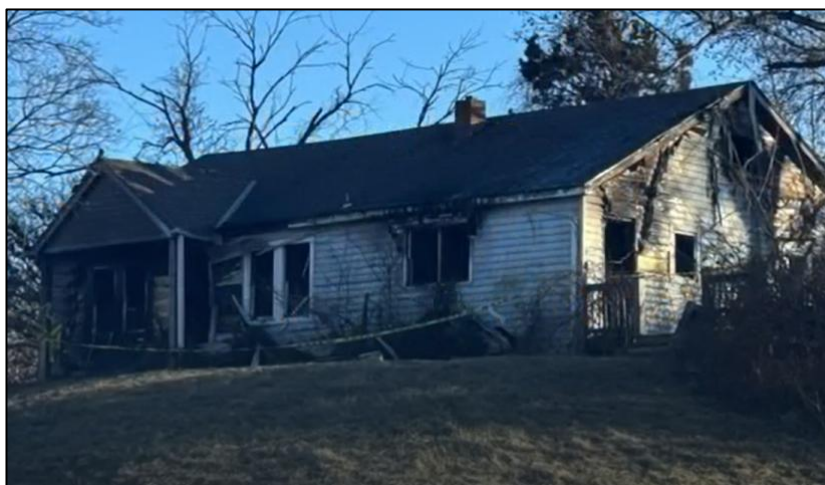
**Photo 1: View of Side Alpha of structure, post-fire.
(Courtesy of the fire department)**

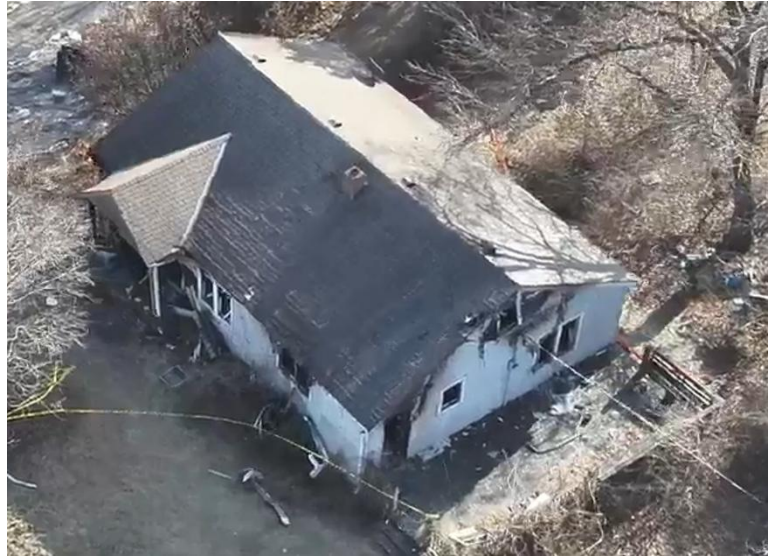
This incident involved a single-family, two-bedroom residential structure built in 1950 (see **Photo 2**). It was wood frame construction containing 1,350 square ft of above grade living space (see **Diagram 1**) and 216 square ft of below grade living space added in 1966. The structure's exterior was constructed with vinyl siding over wood siding and an asphalt-shingled roof. Located on Side Delta of the structure was a 12 ft x 30 ft wood deck. The structure was positioned on a raised lot with steps leading from a large concrete parking area to the main entrance. The parking area led to a below grade, single vehicle garage positioned on Side Bravo.

Photo 2: Aerial view of structure, post-fire.
(Courtesy of the fire department)

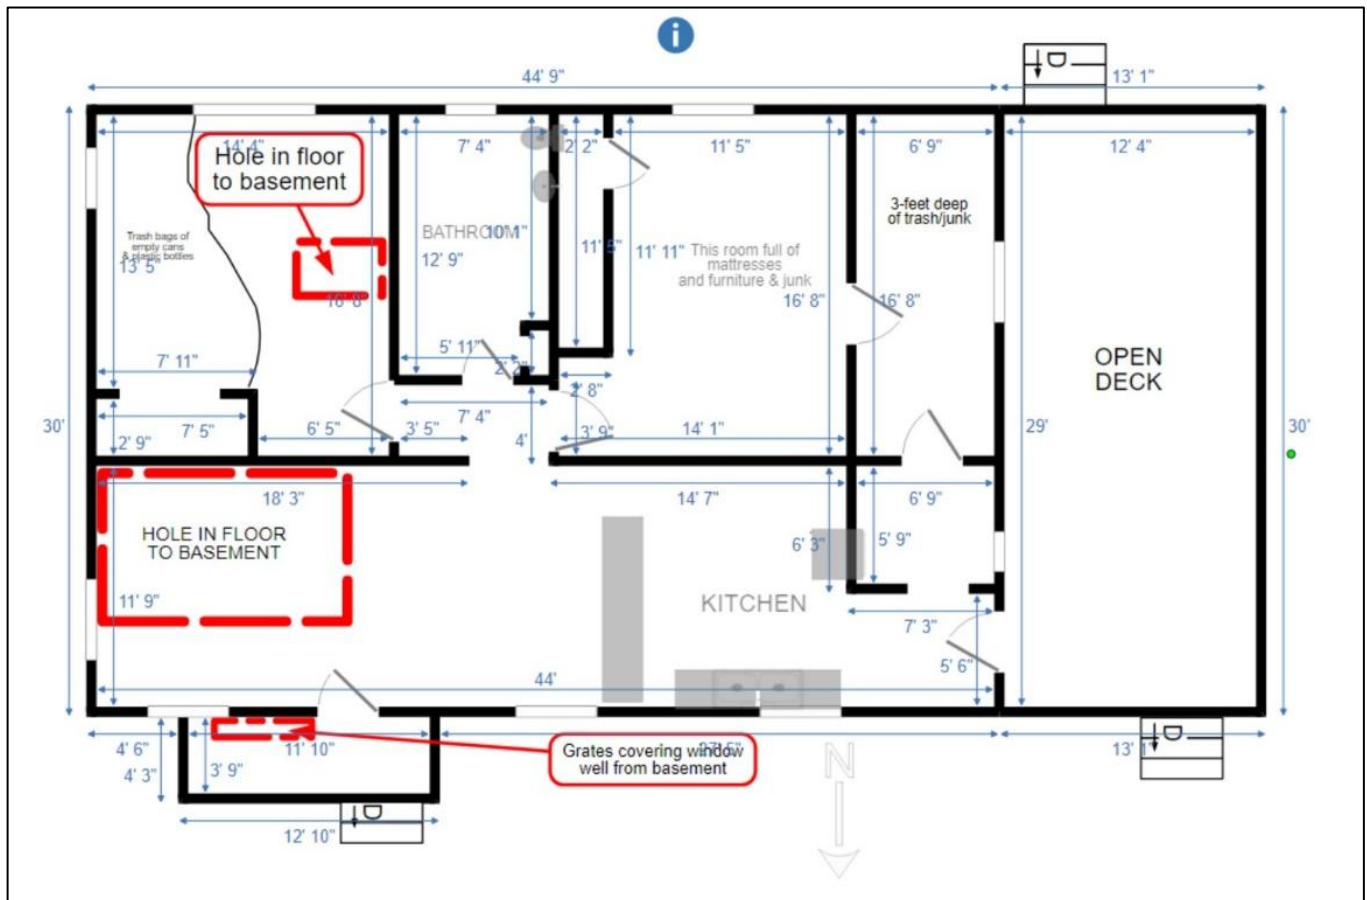
Diagram 1: Floor plan of structure.
(Courtesy of the fire department)

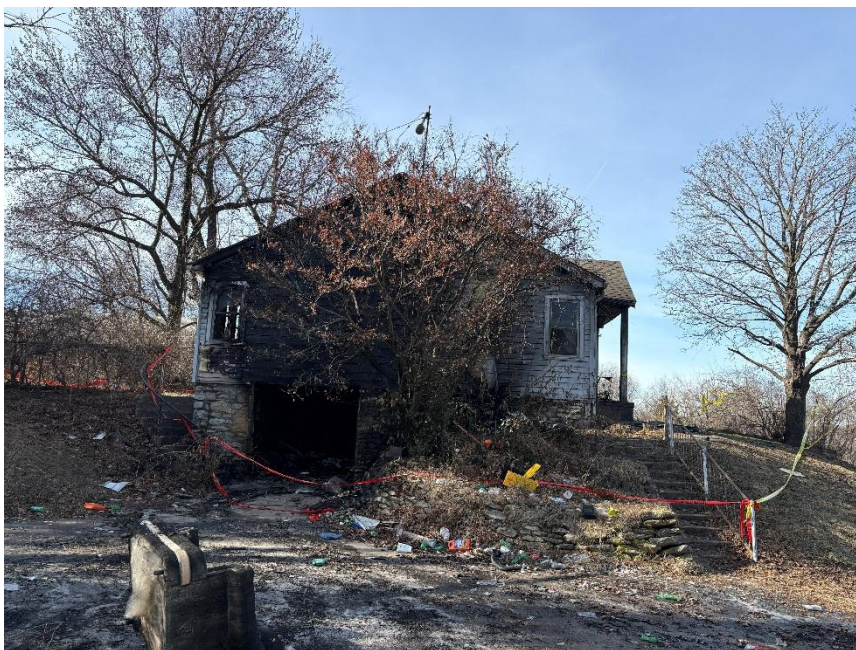
At 03:49 hours, Pumper 18 and Medic 18 arrived on scene. Pumper 18 traveled up a long driveway and staged near the structure. Pumper 18 officer gave a size-up of a single-story wood frame structure with heavy fire showing from Sides Bravo and Charlie (**see Photo 8**). He reported Pumper 18 would be stretching an attack line and directed the second arriving unit (Pumper 14) to establish a water supply. He assigned the first truck to search operations. He announced that he would be completing a 360 size-up.

Photo 8: View of Side Bravo garage entrance, post-fire.
(Courtesy of the fire department)

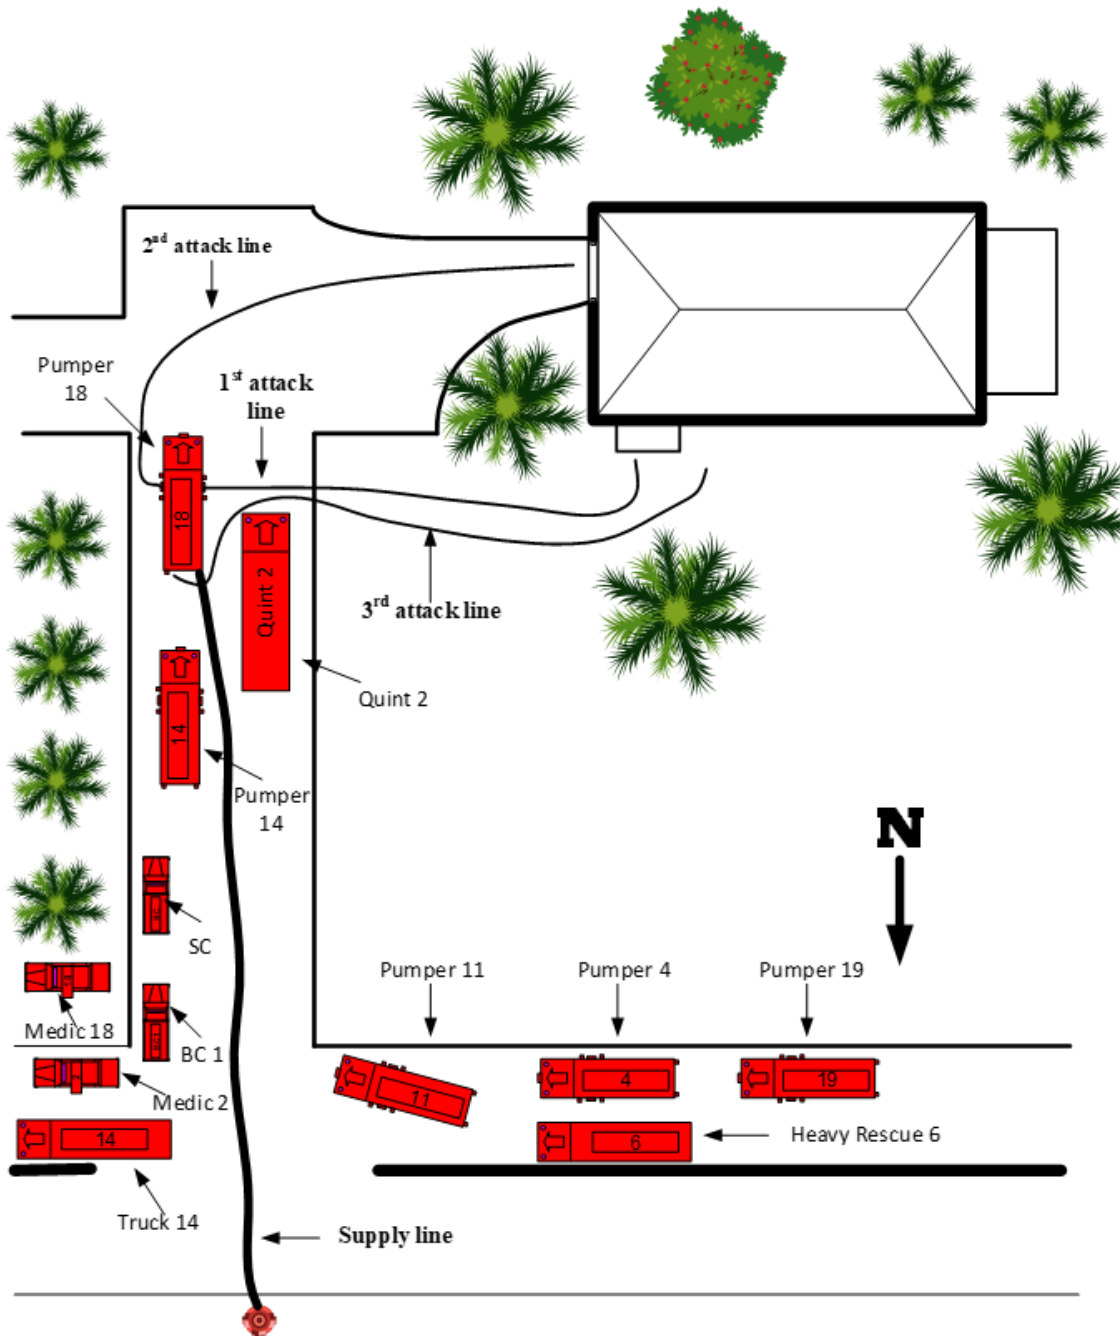
Diagram 3: Apparatus placement on scene.
(Courtesy of NIOSH)
