# NIOSH FIRE FIGHTER FATALITY INVESTIGATION AND PREVENTION PROGRAM

## SERIOUS INJURY REPORT

### Career firefighter sustains serious burns at residential structure fire with hoarding conditions – Virginia

F2026-05 VA · July 2026

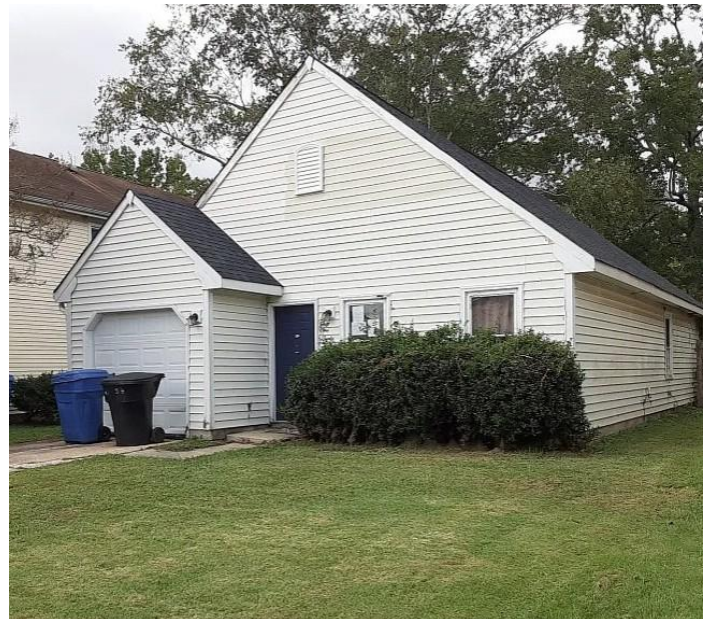
Image 2. View of Side Alpha, pre-incident. (Source: Fire department)

This incident involved a type V, wood-frame construction, residential structure built in 1982. It was two-stories with 1,425 square feet of living space. The structure included three bedrooms, two bathrooms, a garage, and an attic. The backyard (Side Charlie) was fenced off with a 6 ft wood fence. The attic space had knee walls that were approximately 5 ft in height. The attic contained two small rooms connecting into the knee walls on Sides Alpha and Charlie. Each room had a small door. There was one window in the attic on Side Charlie. At the time of the incident, firefighters described the attic as containing hoarding conditions with large amounts of boxes, totes, and other items being stored throughout with only a small path to walk through.

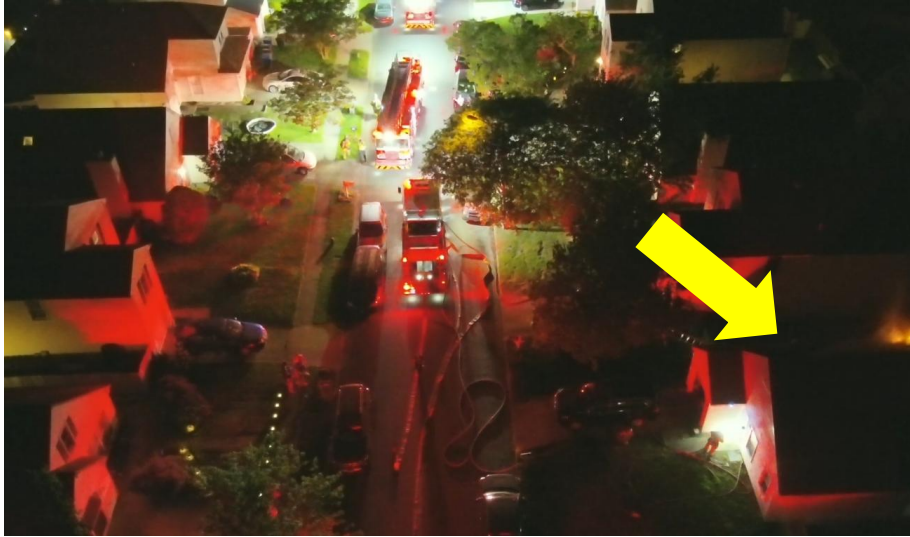
Image 4. Apparatus placement with Engine 16 preparing to enter structure. Arrow indicating incident structure. (Source: Fire department)

- Engine 16 and Ladder 16 arrived on scene.
- Engine 16 officer gave a size-up of a two-story residential structure with smoke coming from the back and fire coming from the vent on the roof. He requested to designate this a working fire, established command, and requested the next arriving unit to establish a water supply.
- Engine 16 officer did a 360 size-up while his driver stretched a 200 ft 1 ¾-inch hoseline to the front door.

- Engine 16 firefighter masked up as the hoseline was charged and Engine 16 officer ordered him to direct water onto the vent fire on the Side Bravo roof.
- BC3 reported he was on scene, assumed command, and that on-scene units would be in offensive mode. He initially staged four houses down and had limited visibility of the fire building.
